Appendix 1O: Terrestrial Biodiversity and Habitat Assessment

Solomon Islands Urban Water Supply and Sanitation Sector Project

September 2022

Terrestrial Biodiversity and Habitat Assessment

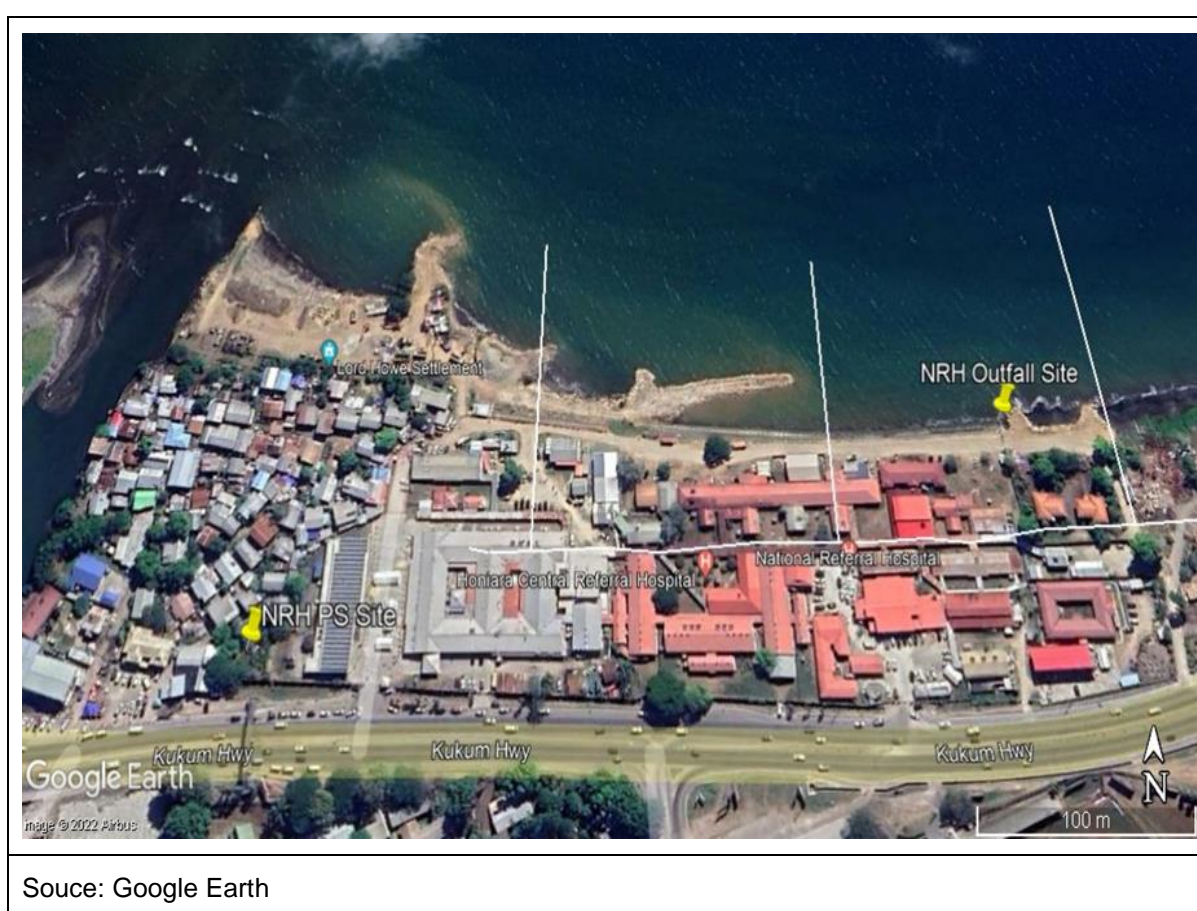
Figure 3-5: Site location of NRH PS and Outfall in relation to its surrounding environments

The NRH outfall and PS are located in highly built-up areas in Chinatown at the NRH Compound in Central Honiara. The PS site is on GPS coordinates 9° 26.137'S, 159° 58.097'E and the outfall site is on GPS coordinates 9° 26.078'S, 159° 58.306'E. The overall site is situated on the Mataniko River Delta. On the southern side is China Town which was recently extensively burnt during the “April” riots. Adjacent to the PS is the Lord Howe Settlement and the main highway. The Outfall site is on the foreshore in front of the hospital’s eastern wing. The pumping station collects the wastewater from Point-Cruz, Mataniko and Mbokonavera catchments and also collects the discharge from Tuvaruhu, Vara Creek, and China Town areas. The wastewater is to be discharged through a single Outfall served by the NRH PS.

The NRH outfall and PS site are located at lower Mataniko on the eastern side of the Mataniko River delta and approximately at coordinates 9° 26.137'S, 159° 58.097'E and 9° 26.078'S, 159° 58.306'E (**Figure 3-5**) respectively. Adjacent to the area is the National Referral Hospital (eye clinic) and the densely populated village 'Lord Howe Settlement' where people from Ontong Java have settled. With limited land available, houses are built less than a meter from each other in a crowded environment.

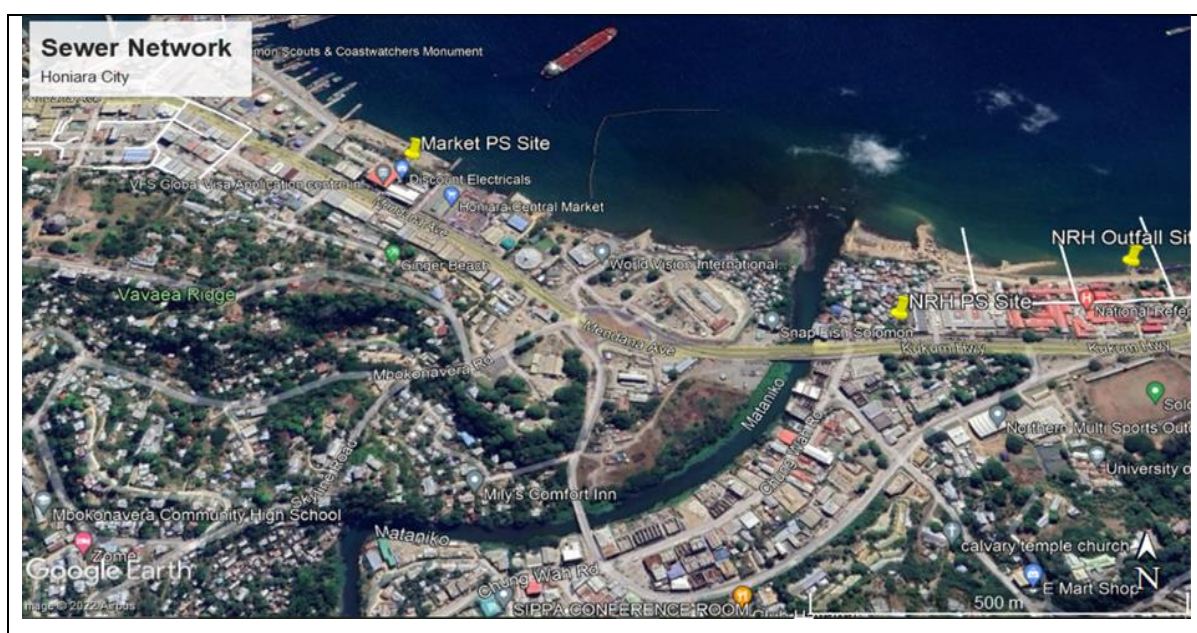
Figure 3-6: Site location of Market PS in relation to its surrounding environment

The new Market PS (also called SIPA PS) is located at the Solomon Ports land on GPS coordinates 9° 25.954'S and 159° 57.674'E. The site is in front of the Hyundai Building and shares a boundary with the Kosol property. Solomon Ports is currently reclaiming the foreshore for its port development expansions for new jetties on the eastern end towards the Central Market. The pumping station will collect wastewater from Point Cruz and Mokonavera's catchments and discharge through a single rising main into NRH PS.

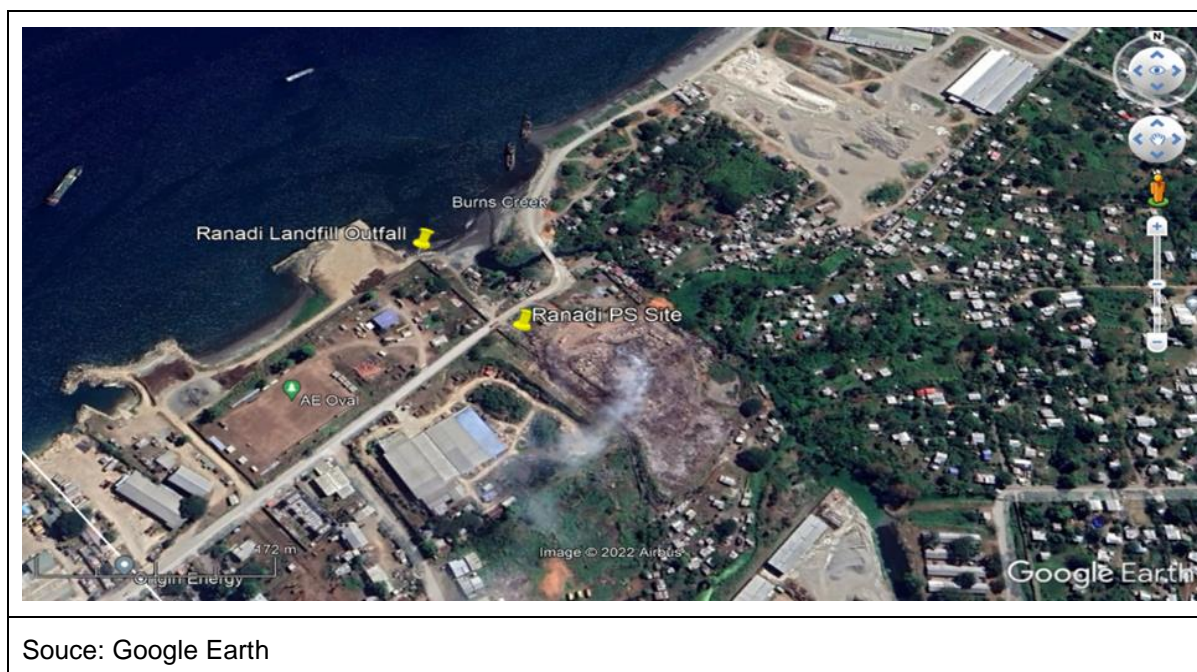
Figure 3-10: Site location of Ranadi landfill PS in relation to its surrounding environment

The Ranadi landfill outfall/PS is located east of Honiara, downstream of the sewer network on the coast at Burns Creek. They are located at GPS coordinates 9° 25.009'S, 160° 0.829'E and 9° 25.055'S, 160° 0.883'E respectively. The pumping station collects wastewater from Ranadi PS and King George VI catchment and discharges the effluent to the Ranadi outfall to the sea.

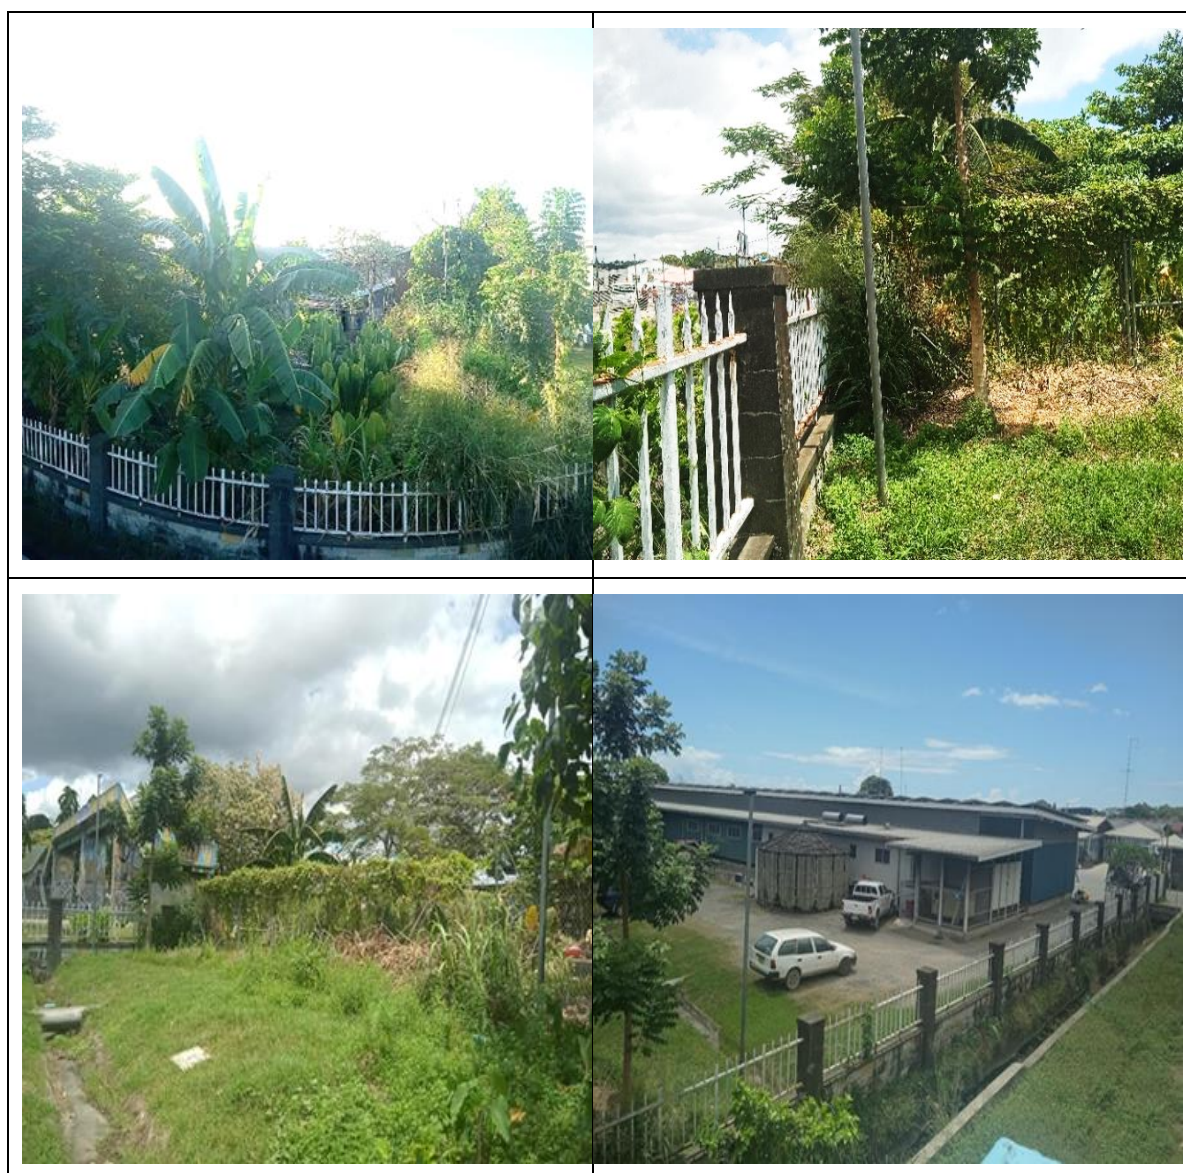
The inland coastal vegetation recorded at the NRH outfall/PS are highly disturbed and tolerant to a highly modified environment. The vegetation recorded at the proposed new pumping station is non-native and the natural vegetation associated with the subproject's direct area of influence (pipeline corridor) has been modified and cleared previously for the existing main road and various buildings. The current development areas support trees and shrubs such as *Spathodea companulata* (African tulip), *Broussonetia papyrifera* (paper mulberry) and *macaranga* sp and including creepers and, grasses such as *Sida acuta*, *Cenchrus calycultus* and *Milkenia micrantha* (cyclone rope). Vegetation directly adjacent to the pumping station includes garden crops planted by residents from the settlement. These includes; *Musa* sp (Banana), *Xanthosoma* spp (Hongkong Taro), *Colocasia esculenta* sp (Taro) *Saccharum officinarum* (Sugar cane) *Manihot esculenta* (Cassava) and *Ipomoea batatas* (Sweet Potato).

The soil type found in this site in general is loam soil. Loam soil is a mixture of clay, sand and silt and is fertile, high in nutrients, provides good drainage and is good for plant growth. This is evident on site as the garden crops and associated flora tend to be growing well.

Plate 4-1: Garden crops and other associated terrestrial vegetation found at the PS Site, NRH

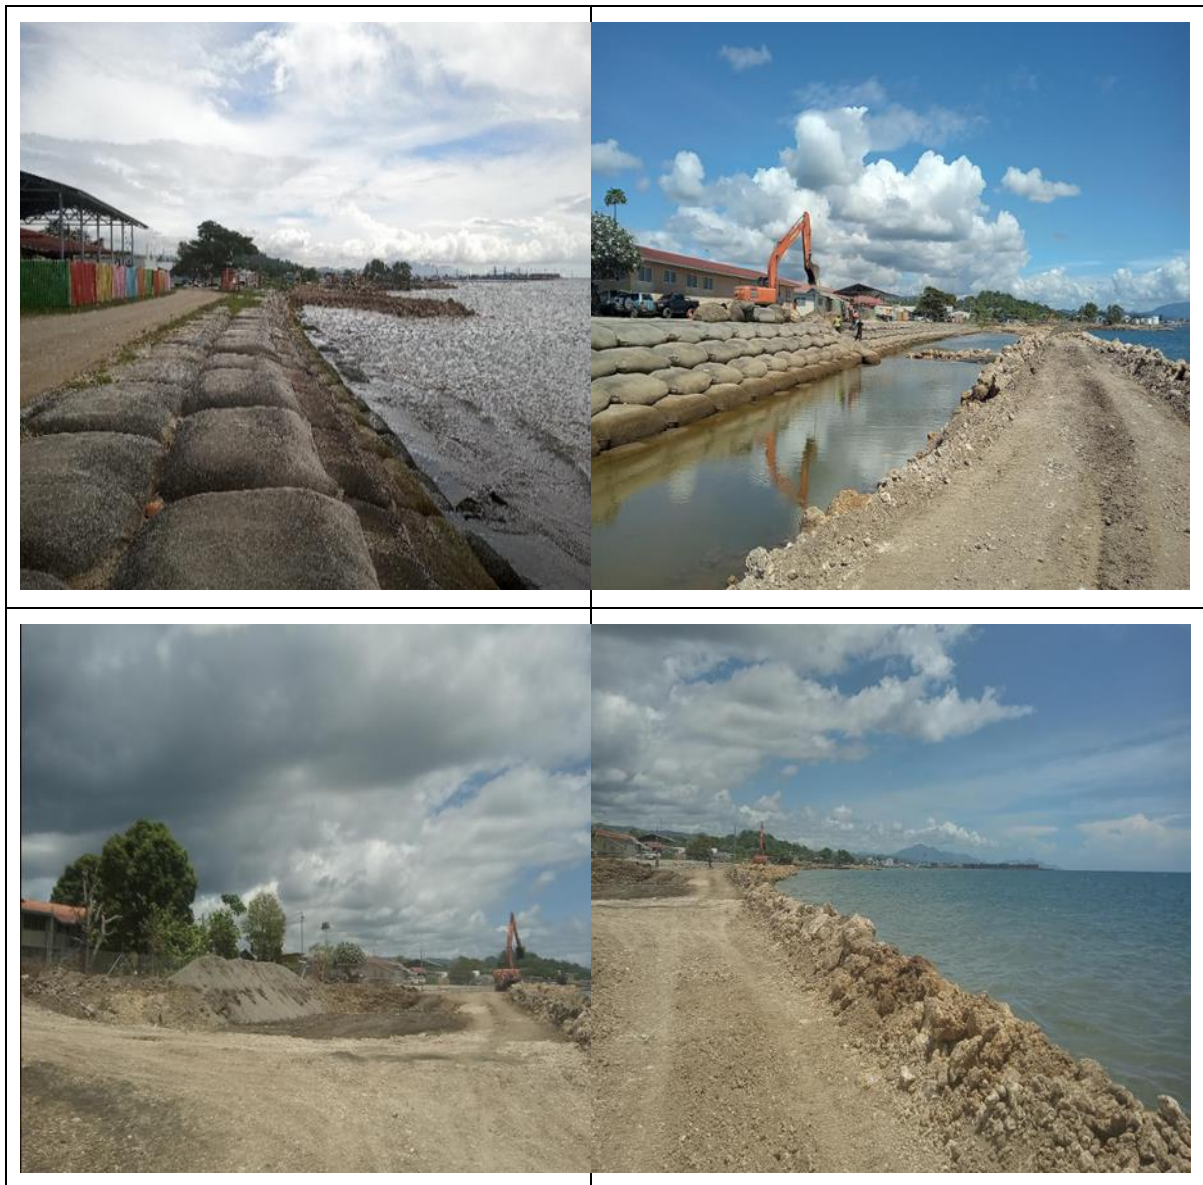
At the outfall site, the surrounding secondary vegetation has been previously cleared in the past for the construction of the National Referral Hospital and staff housing. However, further clearances of the remaining secondary vegetation continue for development expansions. Recently, secondary vegetation east of the outfall site was cleared away completely (**Figure 4-3**). The shoreline has also changed over time due to ongoing and extensive coastal development. The Hospital previously constructed a barrier along the shoreline to prevent the shore from being eroded during cyclones or storm surges due to its close proximity to the sea. Recently, a developer started reclaiming the foreshore near the outfall site and will reportedly continue with the reclamation activities for about 230m seaward and 635m along the coastline. Much of the shoreline had been covered with coronous materials and boulders.

Discussions with the developer and MECDM indicated that the development does not have the requisite approvals and is now in court, but reclamation works are continuing regardless. There is also a concern that the developer does not have an agreement with the correct traditional owners in any case.

Plate 4-2: Extensive coastal developments along the outfall site

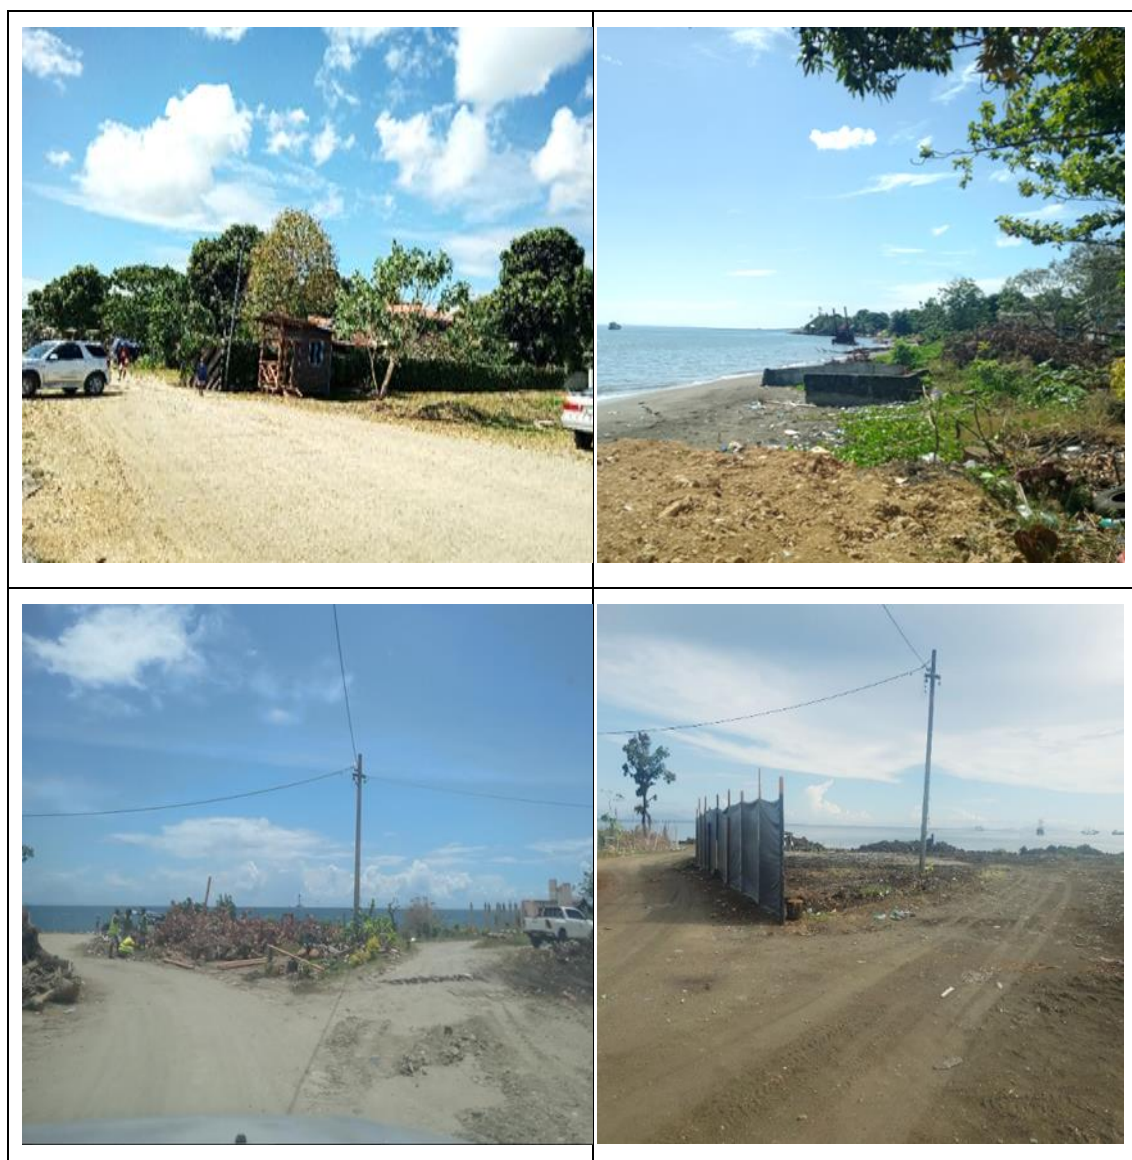
The coastal strand vegetation along the areas inland from high water mark which are indirectly impacted consists mainly of *Macaranga* sp, *Barringtonia asiatica* (fish poison tree), *Annona muricata* (Soursop), *Morinda citrifolia* (noni), *Barringtonia edulis* (Cut-nut), *Jatropha curcas* (poison nut), *Premna serratifolia* (headache tree). Vines and grasses include *Antigonon leptopus*, *Paspalum vaginatum*, *Ipomoea triloba* (littlebell, *Eleusine indica* and *Digitaria sanduinalis*. Towards the eastern side of the outfall, vegetation is dominated by *Terminallia catappa* (Alite), *Premna serratifolia* (Headache Tree) and *Ipomoea littoralis*.

Plate 4-3: Showing the typical coastal strand vegetation prior to clearances and recent vegetation clearances at the eastern side of the outfall site, NRH

The coastal vegetation along the site and which could have acted as a buffer zone from the sea has been changed dramatically due to anthropogenic developments occurring in the area leaving no trace of the original vegetation. And with such occurring, it has potentially affected the abundance and distribution of plant community and also fauna habiting the area. No evidence was recorded of any threatened or endangered flora observed during the site assessment.

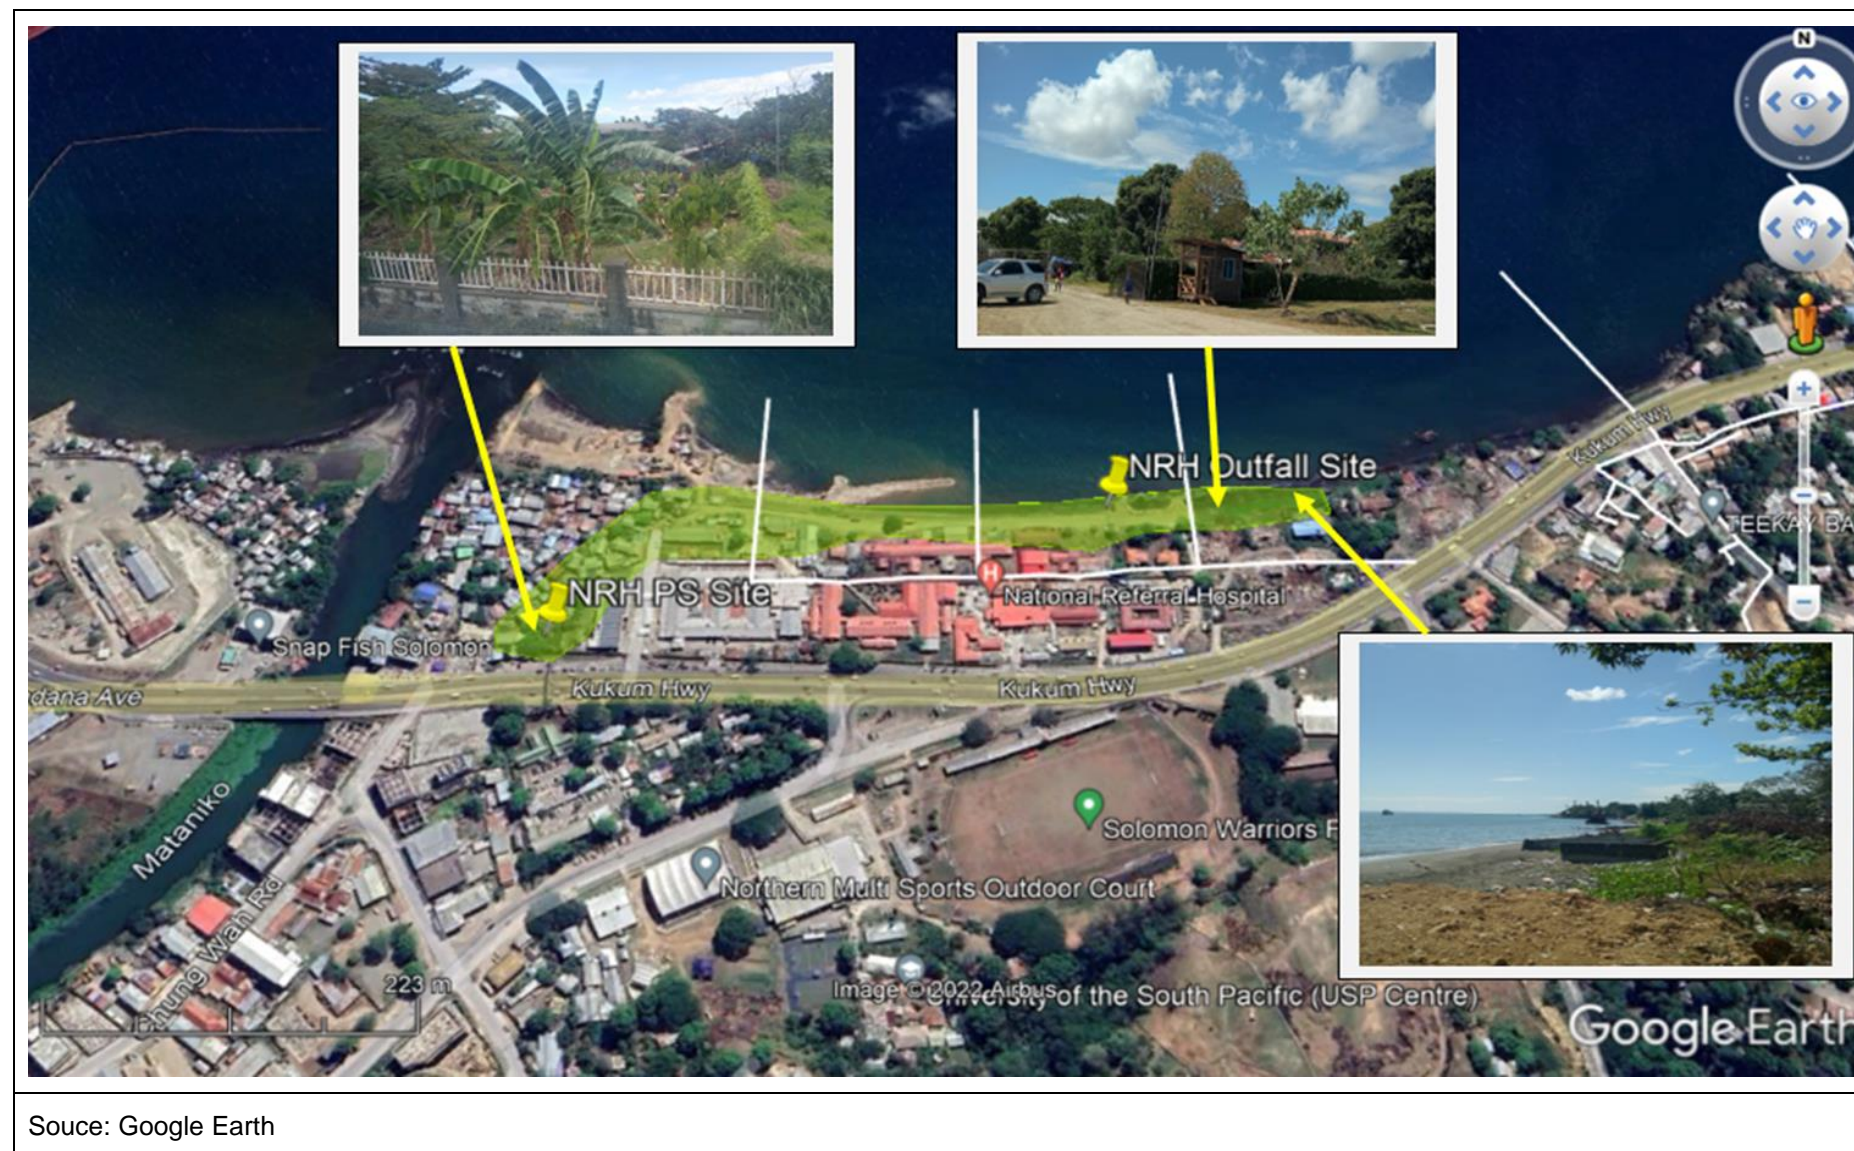
Figure 4-1: Typical vegetation found at the NRH outfall and PS sites

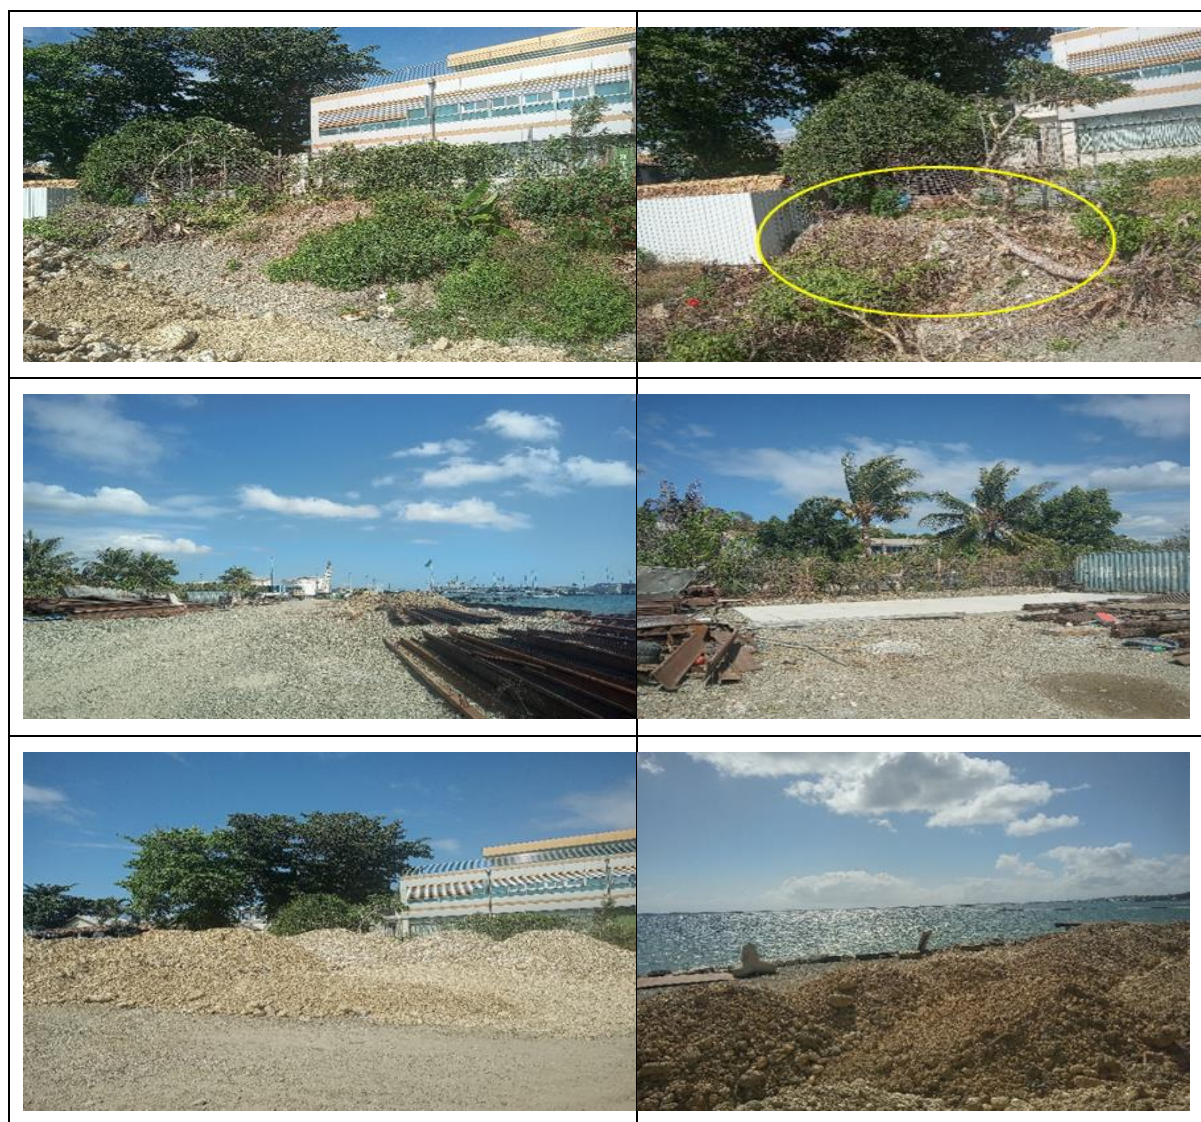
The Market PS (also called the SIPA PS in some documents) is situated at the Solomon Islands Ports Authority (SIPA) land at Point Cruz which shares a boundary with Kosol Ltd Company (**Figures 3-5 and Figure 4-2**). The PS is on reclaimed land at GPS coordinates 9° 25.954'S and 159° 57.674'E. Recently, Solomon Ports are reclaiming the foreshore for its port development expansions. The site is highly disturbed with surrounding vegetation supporting only secondary regrowth. The original coastal vegetation in the area was cleared more than a decade ago for business expansion. Since then, the area has continued to be disturbed with more infrastructure development along the coastline with the remaining original flora completely removed. The recolonizing vegetation species established in the PS site include invasive grasses and creepers comprising of *Passiflora* sp (sweet rope), and *Coccinia grandis* (l.), *Voight* (Ivy Gourd), *lepturus repens* (grass sp) and *Paspalum Vaginatum* (seashore paspalum). Ornamental plants such as *Plumeria* sp (frangipani) and *Jatropha integerrima* (peregrina) and including *Cocos nucifera* (coconut) are grown along the area boundary line. None of the vegetation observed is of significant value and the majority of plants recorded are introduced and invasive species recolonizing the reclaimed land.

Plate 4-4: Typical coastal vegetation at the reclaimed area at Point Cruz (at SiPA land) where Market PS is situated.

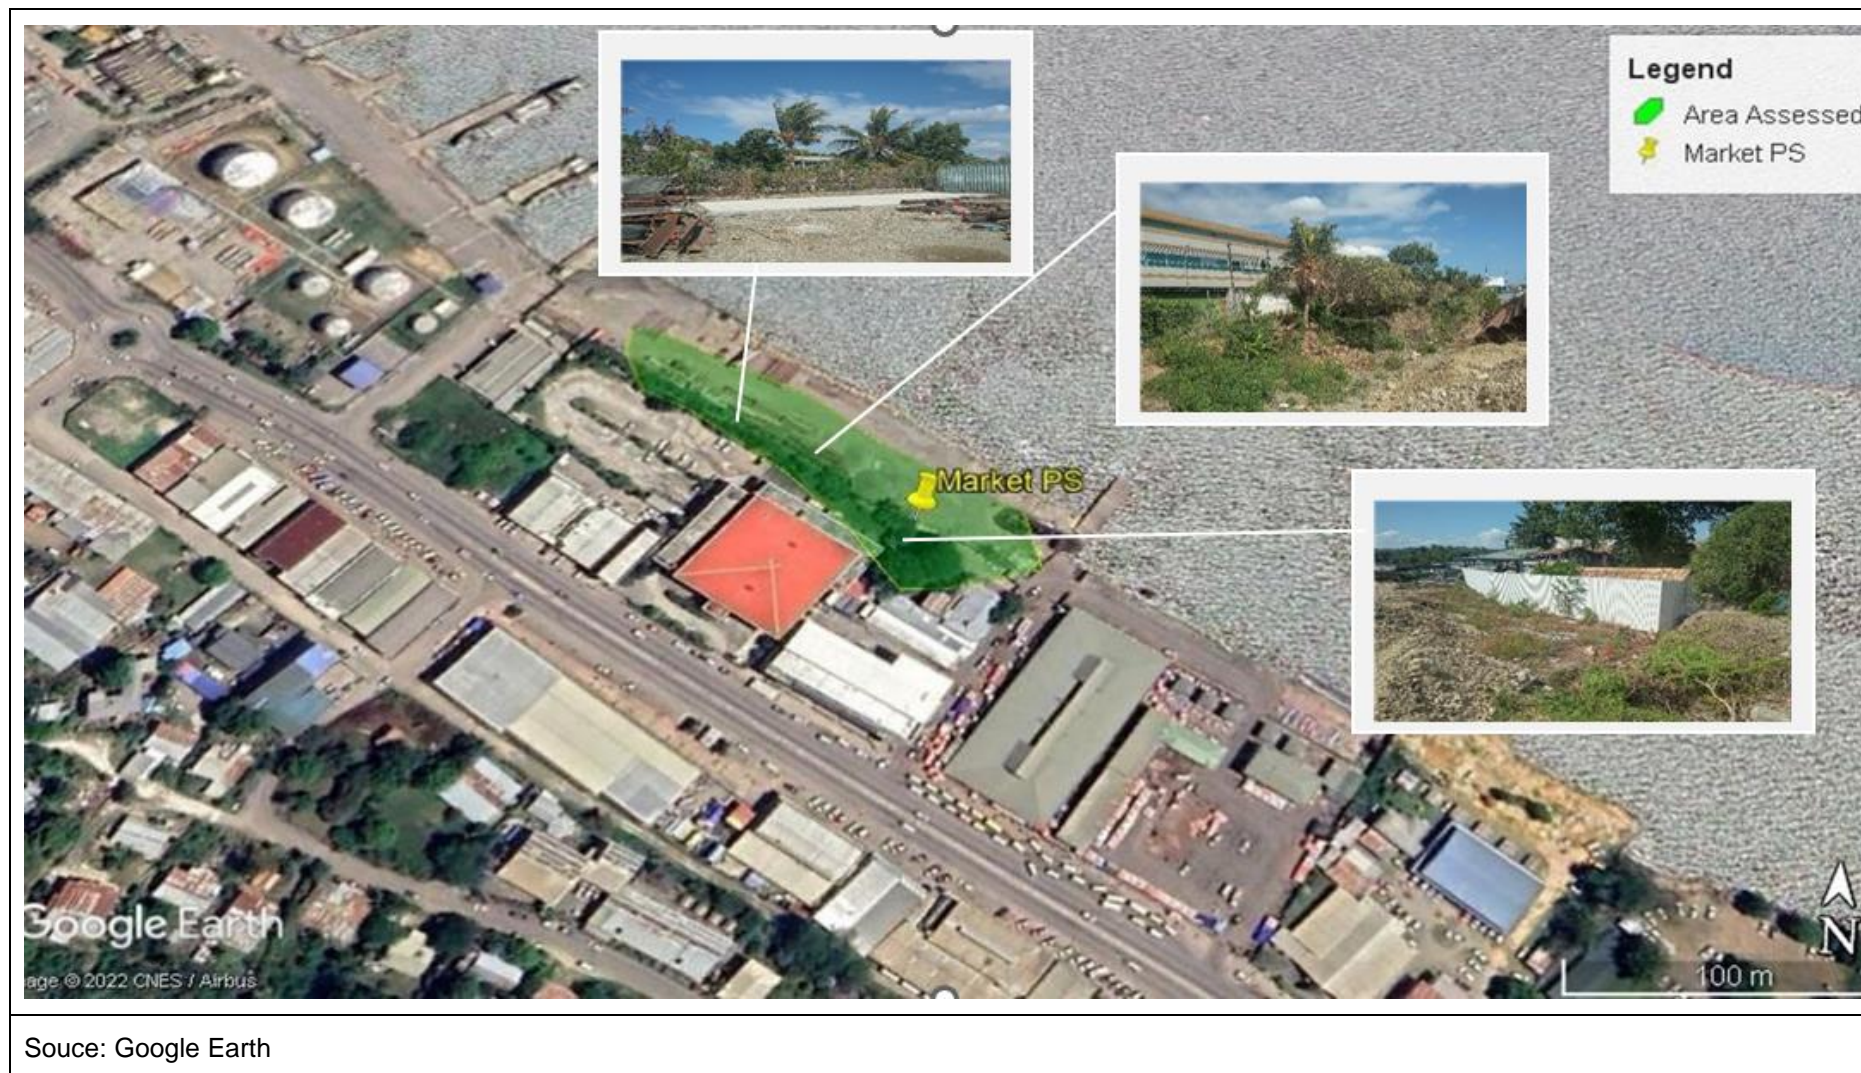
Figure 4-2: Typical Vegetation found at the surveyed area at SIPA land, Market PS Site

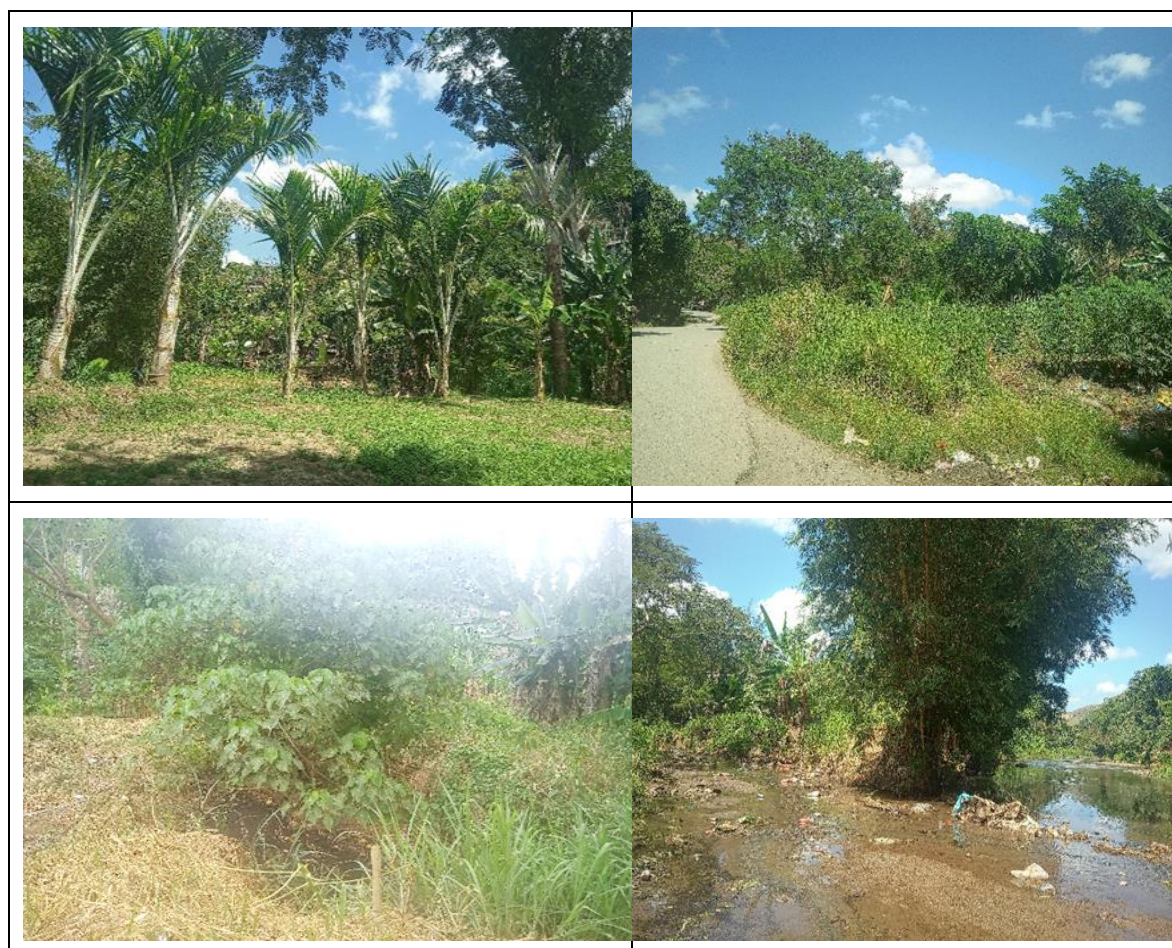
The PS site is highly disturbed and vegetation is secondary regrowth as it was previously cleared with no original flora and fauna now present. Adjacent to the PS site, vegetation has been recently cleared for a community hall. Fringing the creek and riverside, several *Metroxylon salomonense* (Sago) trees were located while *Macaranga sp*, *Samanea saman* (rain tree), *Leucaena leucocephala* (white lead tree) and *Musa sp* (banana) dominated. *Manihot esculenta* (cassava) is also found among other regrowth areas. The dominant species of grass is *Panicum maximum* and vines including *Merremia peltate* (Peltate morning glory) and *Mikania micrantha* (cyclone rope) are common. The majority of vegetation on the site is highly tolerant to disturbance and no threatened or endangered flora species were observed during the site assessment. The soil type present is sandy loam, which is very fertile and rich in nutrients, therefore plant growth on this site is well established.

Plate 4-5: Typical vegetation at the Vara Creek PS site and its surrounding areas.

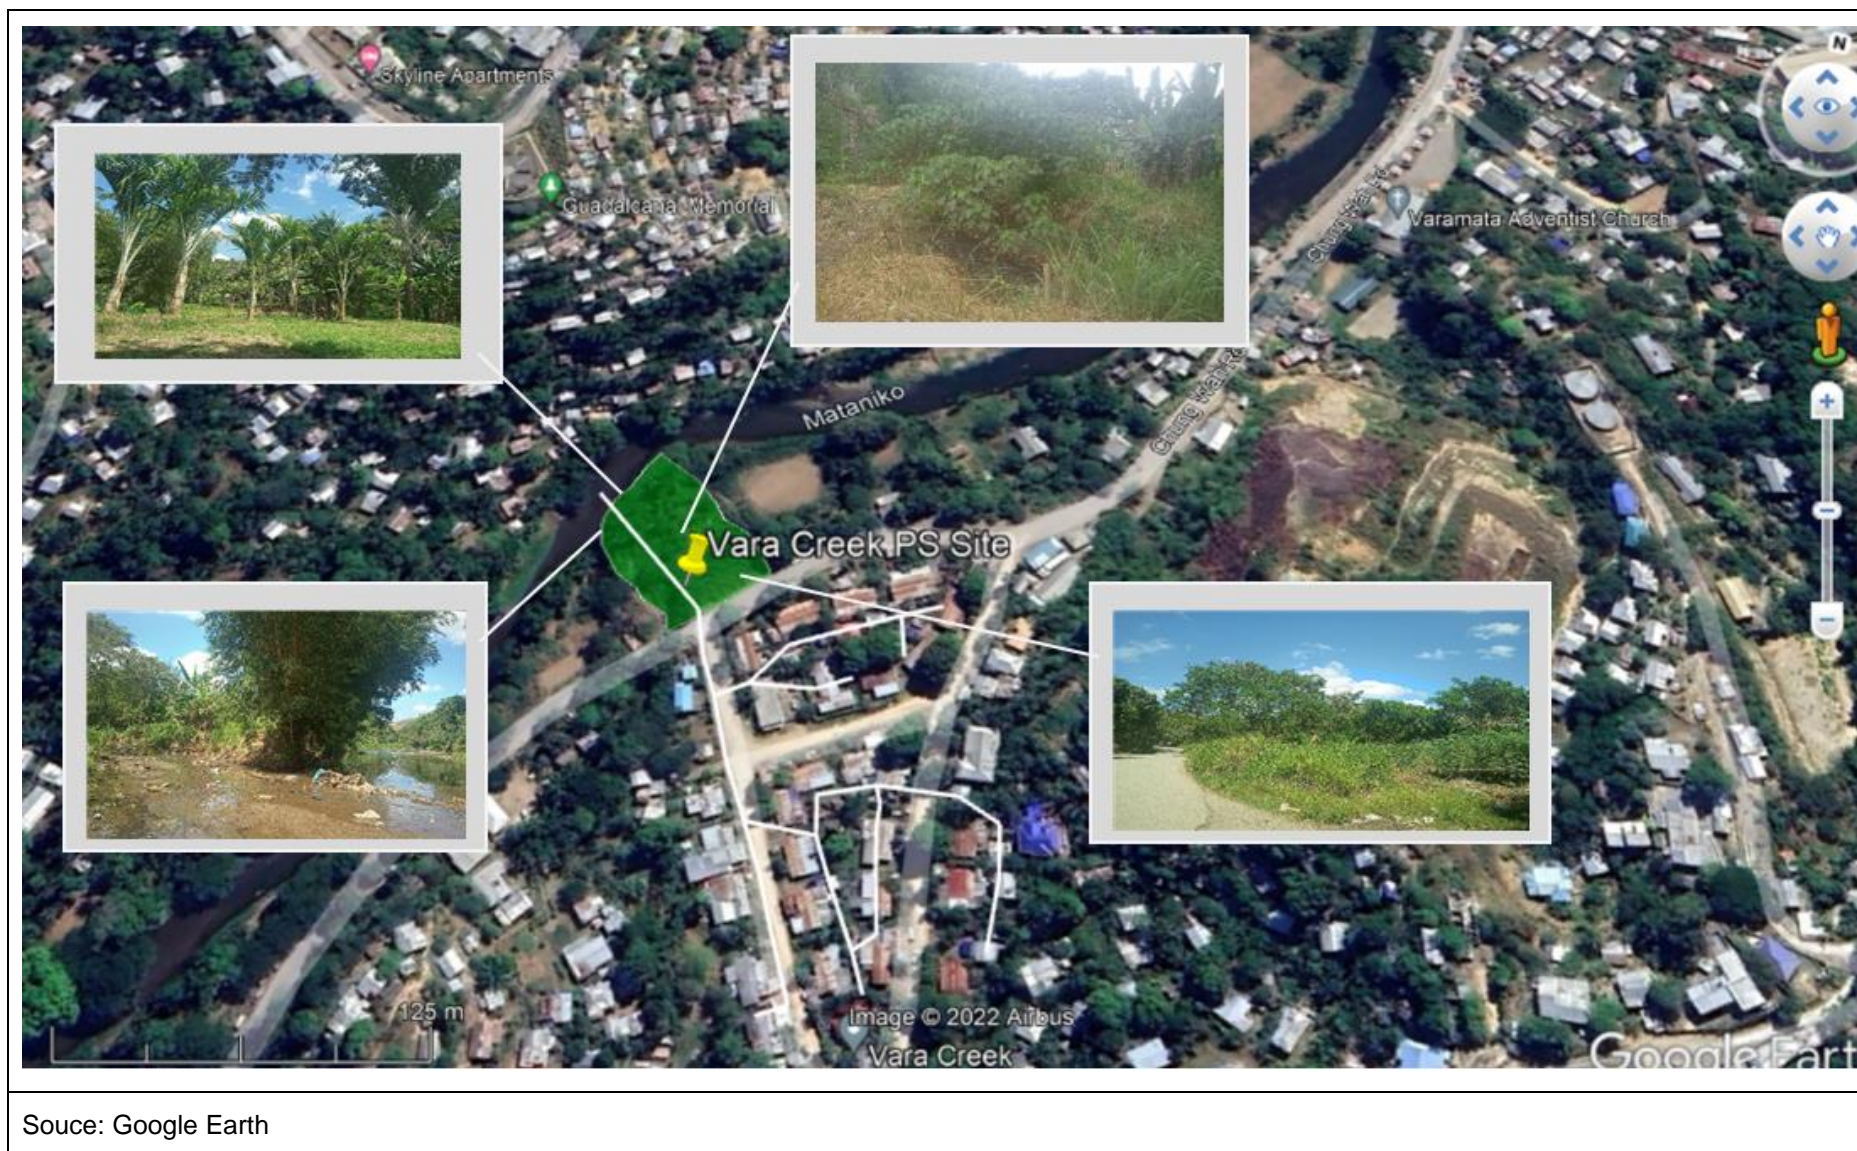
Figure 4-3: Map showing typical vegetation found at area surveyed at Vara Creek PS site

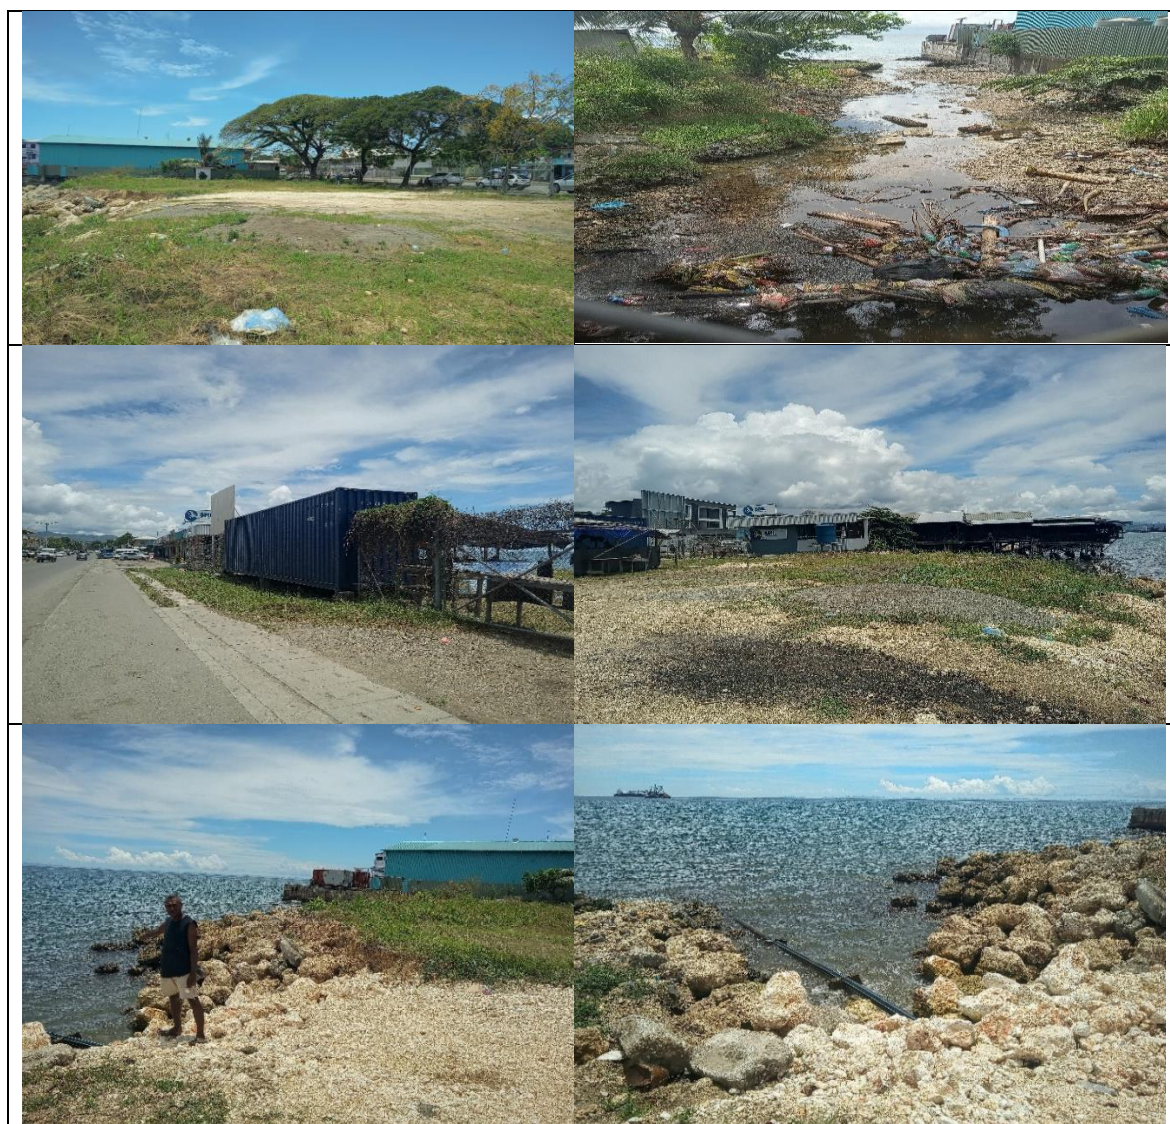
The Naha Pumping Station site is adjacent to the main road along Kukum Highway on the northern coast at GPS Coordinates 9° 25.922'S and 159° 58.982'E (**Figure 3-8**). The site is highly disturbed by recent land reclamation activities along the shoreline. An existing sewer manhole and outfall are also located on this site. The soil type associated with this site consists of backfill materials mostly of limestone mixture with river gravels and sand. Soil fertility on this site is very low therefore the vegetation community comprises of secondary regrowth mainly scattered trees, creepers, weeds and grasses that are recolonizing the area. Towards the east of the site adjacent to the main road, vegetation recorded comprises of *Samanea saman* (rain tree), and *Cocos nucifera* (coconut). On the bare surface of the reclaimed area are grasses such as *Leucaena leucocephala*, *Commelina benghalensis*, and *Imperata cylindrica*. A creek is located east of the PS and it is very polluted with solid waste being dumped into it. Vegetation found along the creek edge is dominated by *Starchytapheta jamaicensis* (Blue rat's tail), *panicum virgatum* (switch grass), and *Pennisetum polystachion* (mission grass). The vegetation record on this site has no significant value and no threatened or endangered flora were noted during the site assessment.

Plate 4-6: Typical vegetation found in the vicinity of Naha PS site.

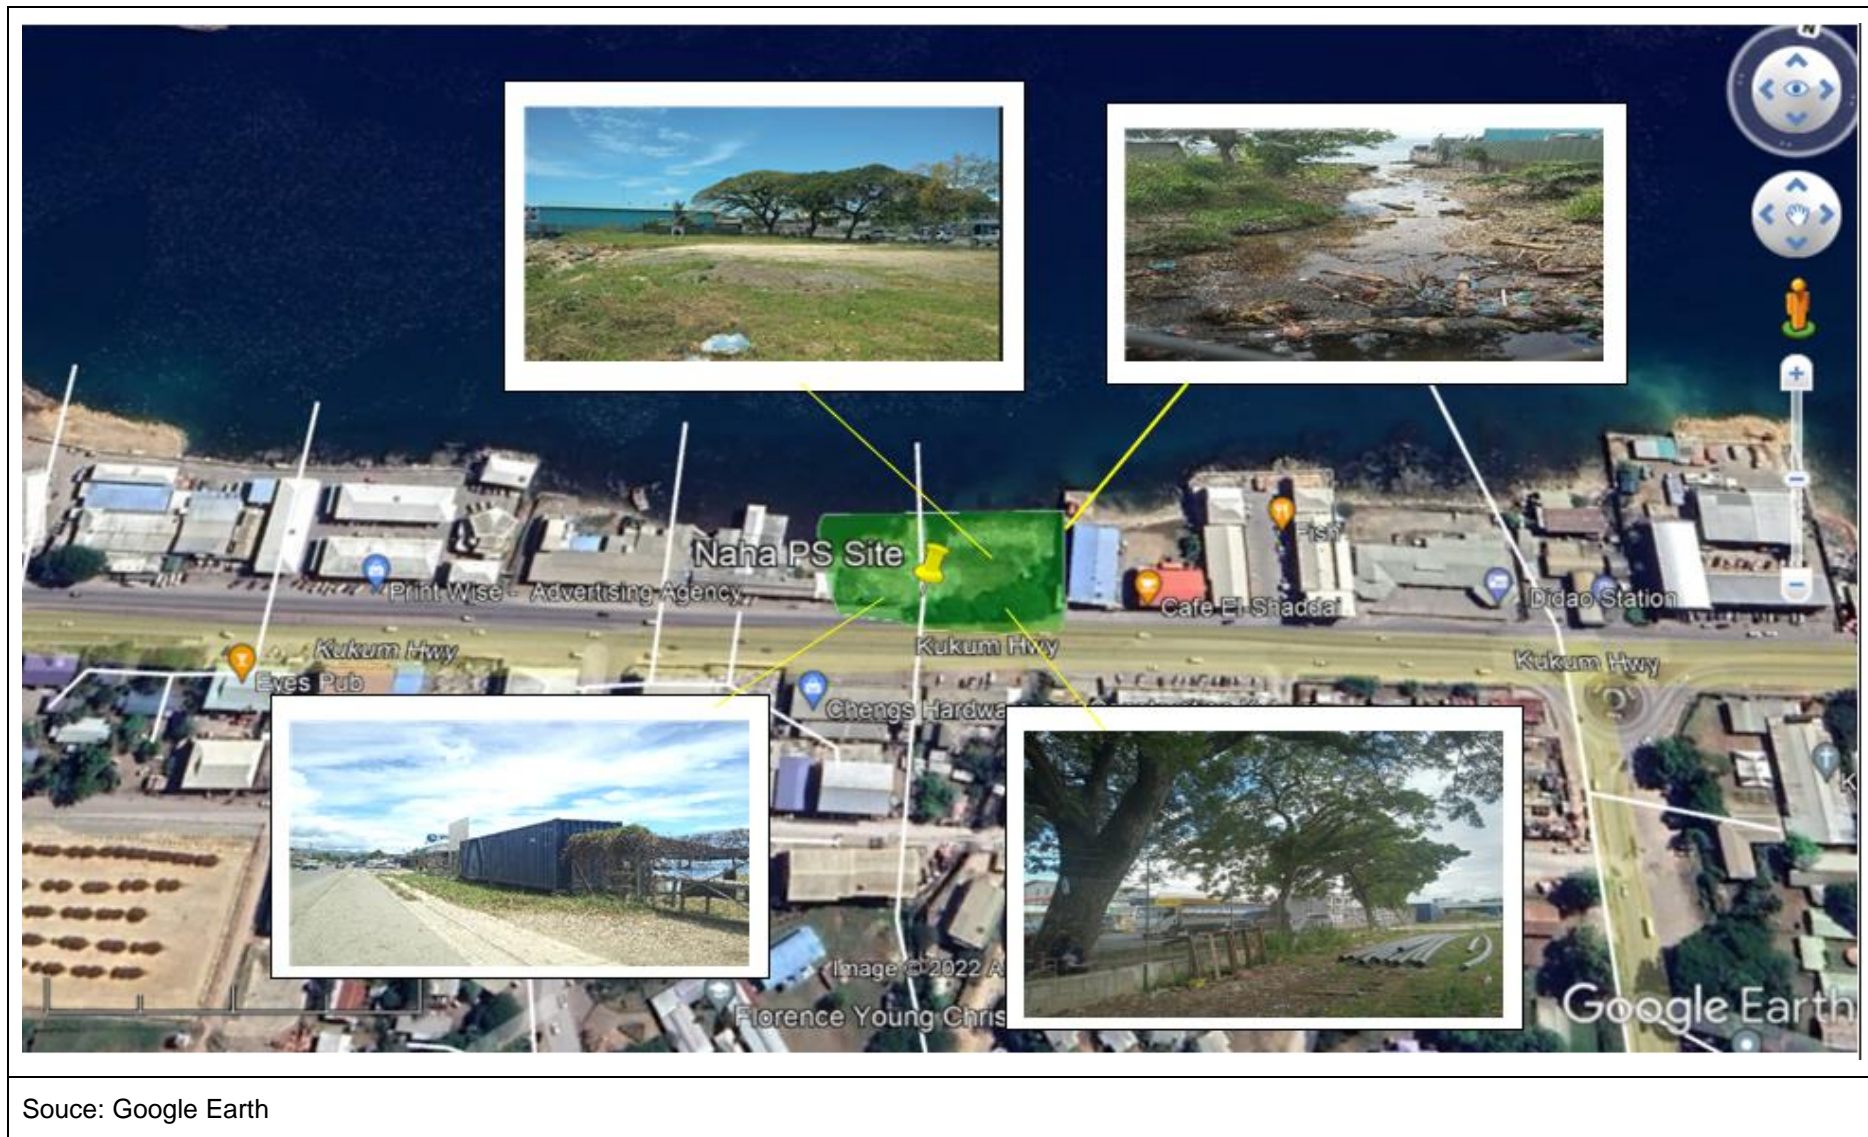
Figure 4-4: Map showing typical vegetation found at the surveyed area at Naha PS site
