Appendix 1O: Terrestrial Biodiversity and Habitat Assessment

Solomon Islands Urban Water Supply and Sanitation Sector Project

September 2022

Terrestrial Biodiversity and Habitat Assessment

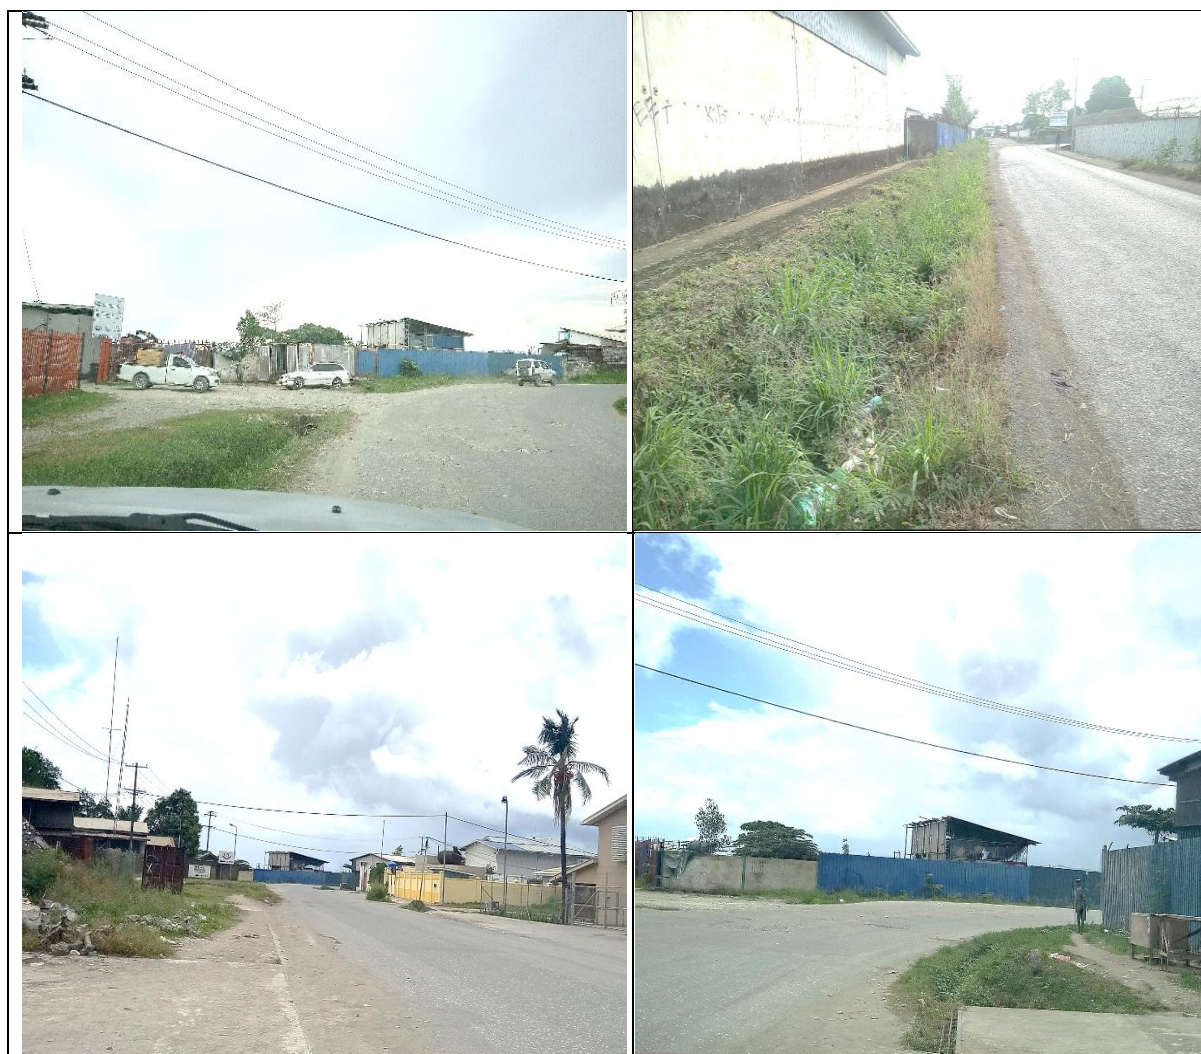
The Ranadi PS is located at East Honiara at GPS coordinates 9° 25.565'S and 160° 0.268'E (**Figure 3-9**). Ranadi is an Industrial zone where most manufacturing and processing industries are located in Honiara. It is a highly disturbed area and much of the surroundings were modified, cleared and backfilled decades ago to accommodate industrial buildings and factories, roads and berthing ramps for landing craft vessels. Since the area is highly disturbed, there are no traces of the original vegetation and ecosystem as it was previously cleared leaving only grasses to recolonize. The type of soil present consists mostly of sand with some river gravels which were backfill materials and is a hostile environment for plant growth and establishment due to its high salt levels, intense heat and light and lack of moisture retention. Therefore, vegetation that has adapted to survive in such conditions is mostly grasses and these include species *Brachiaria mutica* (signal grass), *Eleusine indica* (wiregrass) and *Axonopus compressus* which are dominating and a few individual trees such as *Terminallia catappa* (Alite), *Premna serratifolia* (headache tree) and *Cocos nucifera* (coconut) which are seen within private properties or roadside along the coast.

Plate 4-7: Typical vegetation associated with the Ranadi PS site

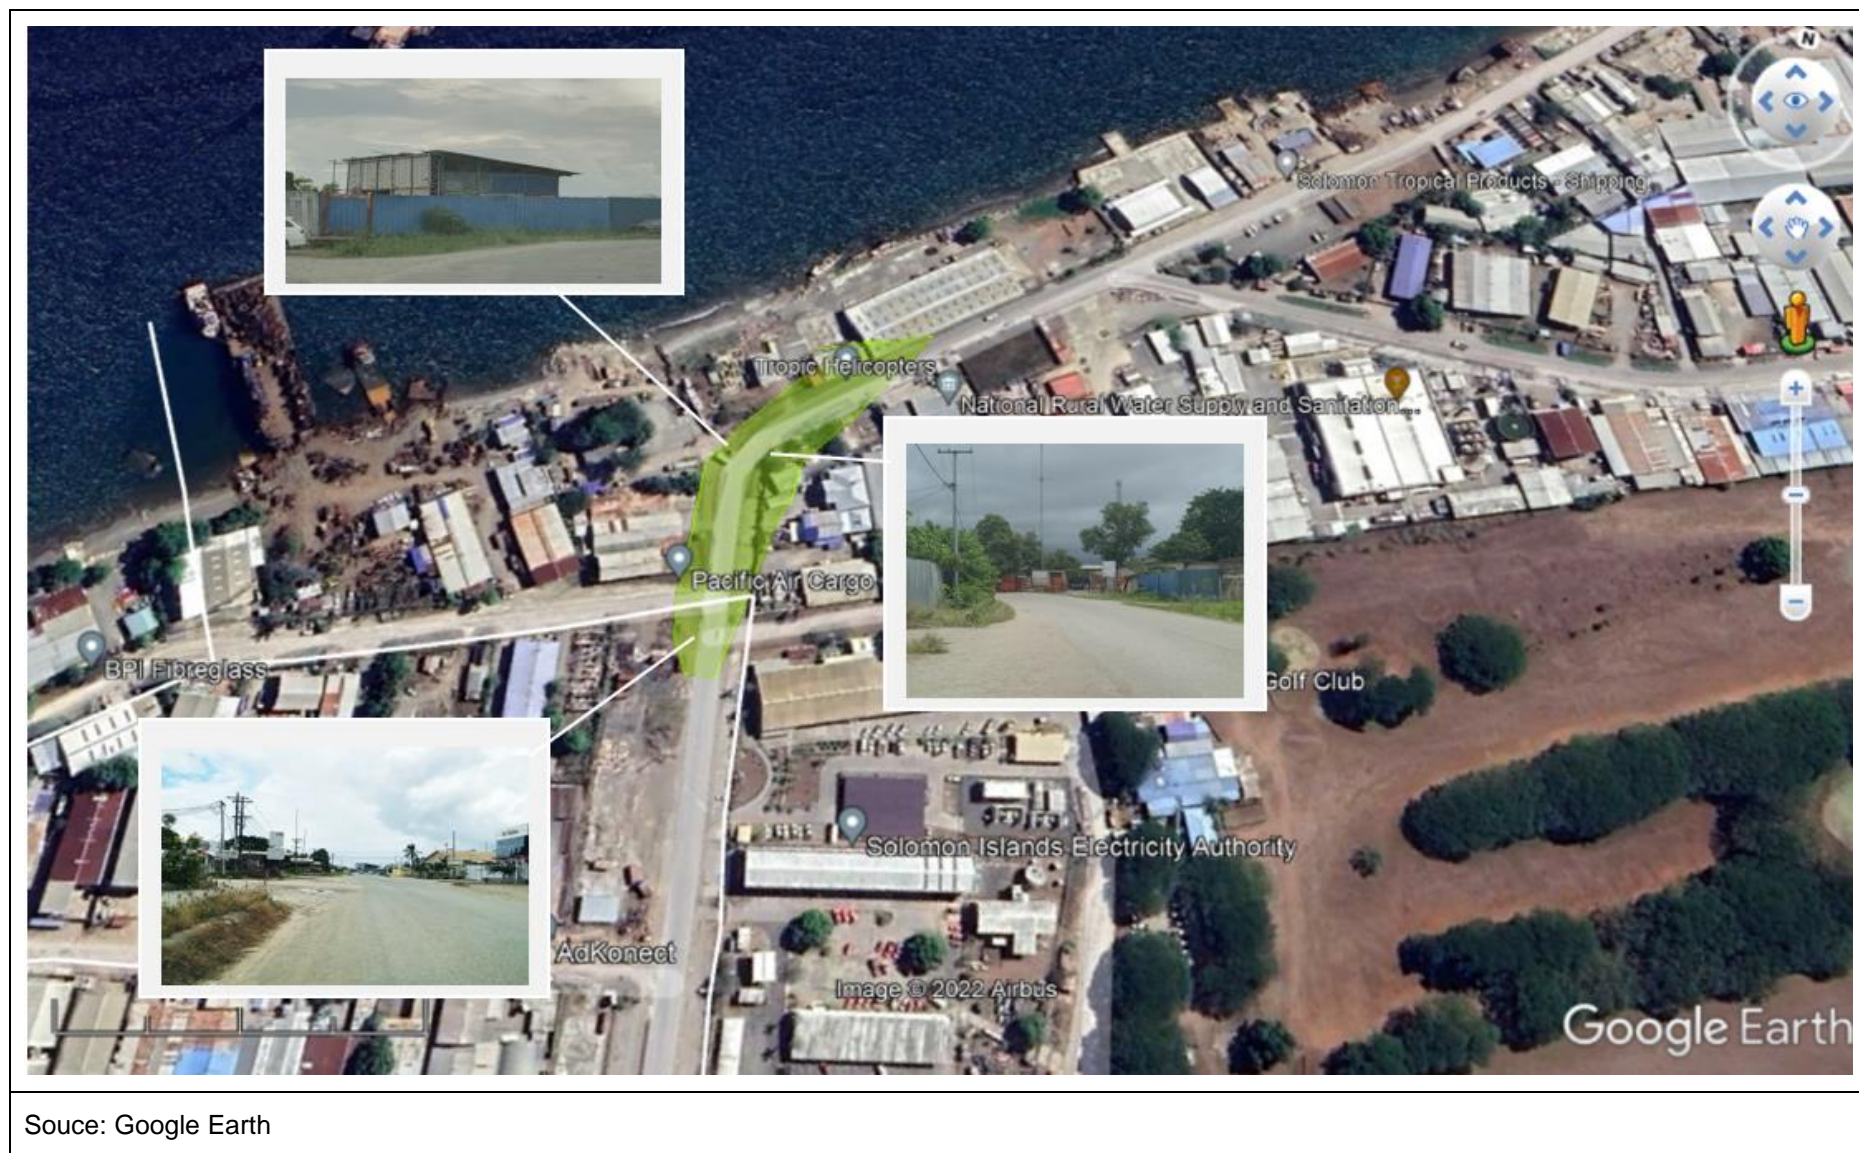
Figure 4-5: Map showing typical vegetation found at the surveyed area at Ranadi PS site

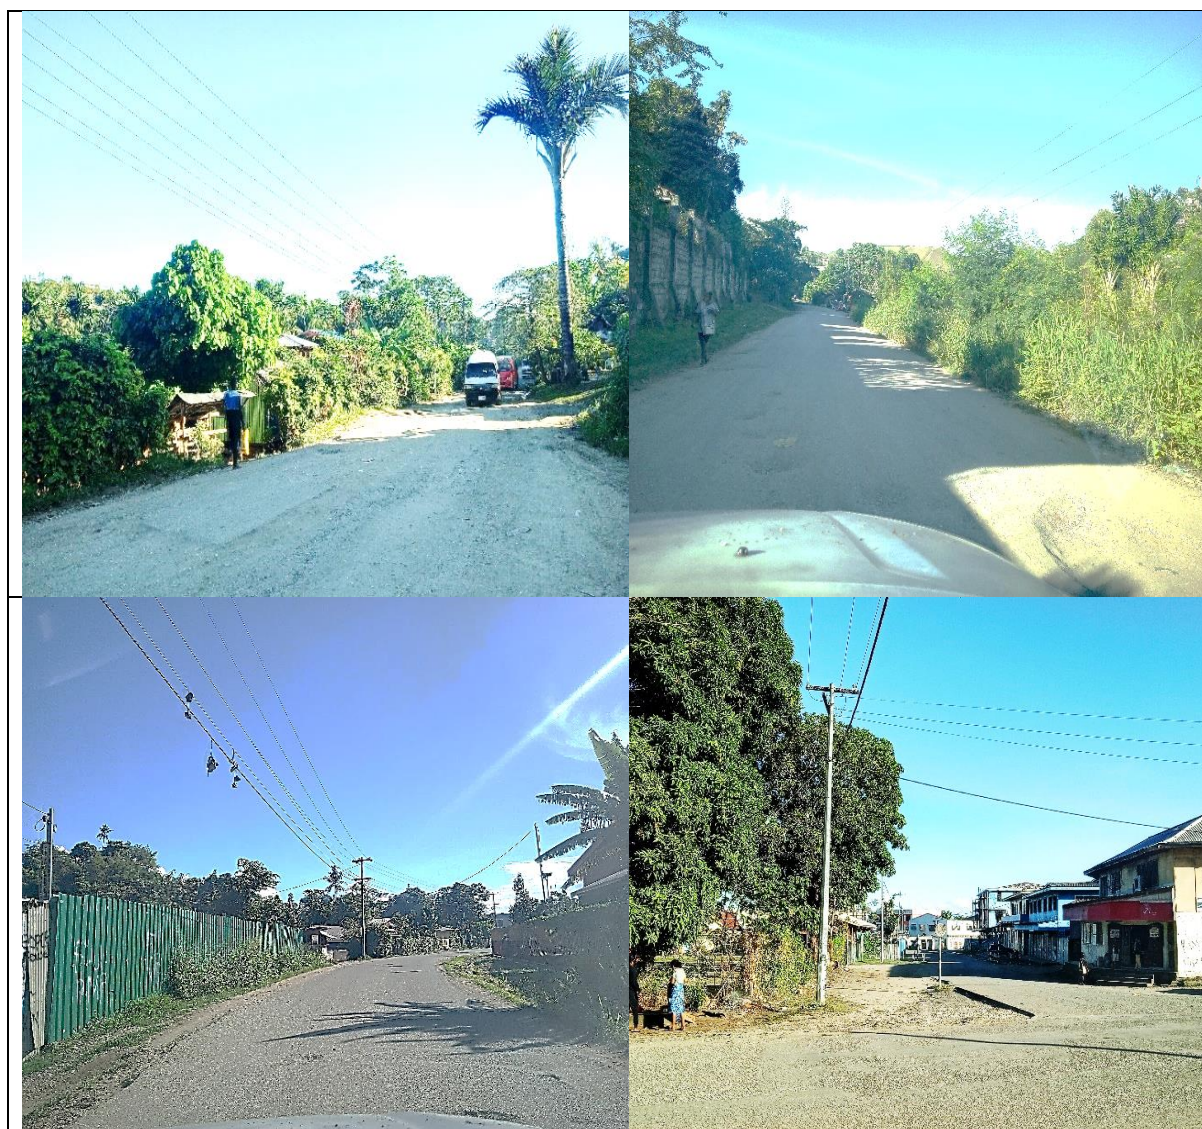
Typical Vegetation along the pipeline route from Vara Creek to the NRH PS comprises of *Samanea saman* (raintree), *Metroxylon sagu* (sago), *Broussonetia papyrifera* (paper mulberry), *Mangifera indica* (mango), *Leucaena leucocephala* (white lead tree), *Tabebuia rosea* (pink trumpet tree) and *Musa sp* (banana). Ornamental plants are grown along property boundaries and this includes *Pulmeria sp* (Frangipanies), *Bougainvillea sp* (bougainvillea), *Hibiscus rosa-sinensis* (Hibiscus), *Ixora chinensis* (Ixora) and *Jatropha integerrima* (Peregrina).

Plate 4-8: Typical Vegetation along the pipeline route along the start of the Chung Wah Road.

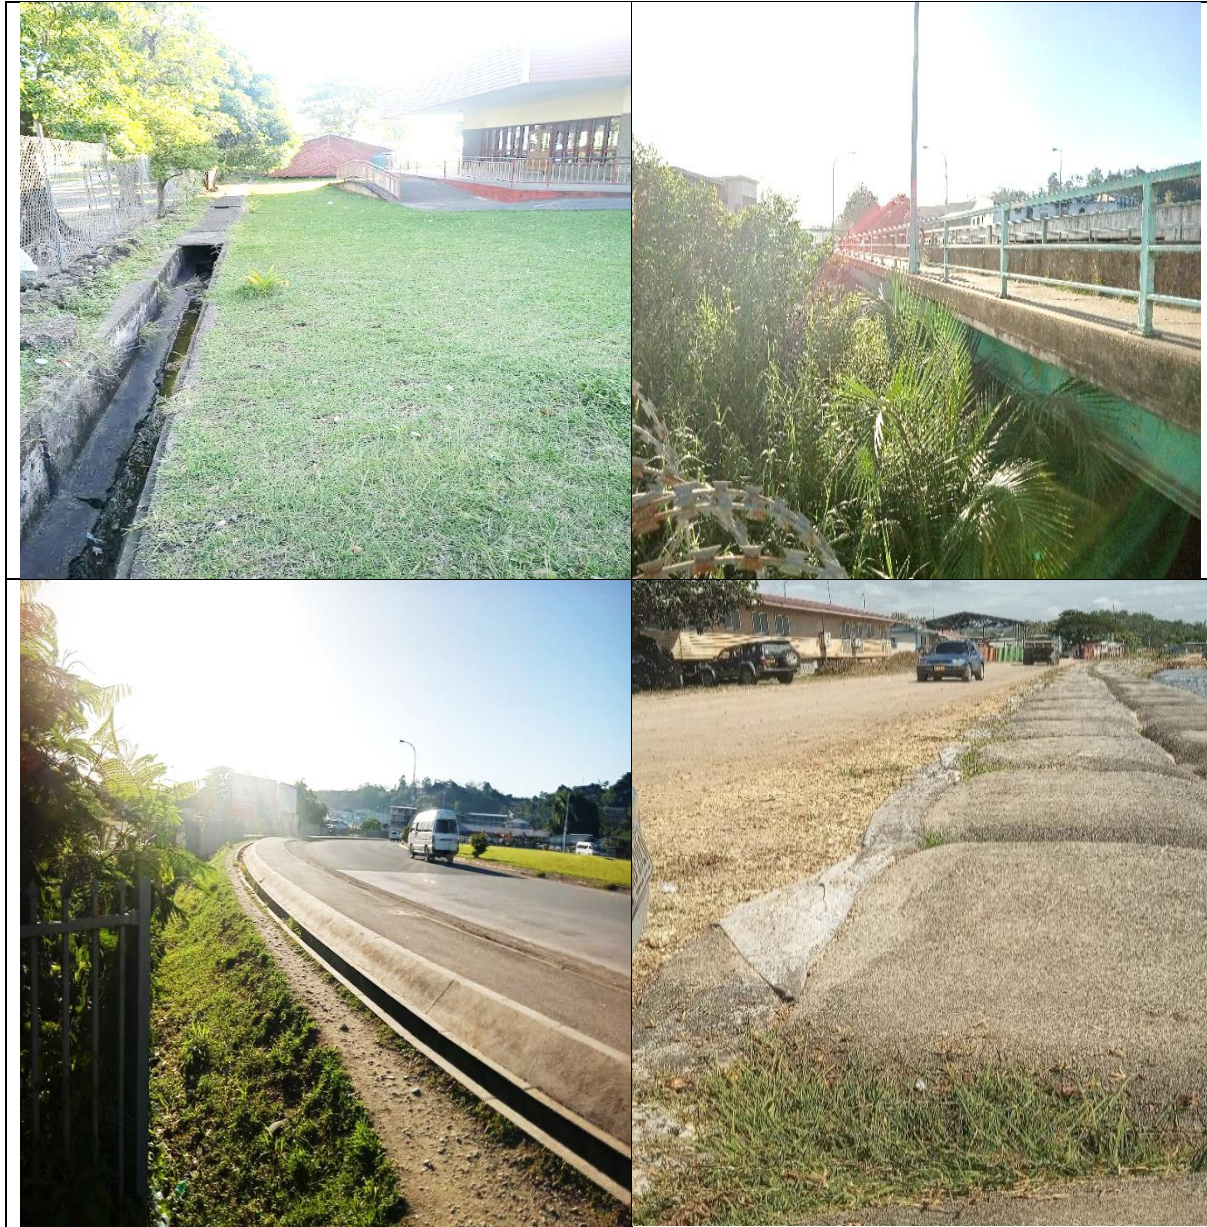
Along the pipeline route from the Market PS through to the NRH PS/Outfall site, the coastal vegetation includes *Terminalia catappa* (Alite), *Cocos Nucifera* (coconut), *Premna serratifolia*

(Headache tree), *Barringtonia asiatica* (fish poisoning tree) and shrubs. At the lower Mataniko River, particularly immediate to the bridge, vegetation is dominated by salt-tolerant plants.

Plate 4-9: Typical vegetation found along the pipeline route from the Market PS through to the NRH PS/Outfall site

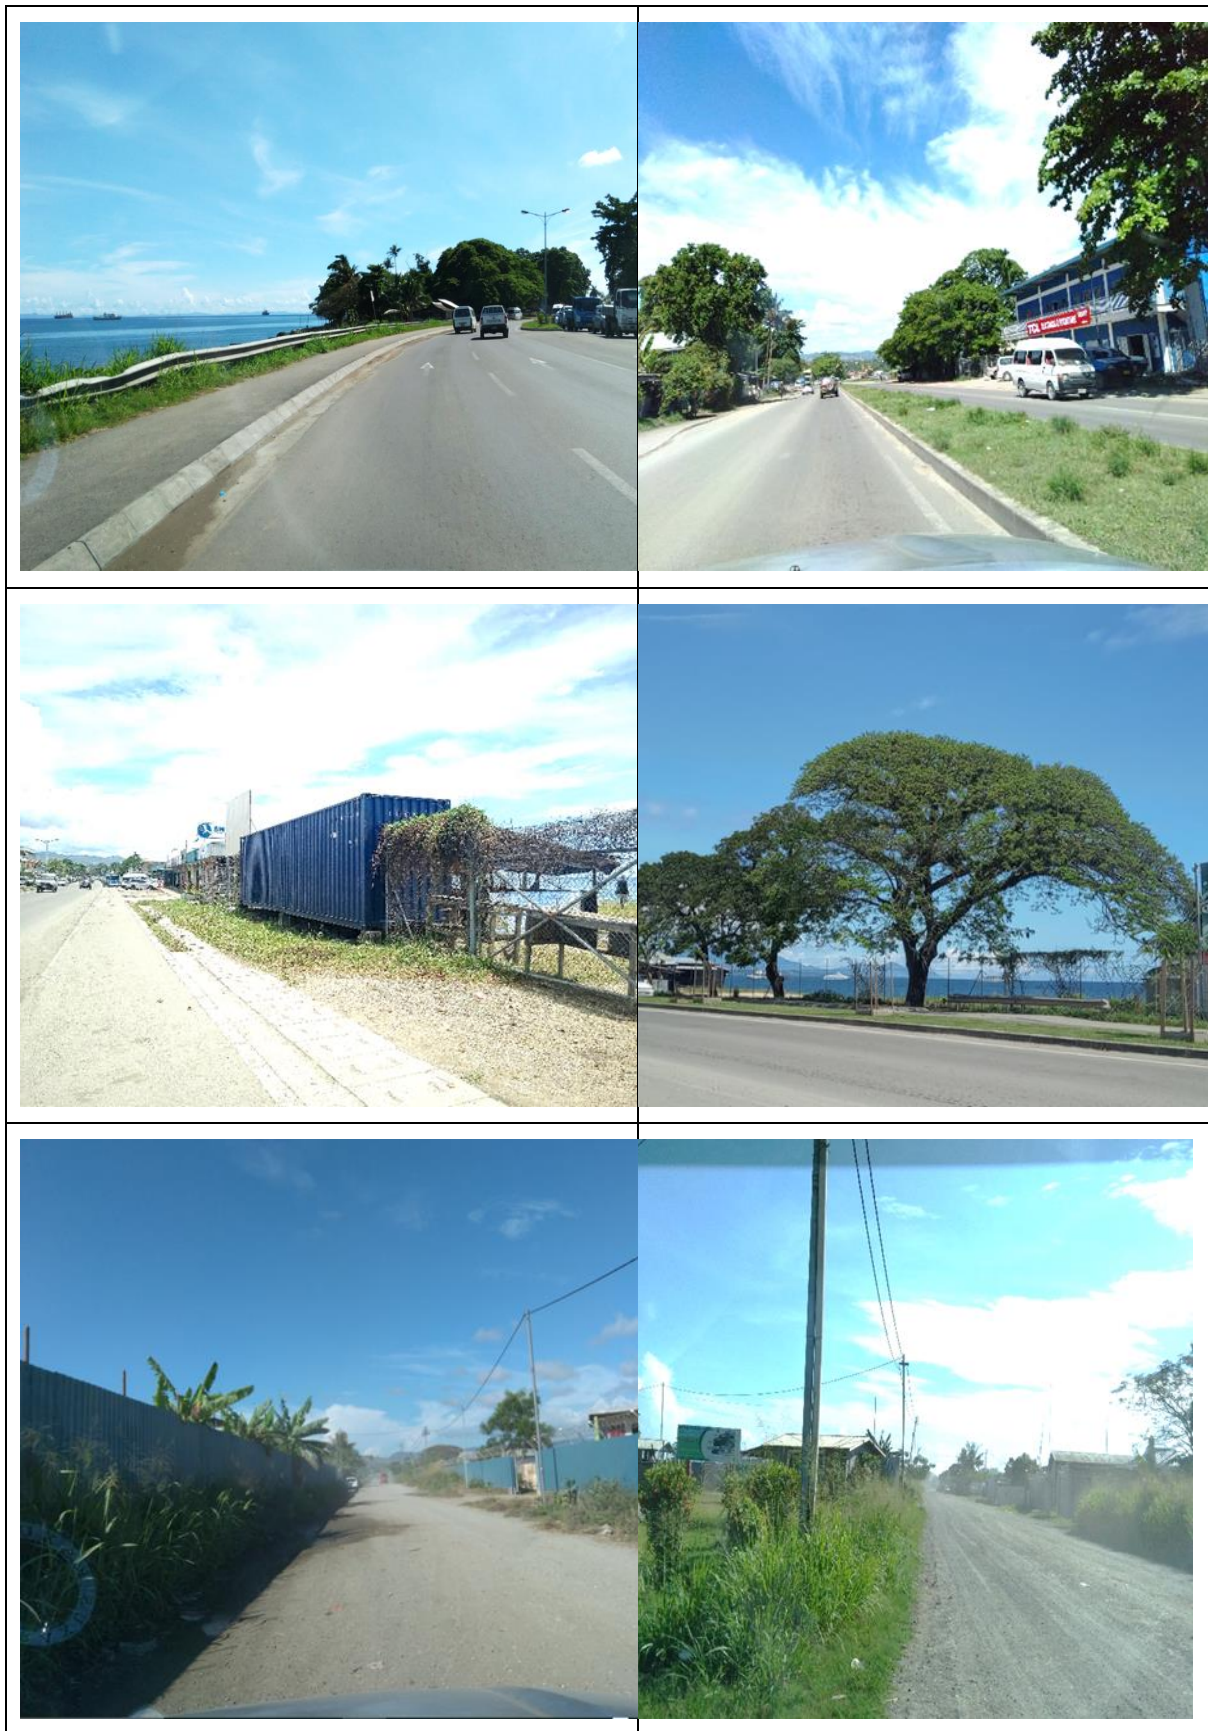
From NRH to Ranadi Landfill along the Kukum highway, vegetation on the road corridor along the pipeline route shares similarities with the other sites assessed. Typical vegetation found along this area includes *Samanea saman* (raintree), *Broussonetia papyrifera* (paper mulberry), *Elaeis guineensis* sp (palm tree), *Mangifera indica* (mango), *Calophyllum inophyllum* (Koilo), *Cocos nucifera* (coconut), and *Pandanus tectorius* (pandanus) and including grasses and weeds.

Plate 4-10: Typical vegetation along the pipeline route from NRH to Ranadi Landfill Outfall site.

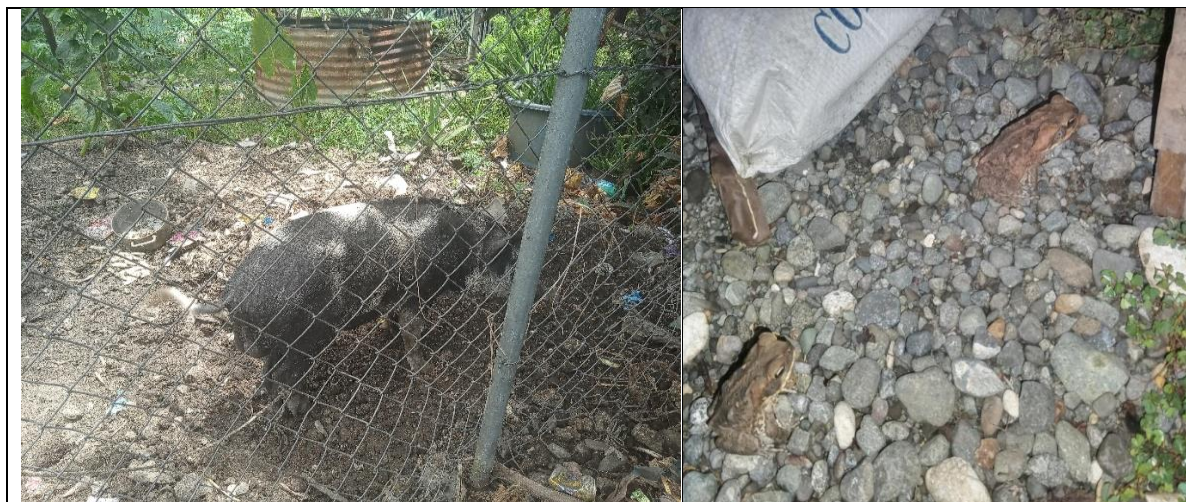
The terrestrial habitats found within the subproject area of influence at each PS and Outfall sites were observed to still provide habitats for birds, reptiles/lizards, amphibians, domesticated animals and other vertebrates. On the trees, rooftops or along the paved footpath, birds such as *Acridotheres tristis* (Common Myna), *Rhipidura leucophrys* (Willie Wag Tail), and Swifts are found to be interacting and feeding. Other vertebrates and amphibians were also found and these include *Oryctes rhinoceros* (Coconut Rhinoceros beetles), Anisoptera (dragon flies), Tettigoniidae (Bush crickets) *Achatina fulica* (Giant African snails) and *Bufo marinus* (Cane toad). The Giant African snail is an invasive species affecting many parts of Honiara. Domesticated and feral animals found in communities along the subproject sites include dogs, cats, rats, chickens and pigs. Other fauna observed habiting the waterways along the subproject area of influence include many unidentified species of insects (grasshoppers, moths, beetles and dragonflies) and some fish species. Field observations did not show any significant wildlife species within the subproject area and the PS and Outfall sites and including the pipeline corridor in a highly modified urban environment.

Plate 5-1: Terrestrial fauna found at the NRH PS site.

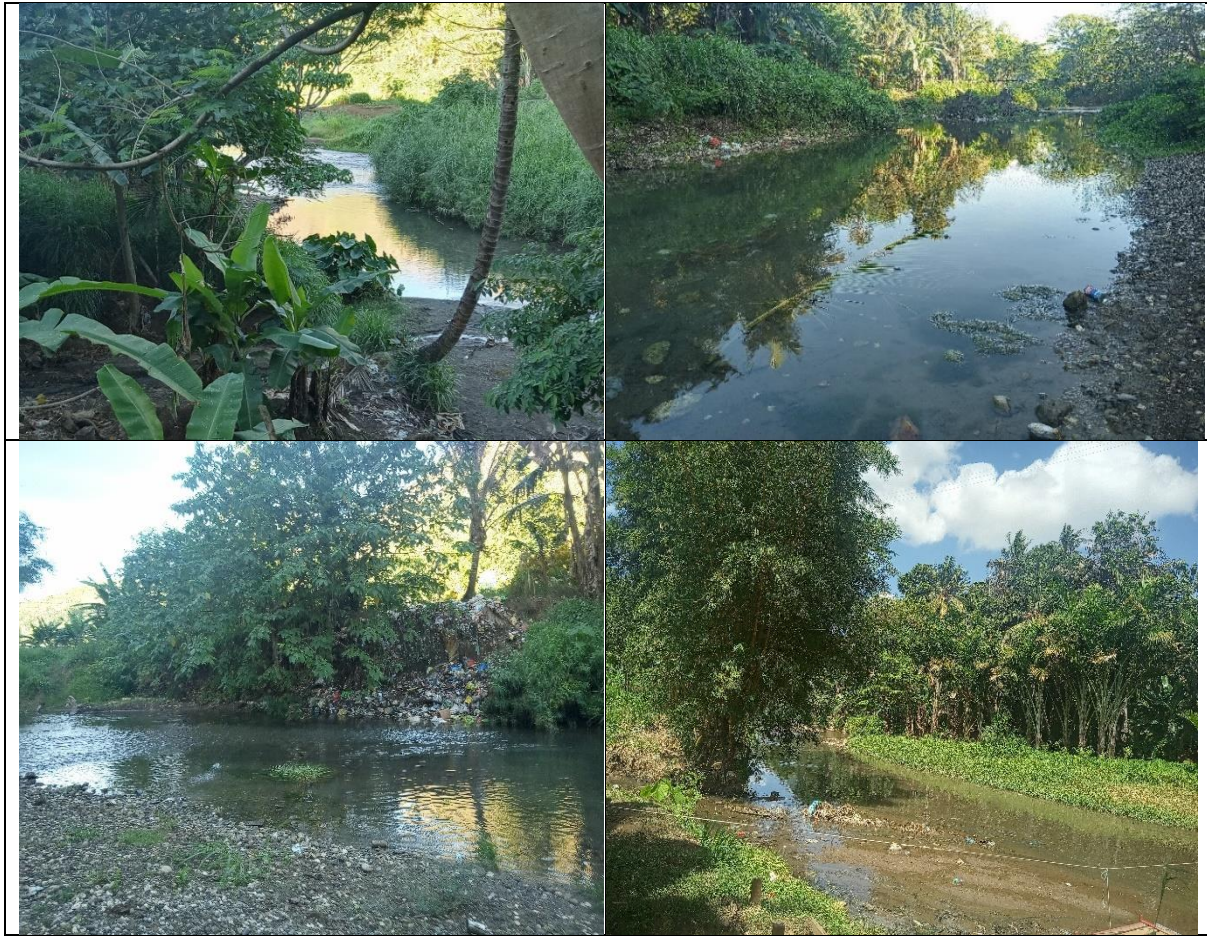
The lower sections of the Mataniko River system, specifically at Tuvalu and Vara Creek, lack any habitats suitable for significant aquatic flora and fauna as these areas were highly disturbed by anthropogenic activities. Activities include residential settlement, farming and waste disposal (sewage, household solid wastes etc), and these have altered the water quality and aquatic flora and fauna composition. Typical riparian vegetation includes but is not limited to *Delonix regia* (flamboyant), *Bambusa sp* (bamboo), *Metroxylon salonesnse*, *ficus sp*, *Cocos nucifera* (coconut tree), *Macaranga sp*, *Musa sp* (banana), *Cryptosperma merkusii* (giant swamp taro) and invasive plants species such as the *Brussonetia papyrifera* (paper mulberry tree) and *Spathodea campanulate* (African Tulip Tree). Riverside grasses dominate the river bank.

Plate 6-1: Typical riparian vegetation at Tuvaruhu, lower section of Mataniko River.

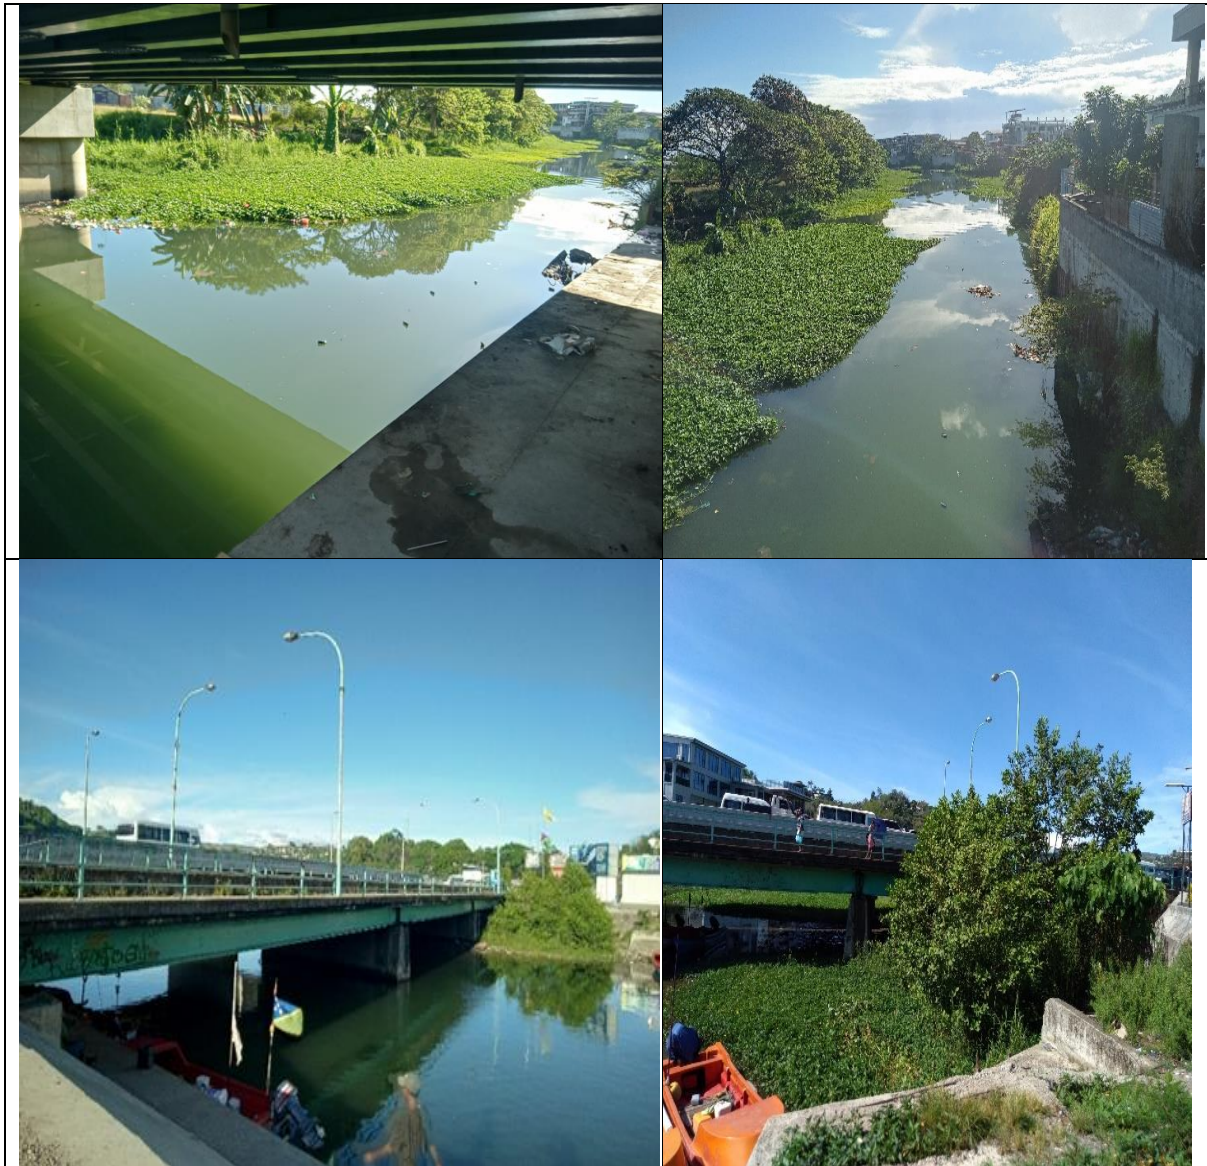
At the upper and lower Mataniko Bridge sites in China Town, the dominant aquatic flora is *Ipomoea aquatica* (kangkong) and is covering much of the river banks whereas vegetation at the lower bridge includes common reeds and other salt-tolerant species. Algae blooms are also occurring in this section of the river as evident in the greenish colour of the river. The anthropogenic disturbances associated with the lower reaches of the river system may have triggered or accelerated the blooms and this includes farming upstream (nutrients from fertilisers), sewage and household waste and other pollution sources such as piggery wastewater. It is a very common practice in Honiara where residents or businesses illegally dump solid wastes or wastewater into the water systems, contaminating and degrading the water quality and ecosystem.

Plate 6-2: Showing aquatic flora and algae blooms at upper Mataniko Bridge and the estuarine flora at lower Mataniko Bridge, China Town

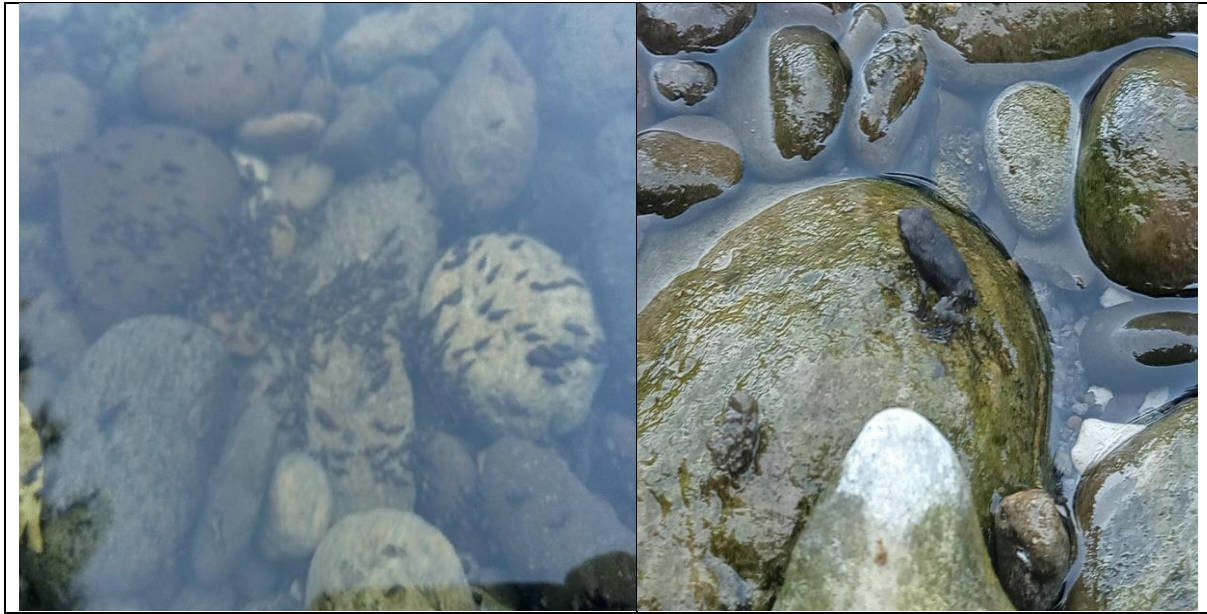
Despite the river being very polluted and disturbed, freshwater fauna inhabit the aquatic environment. The aquatic fauna observed include *Rinella marina tadpole* (giant marine toad), *Neurothemis sp* (Red dragonfly), *Melanoides tuberculata* (freshwater snail) and fish species such as *Khuliidai sp* (flagtail) and *Sicyopus sp* were also observed. The freshwater species live and spawn in the rivers and larvae drift to the ocean to live as pelagic/oceanic marine larvae before returning to freshwater as juveniles to mature.

Plate 6-3: Freshwater fauna species found at Tuvaruhu, Mataniko River

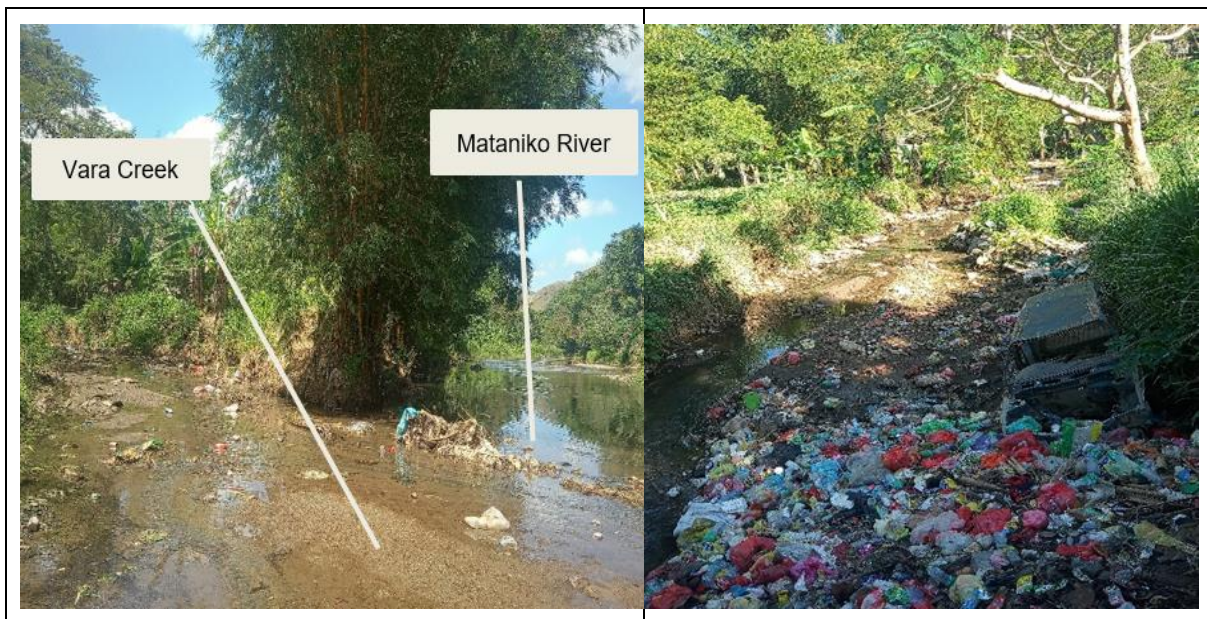
The freshwater habitats at Vara Creek, Kukum Creek and the Burnscreek stream are also highly polluted and the quality of water is very poor. Vara Creek drains into the Mataniko river and the creek is also used as a dump site by the settlers.

Plate 6-4: Showing Vara Creek joining Mataniko River and the household wastes disposed into Vara Creek.

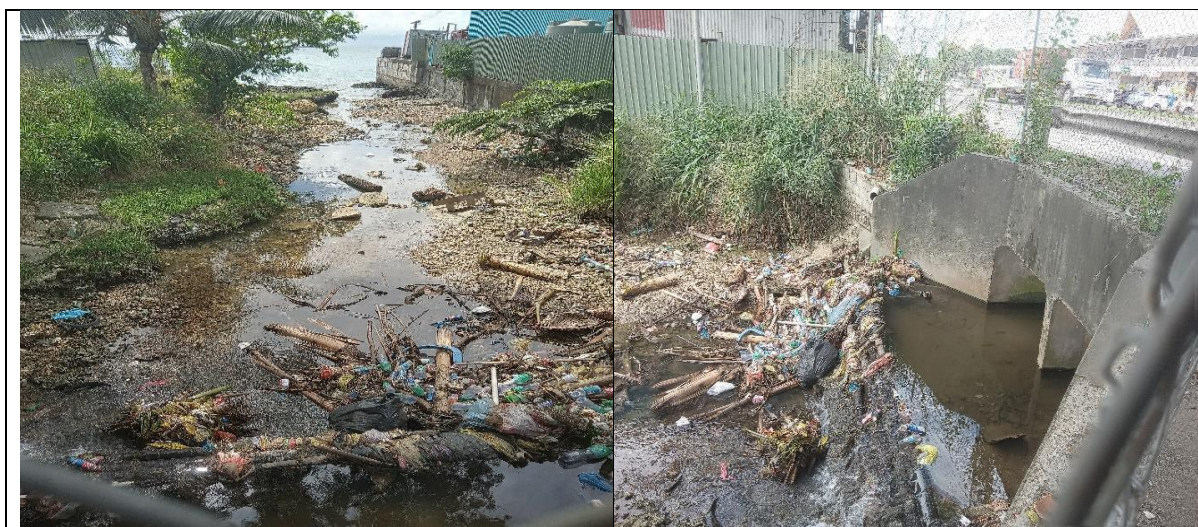
Kukum Creek is east of the Naha PS and like Vara Creek, it is also very polluted. Solid wastes and sewage from households and other shops are directly dumped into this creek.

Plate 6-5: Kukum Creek at the vicinity of the Naha PS site.

Typical vegetation on the creek edges is mostly grass such as *Starchytapheta jamaicensis* (Blue rat's tail), *panicum virgatum* (switch grass), and *Pennisetum polystachion* (mission grass). Aquatic fauna species observed are *Rinella marina* (giant marine toad tadpoles).

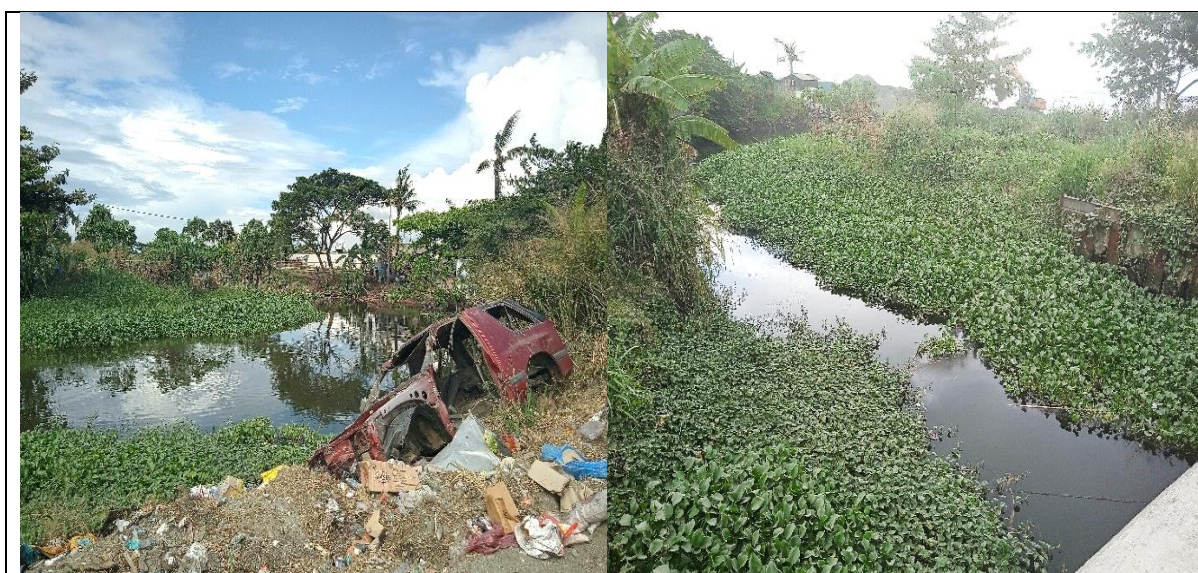
Burnscreek stream is east of the Ranadi Landfill PS/Outfall. The stream was also polluted with untreated fecal sludge/septage being dumped at the Ranadi Landfill and leaks into the stream affecting the water quality. Aquatic flora and fauna were observed habiting the water body and it was noted the *water hyacinth* (Water lily) and *Ipomoea aquatica* (Kangkong) are the dominant aquatic flora. The fish species observed was *Kuhliidae* sp (flagtail). Settlers also farmed tilapia fish species. None of the freshwater flora and fauna species found are threatened or vulnerable.

Plate 6-6: Burns Creek stream, Ranadi Landfill site/Outfall site
