Lake Turkana Wind Power Project - Kenya

Ornithological and Bat Surveys – Final Survey Report

Technical Report
December 2011

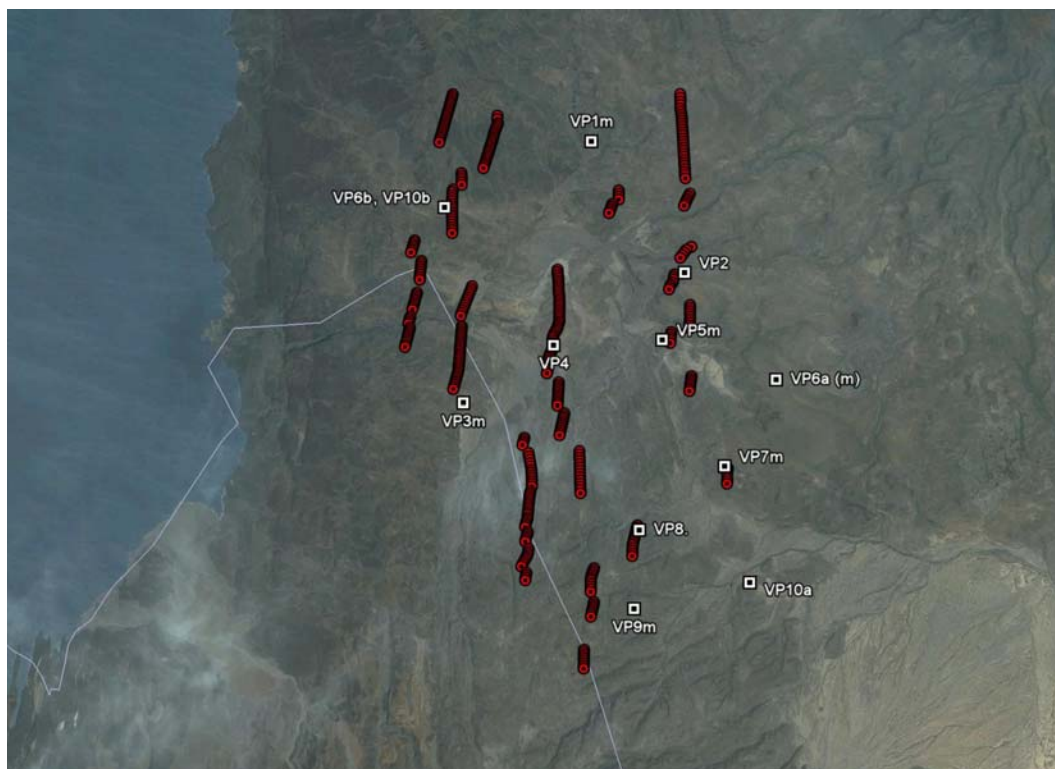
Figure 1 – Wind Turbine and Vantage Point Locations

Note: Due to an amended turbine layout VP6a and VP10a were replaced by VP6b and VP10b from February 2011

- 2.1.1 The proposed Lake Turkana Wind Power Project (LTWP) is situated in the Marsabit district of northwest Kenya (see Figure 1). The wind farm will be positioned within an overall project site of 40,000 acres (162km²), with the turbines located at a distance of around 8km to the east of Lake Turkana itself.

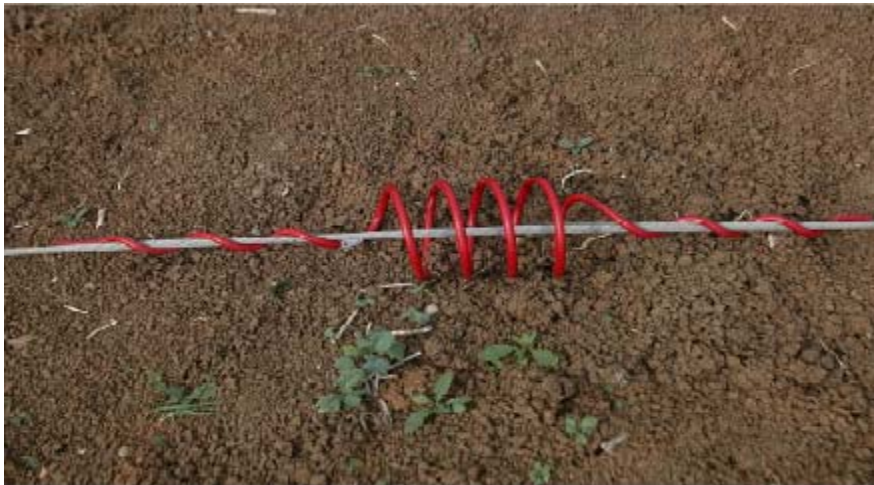
Appendix 6 – An example of bird deflectors used on overhead power cables

This type of deflector is fitted at 5m intervals of the earth wire of the overhead power line network. The aim is to increase the visibility of the earth wire. The design of the diverter used is shown in the photo below. The dimensions of the deflectors were 320mm for the gripping section and 175mm for the outside diameter of the coil (catalogue no.BFD5249065: Preformed Line Products (GB) Ltd). This design and spacing was chosen as tests in the Netherlands indicated that when installed at 5m intervals the collision rate decreased by 80% (Koops 1982¹⁷). Note that the specification for the diverter will be specific to the conditions encountered e.g. lines and pylon specifications, weather conditions and species involved.

- 3.4.6 We recommend that bird deflectors (also known as flight diverters) are fitted to power cables to prevent collisions by large less manoeuvrable species birds such as bustards and birds of prey. These have been shown to reduce bird collisions.¹²

- 6.1.1 It is recommended that bird deflectors are fitted to all power lines within the site. These vary in design but normally hang or are threaded onto the wires making them much more visible allowing birds to take avoiding action early enough to prevent collision. An example is shown in Appendix 6.
