Environmental Impact Assessment (EIA)

Armenia

North-South Road Corridor Investment Program Tranche 3: Talin-Gyumri Road

August 2012

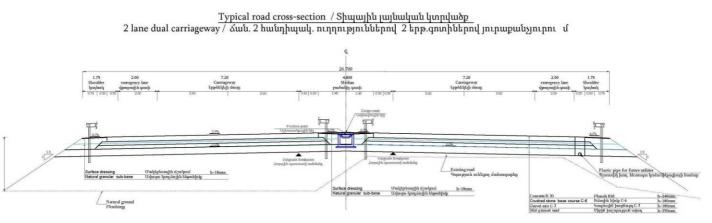
Figure 1. Typical road cross-section

- Safety Guardrail: 136,000 linear metres.
 - Landscaping/grassing after construction: 400,000 sq. metres.
- 40. A typical cross-section through the existing and new road beds are shown in Figure 1 below.

41. The road pavement will comprise 35cm thickness of granular capping layer, 18cm of granular sub-base, and 18 cm of crushed rock base course and 24 cm of cement concrete pavement. Shoulders and median will be covered with double seal surface dressing.

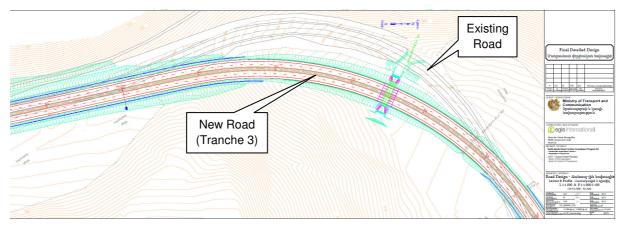
These various realignments are at the following locations:

- i) Km.73+000 to km.73+500
- ii) Km 74+700 to km.75+600
- iii) Km.77+500 to km.83+500

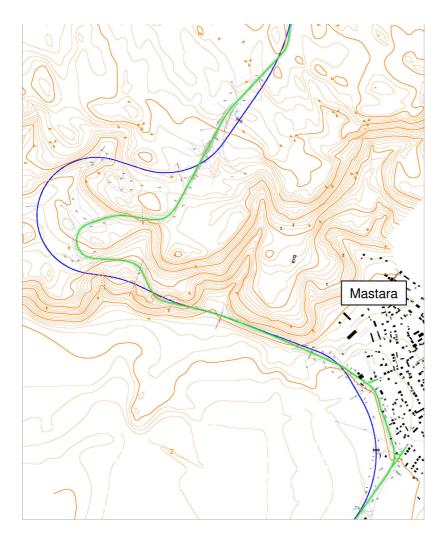
The alignment alternatives are illustrated in the following extract from the Design Drawings :

Existing Road

New Alignment (Category 1 Design Standard)

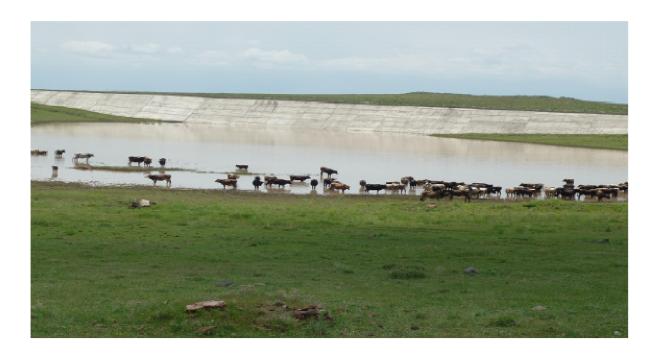
The **reservoir north of Talin** is situated on the left site of the Talin – Gyumri highway, just after Talin city. The reservoir is used for watering of cattle and is therefore important to the local population. It is about 140 m from the highway. New alignment passes through right side of existing road. It may be impacted during construction. The environmental management and monitoring plan (EMP) should include special mitigation measures to protect the reservoir from construction-related impacts.

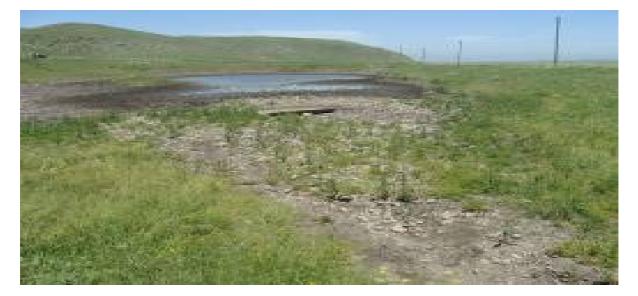
Pond near Town Maralik (ShirakProvince)

This artificial water storage pond for cattle watering with approximate size 40m x 80m is situated near the highway close to the Town of Maralik in ShirakProvince. No submerged and floating aquatic vegetation were found and no conditions for waterfowl were evident. Special ecological values were also not evident. The pond is classified as follows:

Ramsar Classification Wetland Type	(2) - ponds (Farmer, watering place, etc.)	
	up to 8 ha

Caution is recommended during construction to avoid contaminating the pond. Appropriate mitigation measures should be included in EMP.

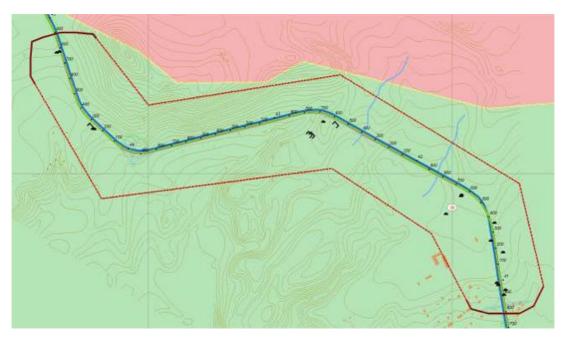
Map 11. Protection area of Talin tomb field in relationship with the new design of the Ashtarak-Gyumri Highway.

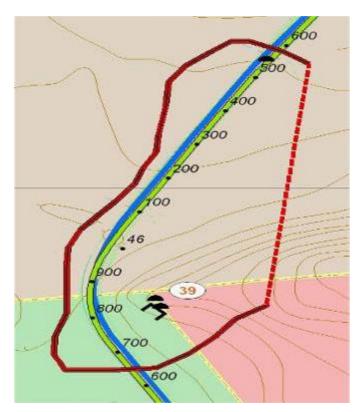
Map 12. Physical boundaries of Yeghnasar tomb field in relationship with the new design of the Ashtarak-Gyumri Highway

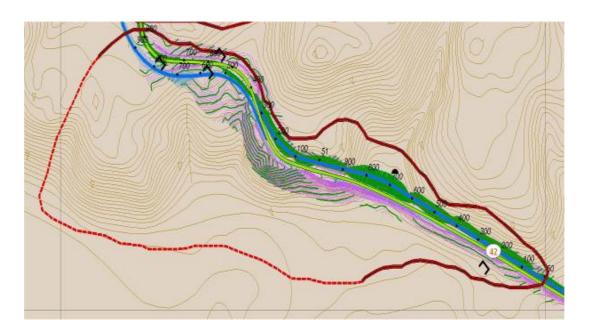
Map 13. Physical boundaries of Mastara archaeological complex in relationship with the new design of the Ashtarak-Gyumri Highway

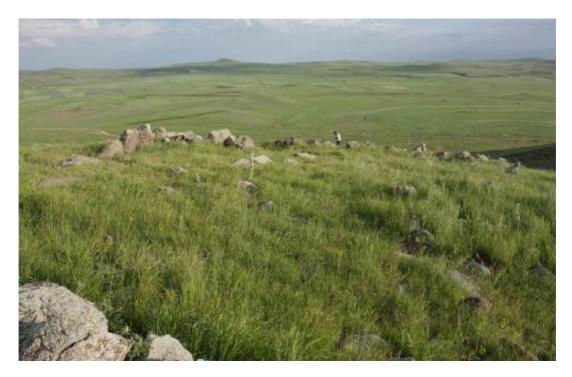
Early Bronze Age settlement constructions of the Mastara Archaeological complex attached directly to the left side of the existing Ashtarak-Gyumri Road

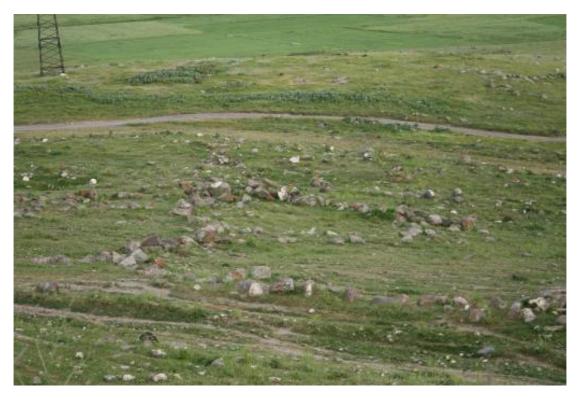
Walls of the settlement of Classical period of the Mastara archaeological complex on the left side of the existing Ashtarak-Gyumri Road

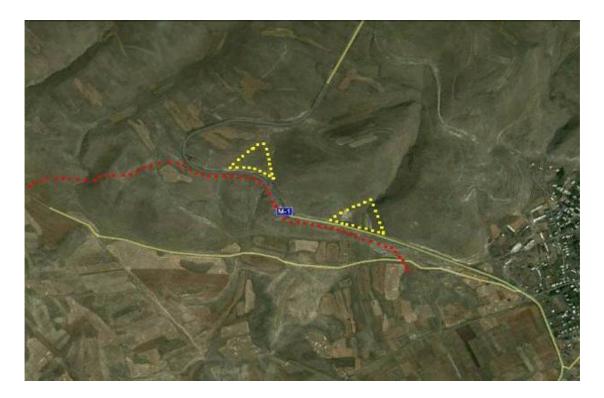
Map 14. Aerial photograph of the northern edge of the Mastara Archaeological Complex (red dots) and the area of the archaeological excavations on the right side of the existing Road (yellow dotted triangles).

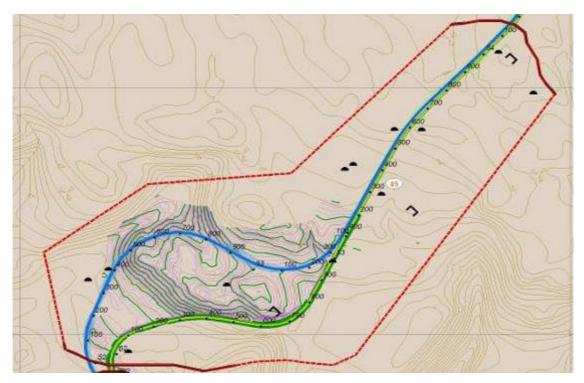
Map 15. Physical boundaries of Mastara-2 tomb field in relationship with the new design of the Ashtarak-Gyumri Highway

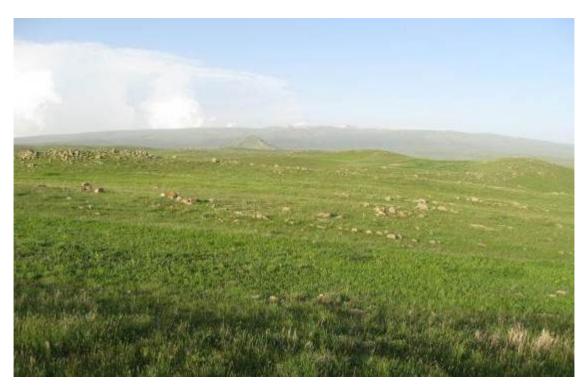
Main view of the Mastara-2 tomb field on the left side of the Ashtarak-Gyumri highway at the place where the new highway construction is planned

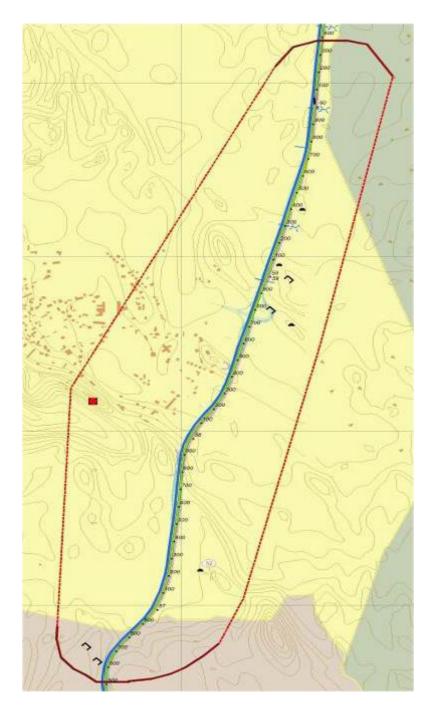
Map 16. Protection area of Lanjik archaeological complex in relationship with the new design of the Ashtarak-Gyumri Highway

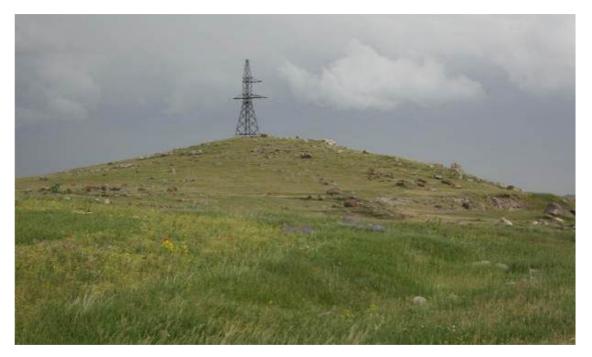
Main view of the III-I Millennia B.C. fortified settlement of the Lanjik archaeological complex on the left side of the existing Ashtarak-Gyumri Road

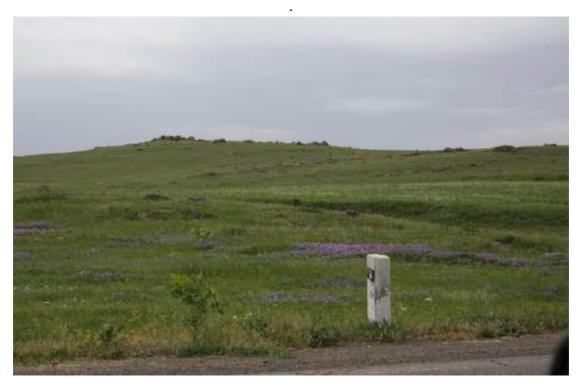
Circular structure in Lanjik archaeological complex on the right side of the existing Ashtarak-Gyumri Road.

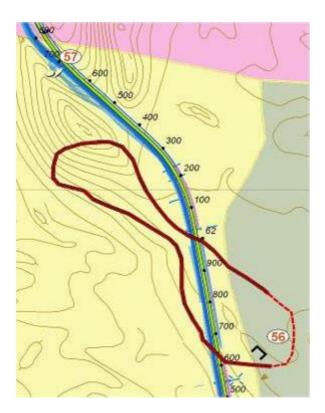
Map 17. Physical boundaries of settlement and tomb field of Lanjik in relationship with the new design of the Ashtarak-Gyumri Highway

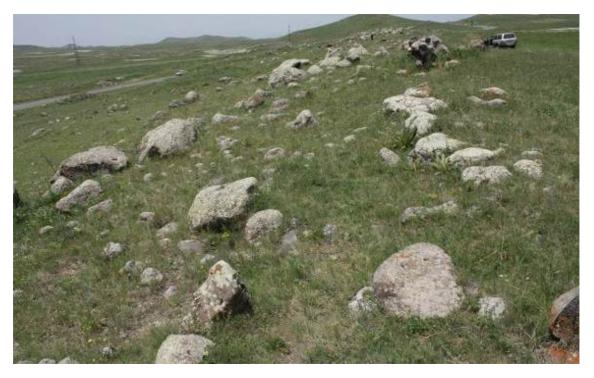
Main view of the settlement and tomb field of Lanjik on the right side of the existing Ashtarak-Gyumri Road.

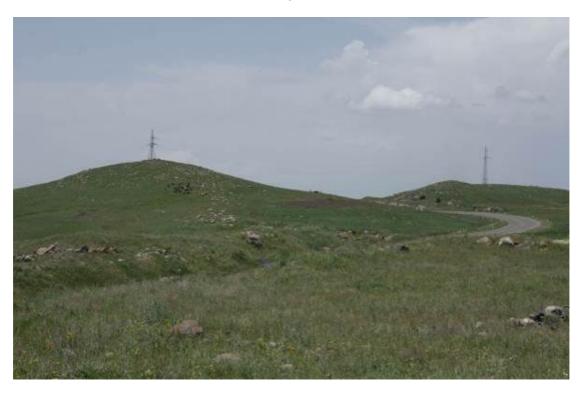
Main view of the settlement and tomb field of Lanjik on the left side of the existing Ashtarak-Gyumri Road.

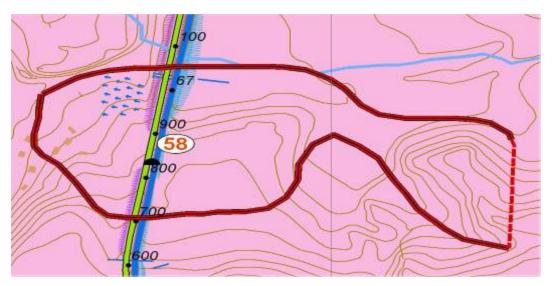
Map 18. Protection area of fortified settlement and tomb field of Dzorakap in relationship with the new design of the Ashtarak-Gyumri Highway

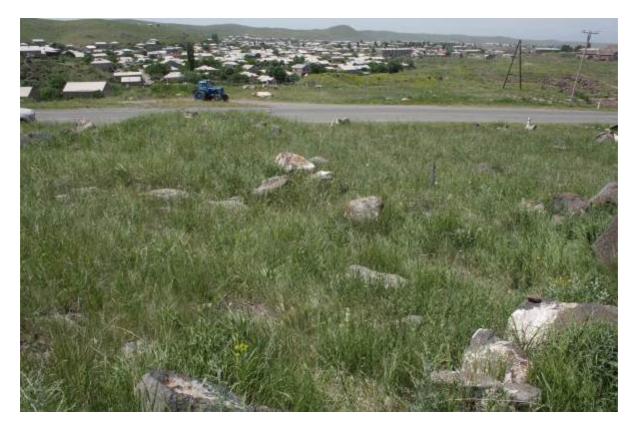
Traces of constructions of fortified settlement and tomb field of Dzorakap on the right side of the existing Ashtarak-Gyumri Road.

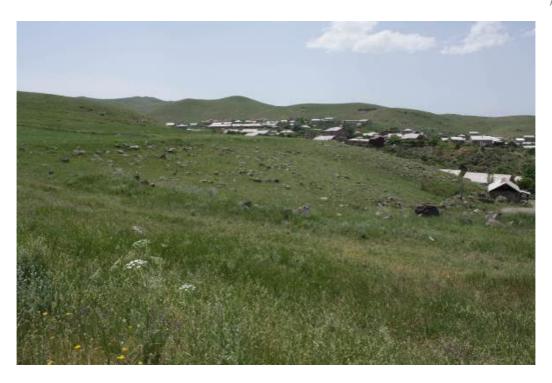
Traces of constructions of fortified settlement and tomb field of Dzorakap on the left side of the existing Ashtarak-Gyumri Road.

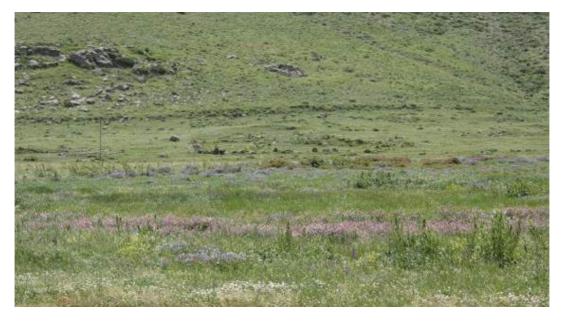
View of the Medieval village remains of Hayrenyats on the left side of the existing Ashtarak-Gyumri Road, closer to the area of the cloverleaf joining the highway with the community

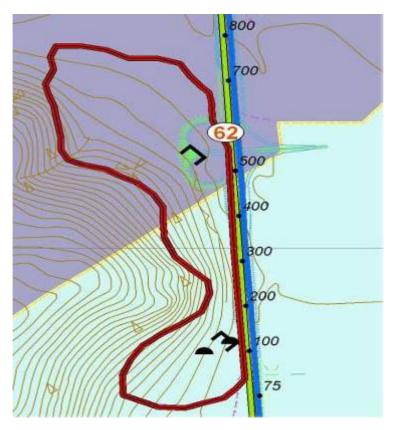
Map 19. Physical boundaries of tomb field and medieval village remain of Hayrenyats in relationship with the new design of the Ashtarak-Gyumri Highway

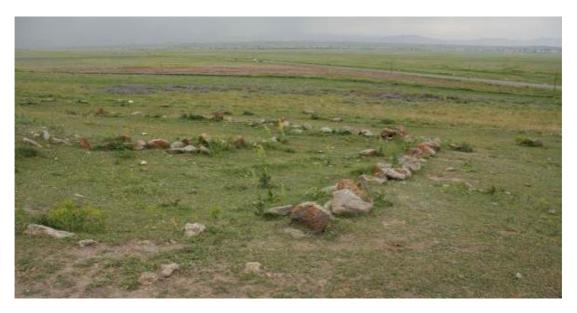
Traces of wall constructions in the area of Medieval village remains of Hayrenyats

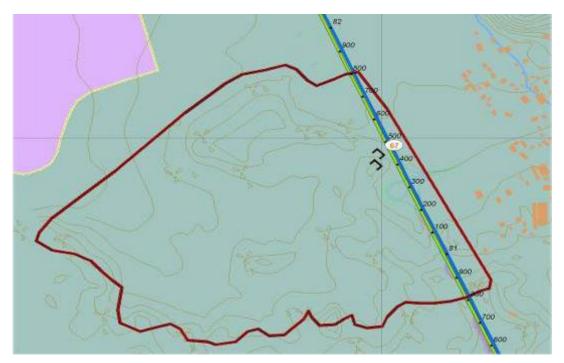
Map 20. Protection area of Benyamin archaeological complex in relationship with the new design of the Ashtarak-Gyumri Highway

Suggested design of the road is directly affecting the site from the right side of the existing Road, which is cutting it into two sides and running through the protection area of the complex. Another problem related to the suggested design is the "cloverleaf" for the entrance to the territory of the Benyamin community.

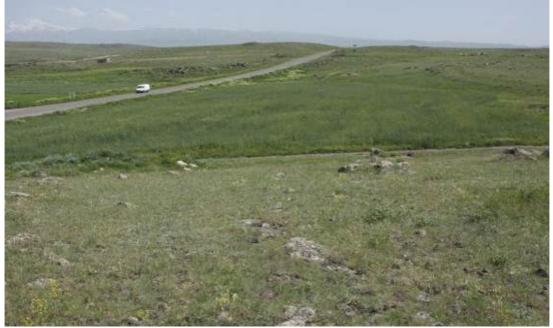
Main view of Benyamin archaeological complex from the North-East, hafted by the existing Ashtarak-Gyumri Highway

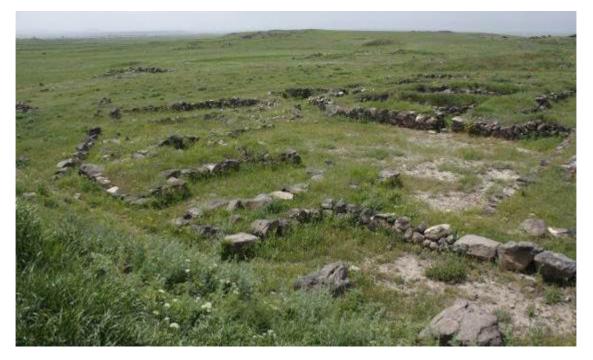
Traces of Hellenistic period wall constructions in Benyamin archaeological complex on the left side of the existing Ashtarak-Gyumri Highway

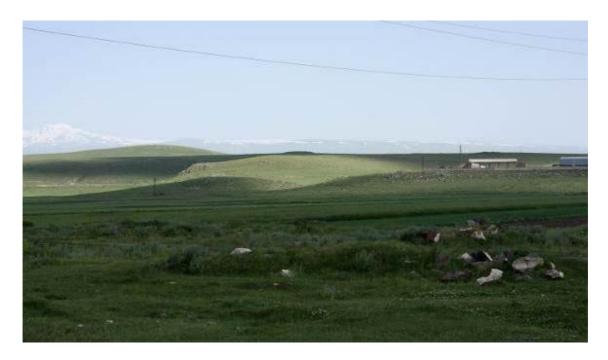
View of Benyamin archaeological complex on the right side of the existing Ashtarak-Gyumri Highway

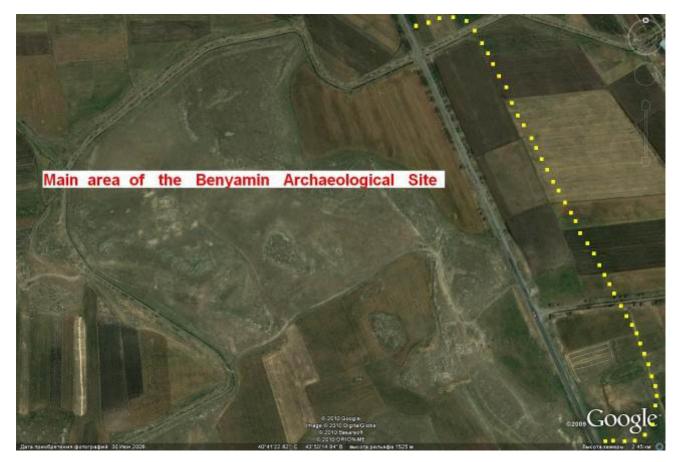
Map 21. The aerial photograph of the Benyamin archaeological complex. The yellow dotted line is marking the area required for test excavations on right side of the existing Road.

Complex solutions for minimizing the actual damage to the site during construction of the new Highway are required. First of all the change of "cloverleaf" location is required, which will cause the damage to the most well preserved part of the site. Next requirement is the redesign of the Highway further right, closer to the Benyamin village as much as it possible. In the case of redesigning the Highway and pushing it at least 80-100 m to the East, the new Highway will partly bypass (although not completely) the protection area of the site. At the same time, it does not exclude the <u>absolute necessity of the</u> <u>test excavations of this new area.</u>

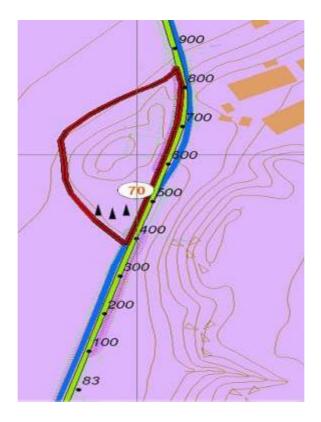
Map 22. Protection area of Azatan Megalithic structures in relationship with thenew design of the Ashtarak-Gyumri Highway.

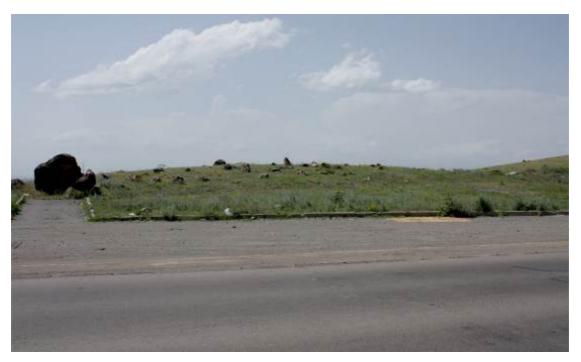
Azatan Megalithic structures on the left side of the existing Ashtarak-Gyumri road.

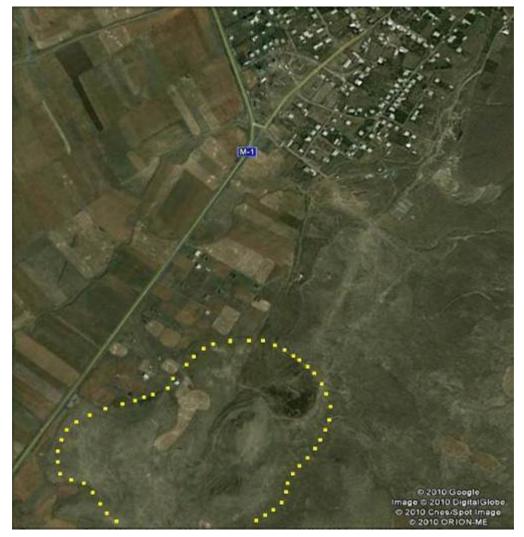
Map 25. Boundaries of the Mastara -3 Bronze Age settlement (yellow dotted).

The site is located nearby the southern outskirts of the village of Mastara. According the surface materials the Mastara-3 settlement belongs to the Bronze-Iron Age period and is representing rich archaeological deposits and the remnants of the dwelling constructions.
