Environmental and Social Assessment for EBRD
GAP ANALYSIS & DISCLOSURE PACK

CATEGORY A PROJECT
SKOPJE WASTEWATER TREATMENT PLANT
FYR MACEDONIA

Supplementary Information
to the 2017 ESIA for WWTP Skopje

1 November 2018

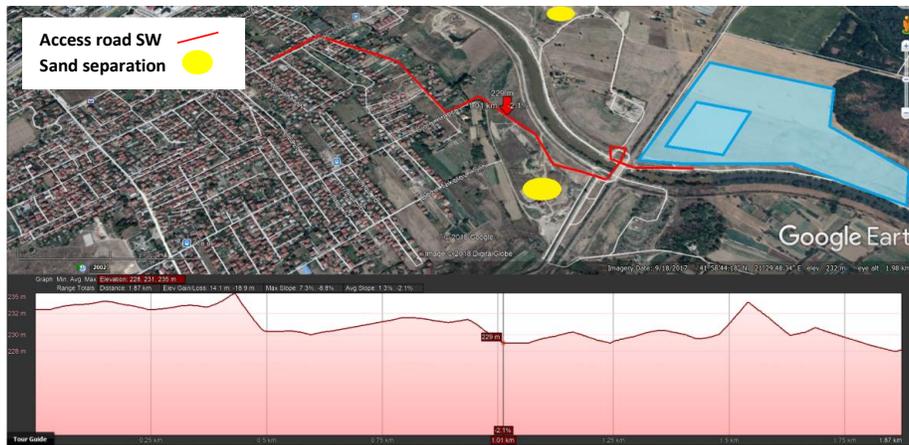
Figure 2: Position of Sand Separation Facilities (source: field observations and Google Earth)

3. Existing sand extraction facilities at two locations and transport of sand material	3. Noise emissions, air emissions, water pollution (only in accidental situations), reduction in visual values of the areas surrounding the WWTP site

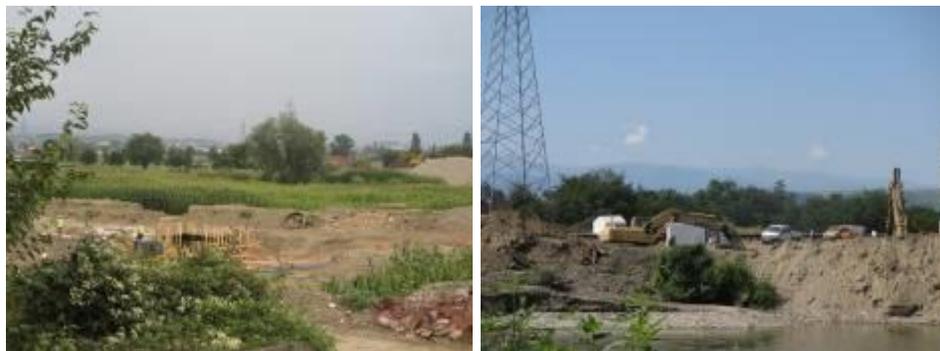
Figure 4: Photos of Activities at Project Location

<i>Issue</i>	<i>Updated baseline information</i>
<p>Location, accessibility and land use</p>	<p>The WWTP site is categorised as agricultural land. On the site and its surroundings, there are: the Vardar River (flows south from the site); the protected area “Ostrovo” (Monument of Nature from 1976) located approx. 50-100 m east from the site with Arboretum and Ezerce on the north); the railway located west to the site, connecting the settlement Dolno Lisice with Trubarevo, after which it divides into two directions (continues either to Thessaloniki or to Belgrade); a high/medium voltage power line 110 kV passing across the site; and an underground gas pipeline across the site.</p> <p>The site is accessible by three unpaved access roads. The south west road enables approach to the site from the northeast, directly connected to the regional road R1102 (the old road Skopje-Veles). It passes through the settlement Ergele (part of the rural settlement Trubarevo), and then beneath the existing railway (underpass with dimensions: 2.5m x 4m) reaches the site from the north. The north east access road (the one from the south) starts from the last bus station in settlement Novo Lisiche and then passes along the bicycle path on the right side of the Vardar River (parallel to the settlement Gorno Lisiche). Further, the road goes through the bridge on the river, then turns left and continues under the bridge, from the left side of the river to the site. There is another possibility for access to the site – through the densely populated settlement Gorno Lisiche, over the sewage collector (right side) and the bridge. At present, this access road is not intended for vehicle transport, since the road is a bike track along the river flow. The third access road is from the northwest direction, starting at the end of the settlement Vardarishte, over the left sewage collector and local fields, next to the river embankment and under the bridge to the site. The Main Design will determine the main future access road to the WWTP.</p> <p>The site is not used for any industrial activities. The only identified user of the land planned for WWTP construction is the company <i>Fakultetsko Zemjodelsko Stopanstvo Trubarevo AD</i>. Based on information provided during an interview conducted in August 2018 with the company’s general manager, the company is a joint stock company privatised during the 90s. The company is a tenant on state owned land within the WWTP footprint, based on a contract with the Ministry for Agriculture and Water Management. The company grows corn, wheat and alfalfa (<i>Medicago sativa</i>) on the land, used to feed livestock.</p> <p>Along the Vardar River basin, there are several private sand separation companies. Some of the ongoing activities (corn planting and sand extraction) are shown in Figure 4.</p>

Based on the site visit observations, the Project location is characterised as a modified area with agricultural crops (wheat) where ruderal vegetation is evident. Corn crops are also found north from the Project area, and at the location Ostrovo east-north east from the Project location.

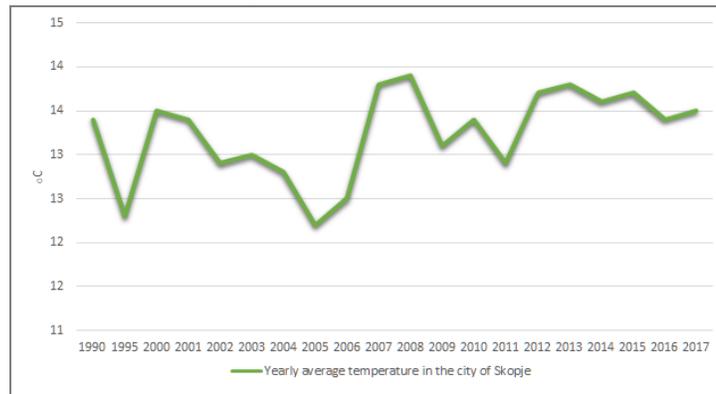
Figure 6: Annual Average Temperature in Skopje 1990-2017 (Source: http://www.moep.gov.mk/?page_id=5683)

Climate The climate in Skopje is classified as continental sub-Mediterranean or even hot continental climate. The summers are long, hot and humid, while the winters are short and relatively cold. Snowfall is common in the winter period, but heavy snow accumulation is rare and the snow cover lasts only for a few days. Annual average temperatures in the City of Skopje for the period 1990-2017 varied from 12.2 up to 14 degrees (Figure 6).

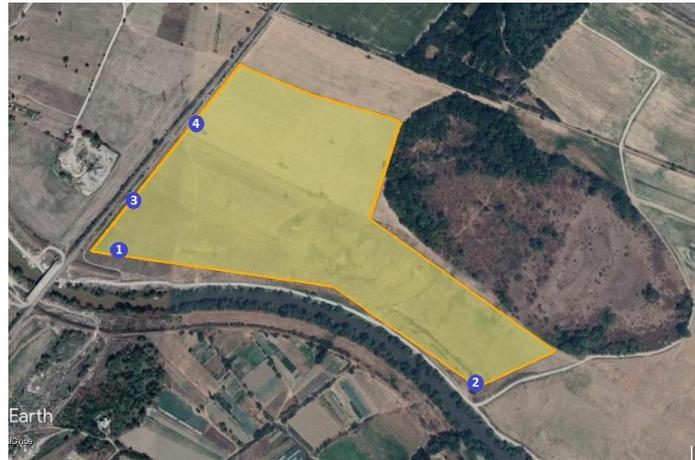
Figure 10: Noise Level Measuring Points around the WWTP Site

During the second site visit conducted on 13 August 2018, the Consultant conducted noise measurements on the borders of the WWTP site (4 sampling points). Measurements were conducted by means of a Sound Level Meter Model: SL-4012 and data processed by the software LUTRON sound system. Coordinates and a map of the measuring points are provided in Figure 10 and Table 2.

The measured noise levels at 3 out of 4 points (except point 1) were within the limit values for area with 4th degree of noise protection according to national legislation (i.e. non-residential areas exclusively intended for industrial activities, storage activities and other production facilities). The exceeding noise level at point 1 was due to occasional truck transport on the unpaved road. The trucks are owned mainly by the contractor engaged for construction of the sewage collector (left and right) and other companies that use sand from the surrounding sand separations activities in the vicinity of the site.

Noise level point	Coordinates	Average noise level (dB)	Max. noise level (dB)
1	N:41°58'35.26" E: 21°30'14.17"	56	76
2	N:41°58'35.26" E: 21°30'14.17"	37	42
3	N:41°58'35.26" E: 21°30'14.17"	45	55
4	N:41°58'35.26" E: 21°30'14.17"	41	56

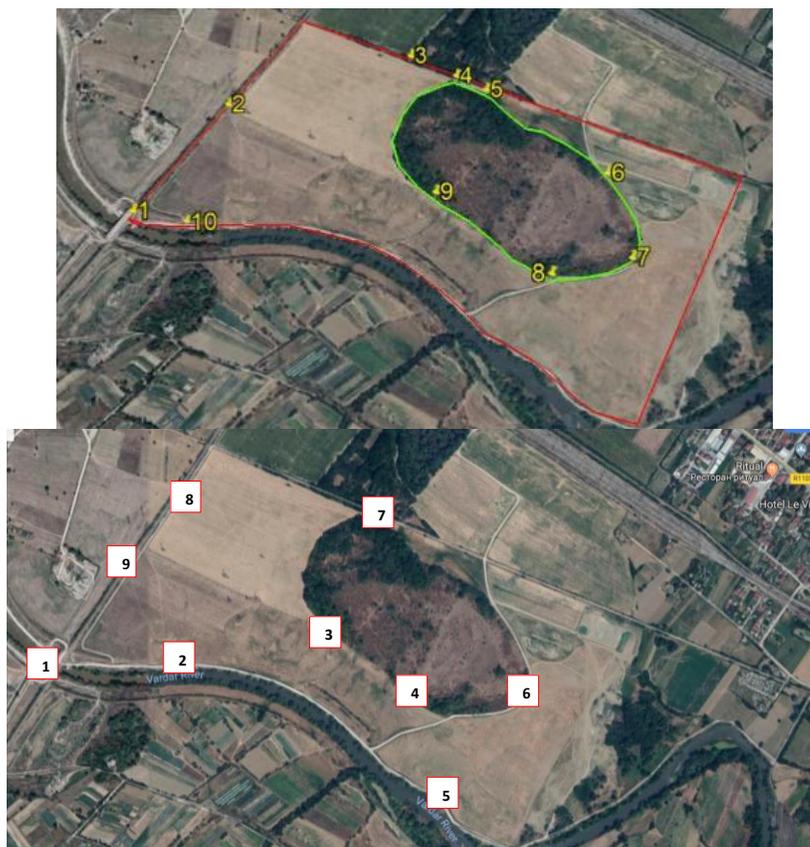
Figure 15: Surveying Directions Points for Identification of Flora and Fauna during the First Site Visit (left) and Second Site Visit (right)

Maps showing observation points where the site visits were conducted and flora and fauna species were recorded are given

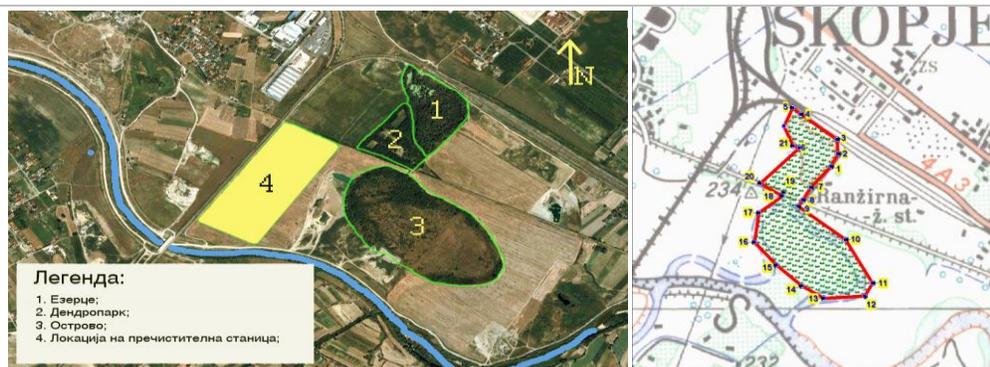
Figure 16: Position of Ostrovo (3), Arboretum (2) and Ezerce (1) in relation to the WWTP (4)

Protected areas	<p>The Natural Monument "Ostrovo" is situated in close proximity to the WWTP site (approx. 50-100 m from the site). It was designated as protected in 1976 by the Assembly of the City of Skopje (III degree of protection which is equivalent to III category according IUCN). This area covers 0.29 km² and is a relict ecosystem (specific flora and fauna) of the former riverbed of the Vardar River. The regulation of the water from the river and cutting of the meander (Figure 16) has most likely changed the occurrence of species.</p> <p>Based on information provided by MoEPP in August 2018, the area is still protected within the boundaries from 1976 in line with the <i>Law on Protection of Nature</i>¹⁰, even though there are no precise data on biodiversity values of this area. There are indications that species like butterflies, Odonata, Fish, Amphibians (Triturus), Reptiles (marsh turtles, water snakes), and Mammals (Spalacidae species, bats, <i>Lutra lutra</i>¹¹ - otter) could be present, as well as colonies of water and swamp birds (Ciconiidae, Ardeidae, <i>Phalacrocorax pygmaeus</i>¹² - Pygmy cormorant <i>Alcedo atthis</i>, etc).</p> <p>In 2010, the <i>Proposal of the Law on Designation of the Protected area - Integral Area of Ostrovo, Arboretum and Ezerce</i> (within Arboretum) was suggested to the Government of FYR Macedonia with the aim of revalorisation/re-categorisation of the area. Based on information provided by MoEPP, the Proposal was rejected due to the fact that the Faculty of Forestry does not have the capacity to manage the new protected area.</p>

In the radius of 5 km, there are no other protected areas, no Natura 2000 sites identified, and no important areas for birds, plants and butterflies. The area is not included into the National Emerald network of protected areas.

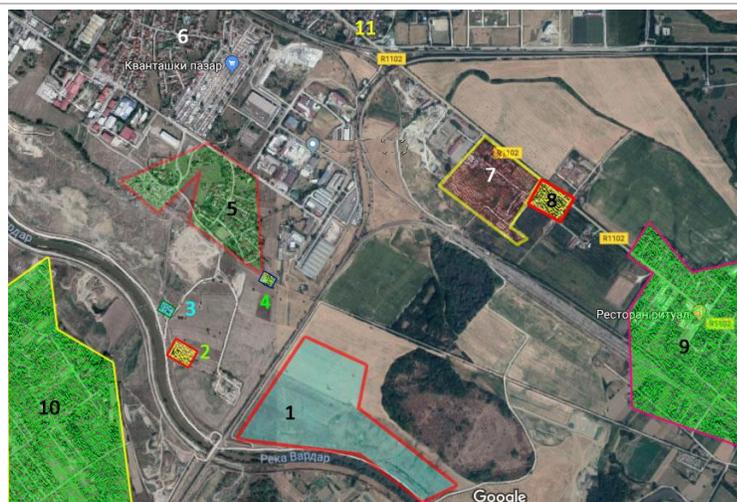
The following map shows the above mentioned neighbourhoods:

- 1.** WWTP site
- 2/3/4.** Three small dislocated clusters of houses in Vardarishte
- 5.** Vardarishte
- 6.** Kvantashki (part of Madzhari)
- 7.** Ergele (part of Trubarevo)
- 8.** Headquarters of the company Fakultetsko Zemjodelsko Stopanstvo Trubarevo AD
- 9.** Remaining part of Trubarevo
- 10.** Gorno Lisiche
- 11.** Hipodrom
