Mediterranean Corridor, Bosnia and Herzegovina - Croatia CVc Road Interconnection, Subsection: Konjic (Ovcari) - Prenj Tunnel - Mostar North

Gap Analysis & ESIA Disclosure Pack

Volume 1: Environmental and Social Impact Assessment Report

Chapter 13 Soil

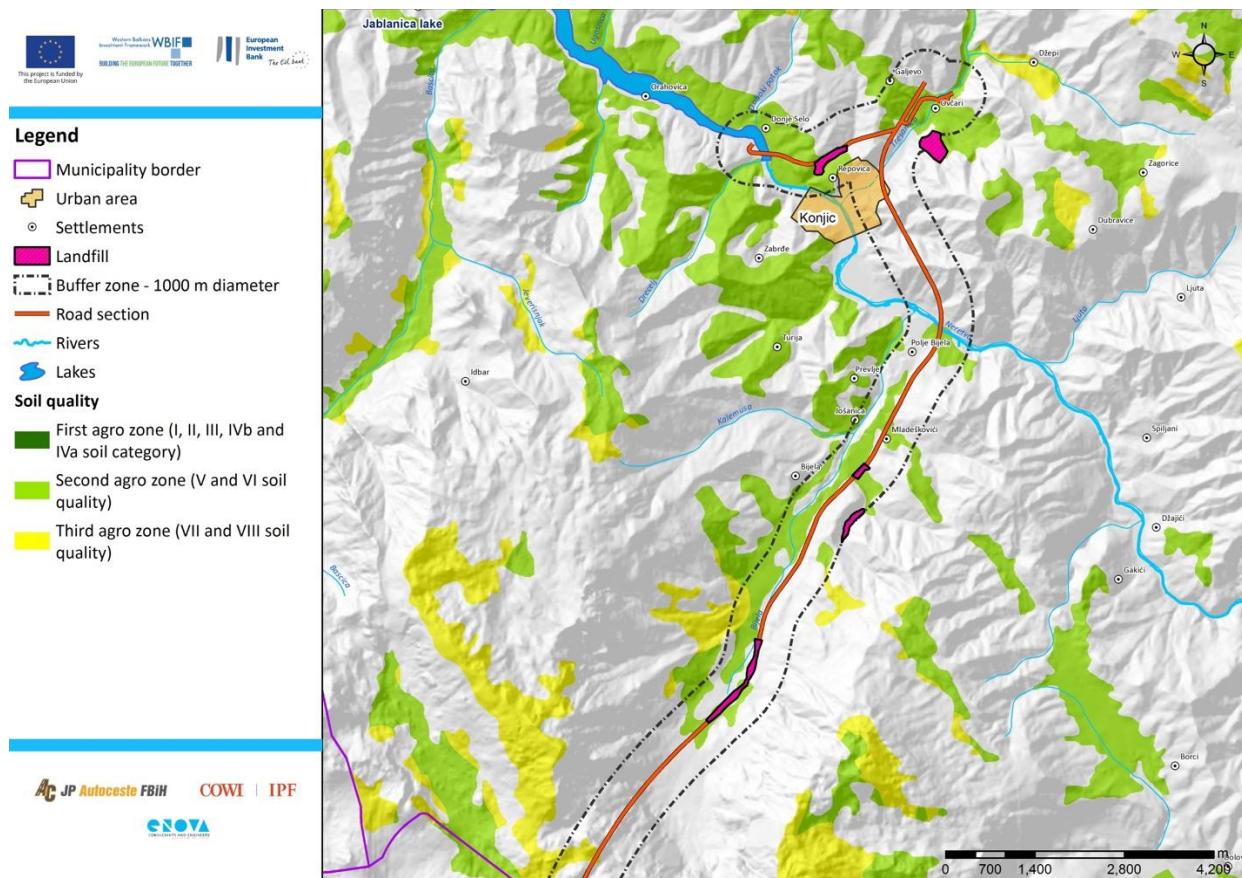
Figure 13-1: Land categorisation in the Project area – Konjic side

Land categorisation is presented in

Figure 13-1 and Figure 13-2.

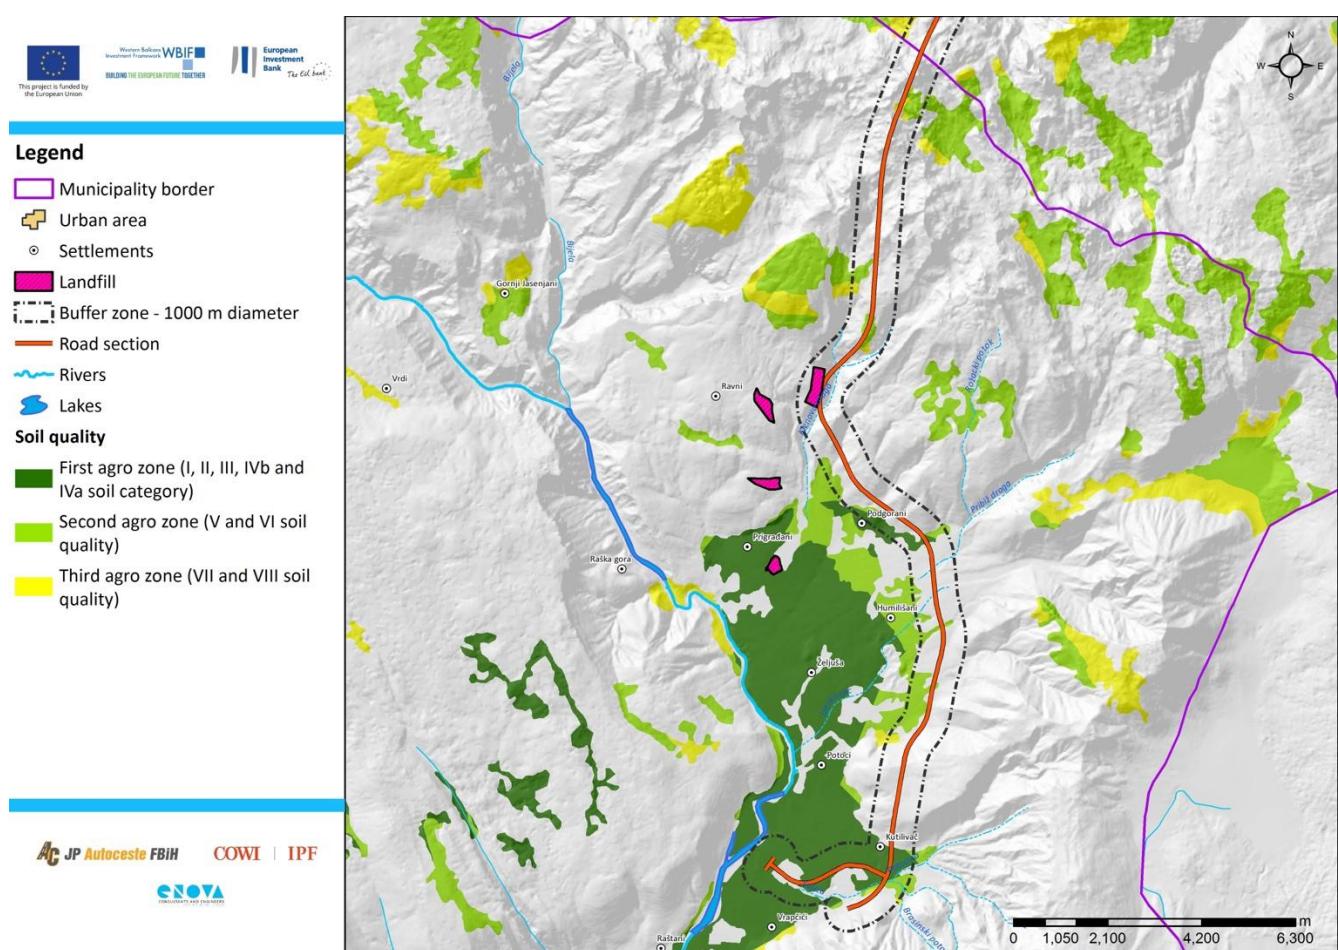
Figure 13-2: Land categorisation in the Project area – Mostar side

As shown in the figure above, the Project area is mostly uncategorised in terms of the soil quality values, except for the part of the route passing through Konjic urban area, area of the Konjic Bypass in the alluvium of Neretva River, and before Mostar North Interchange.

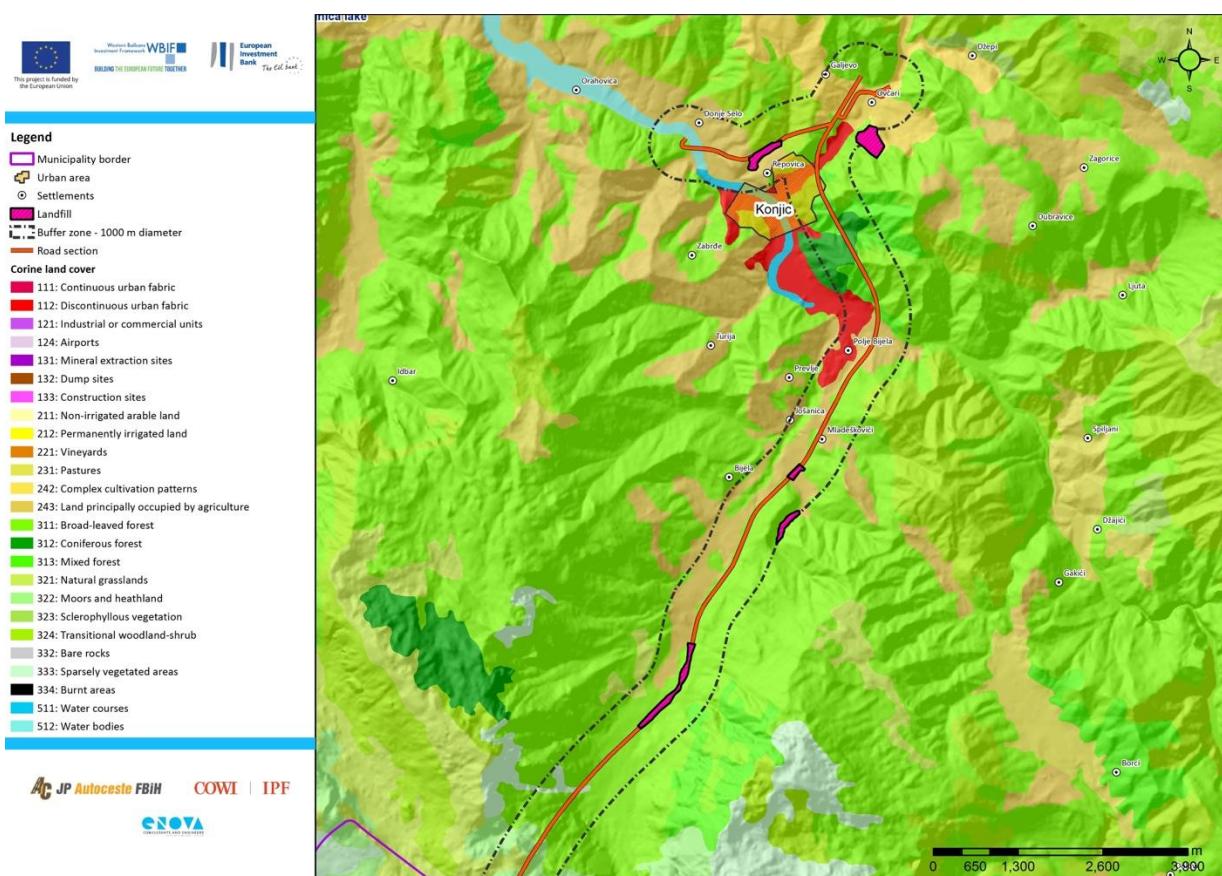
Figure 13-3: Land use on the Konjic side

The land use according to the 2018 Corine Land Cover for BiH for Konjic and Mostar side of the motorway alignment is given in Figure 13-3 and Figure 13-4.

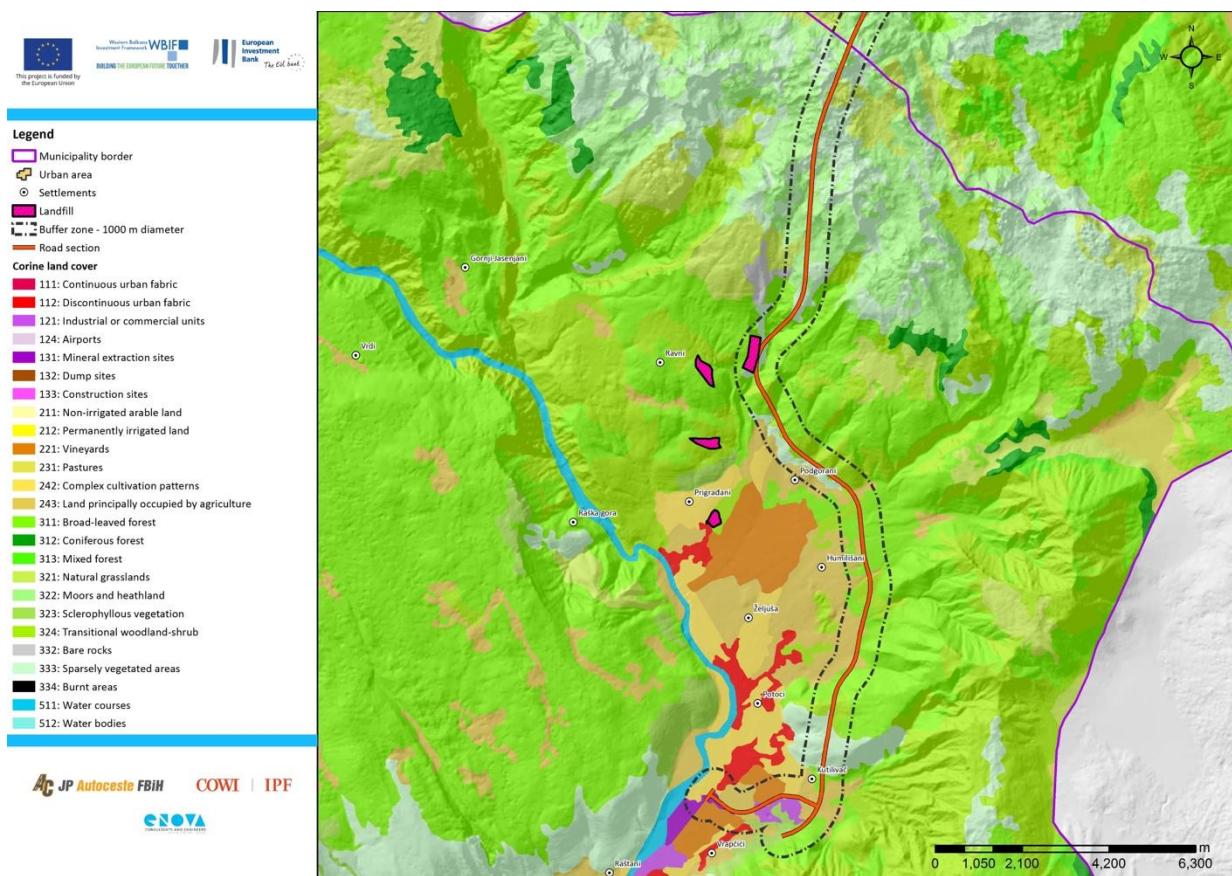
Figure 13-4: Land use on the Mostar side

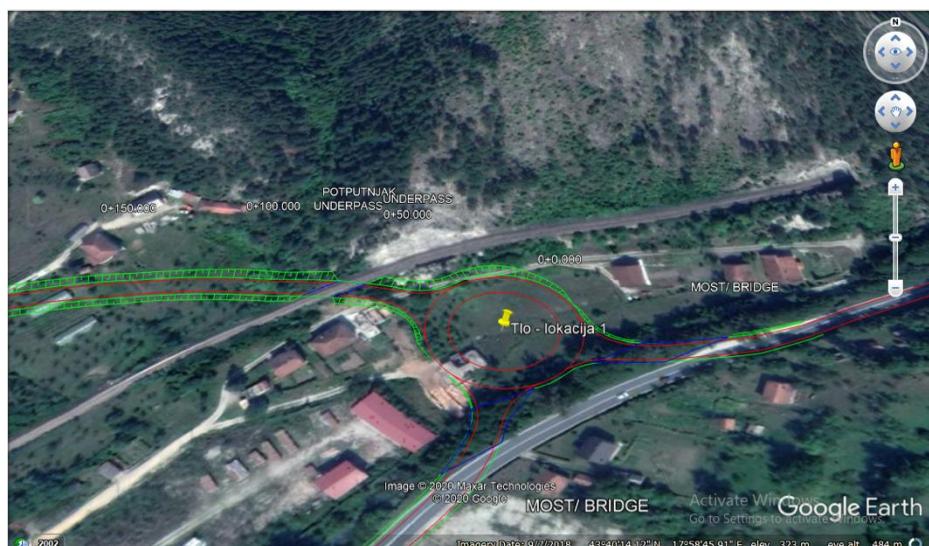
Figure 13-5: SP1 - Ovcari

SP 1, 3, 4, 5, 6 can be classified as agricultural land. Comparing the content of total forms of heavy metals in the soil sample with the values of the pollutants in agricultural land in accordance with the *Regulation on Determining the Permitted Quantities of Harmful and Dangerous substances in the Soil and the Methods of Their Testing*³, it was found that the samples at the following sampling points during the winter period do not meet the limit values for agricultural land:

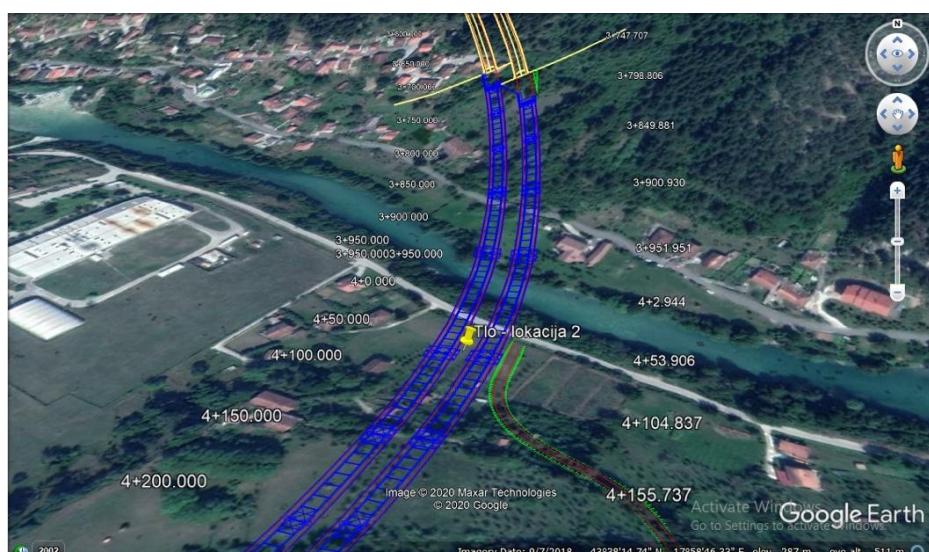
Figure 13-6: SP2 - Polje Bijela

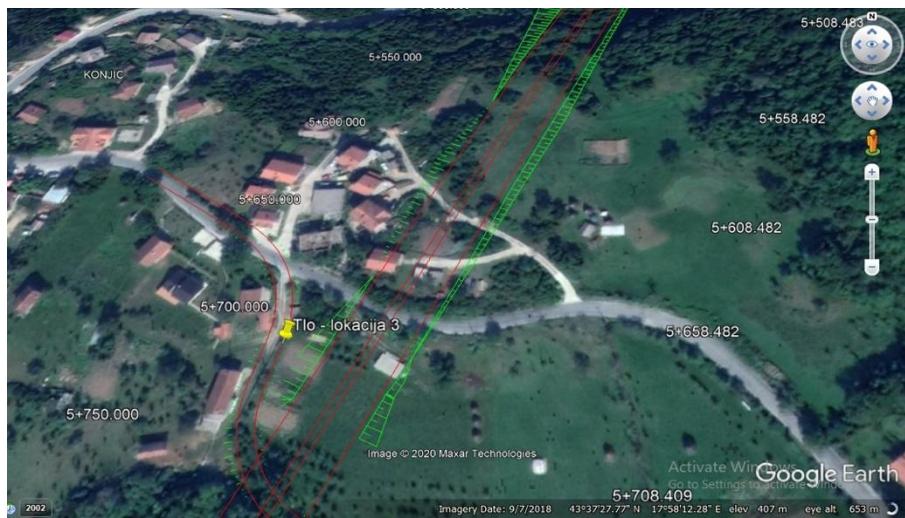
Figure 13-7: SP3 - Bijela

Ordinal number	Description of the SP	Location
SP 3 – Bijela	Next to the road R435	N: 43° 37' 26,71" E: 17° 58' 9,66"
SP 4 – Mladeskovici	Village Mladeskovici under the Viaduct	N: 43° 36' 58,37" E: 17° 57' 53,23"
SP 5 – Podgorani	Close to the village Podgorani under the Viaduct	N: 43° 27' 48,86" E: 17° 53' 39,14"
SP 6 – R435a	Next to the road R435a towards Rujiste	N: 43° 26' 37,20" E: 17° 54' 41,11"

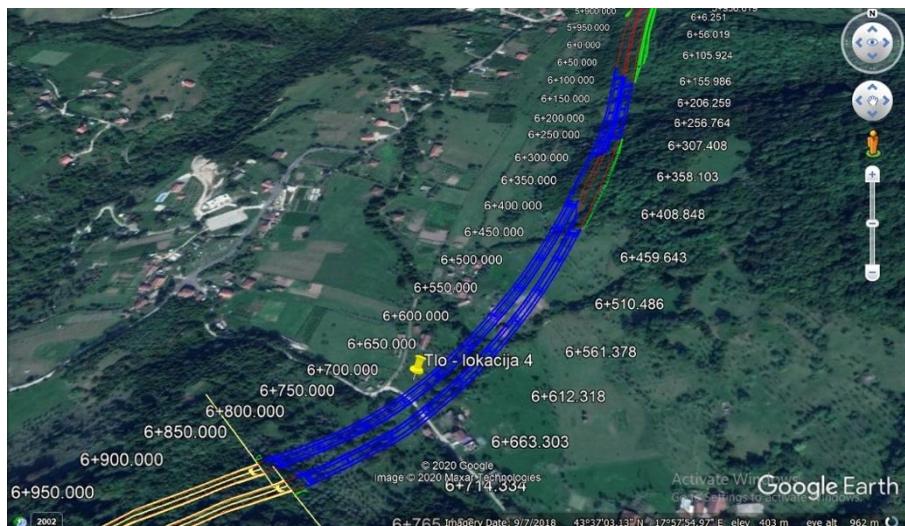
Figure 13-8: SP4 - Madeskovicci

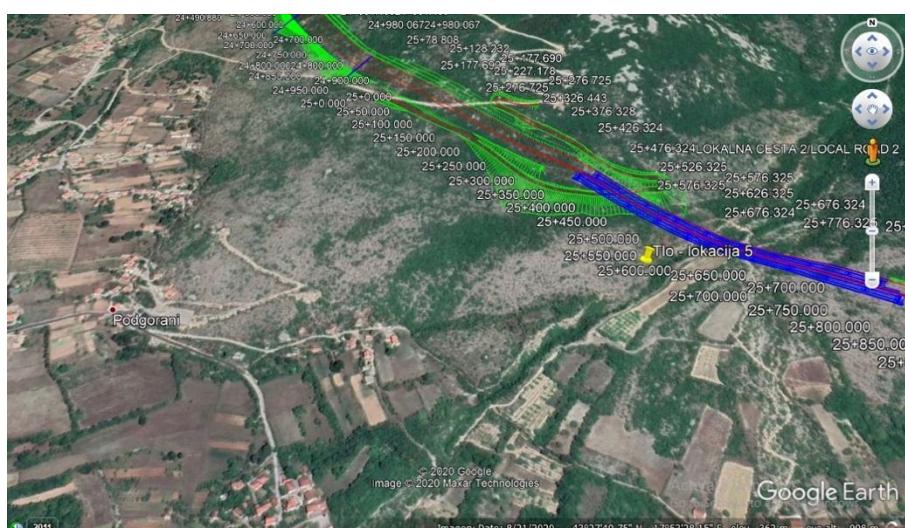
Figure 13-9: SP5 – Podgorani

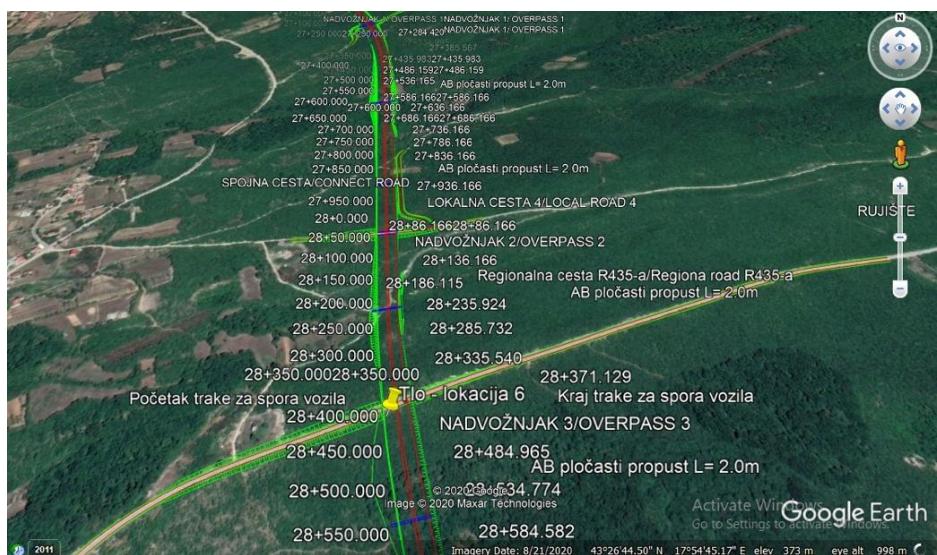
Figure 13-10: SP6 - R435a

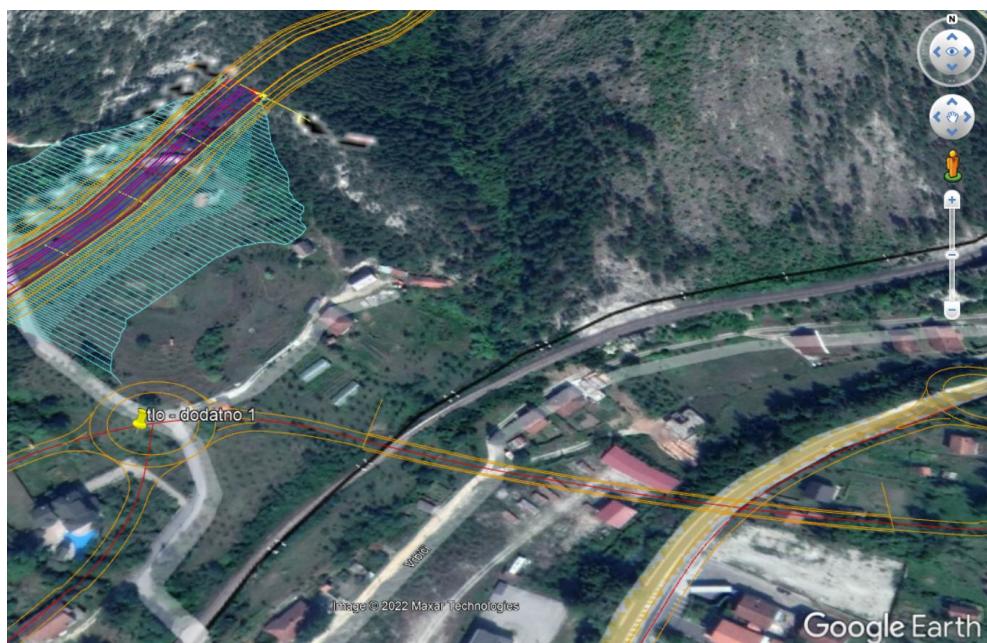
Figure 13-11: Beginning of the Konjic Bypass in Ovcari

Ordinal number	Description of the SP	Location
SP 1 – Ovcari	Beginning of the Konjic Bypass in Ovcari	N: 43°40'11.86" E: 17°58'35.90"
SP 2 – near the Konjic landfill	In the settlement near the municipal solid waste landfill site	N: 43°39'38.46" E: 17°57'15.81"

According to the structure, the soil is powdery-loamy and in accordance with the limit values shown in the *Rulebook*, the tested soil samples **meet the limit values** according to the soil type.

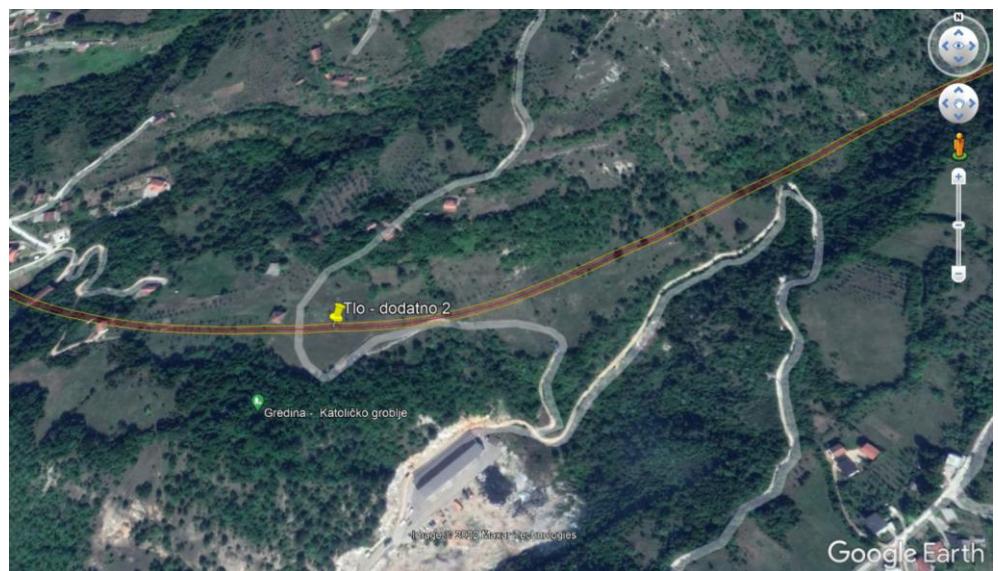
Figure 13-12: Settlement near the municipal solid waste landfill site

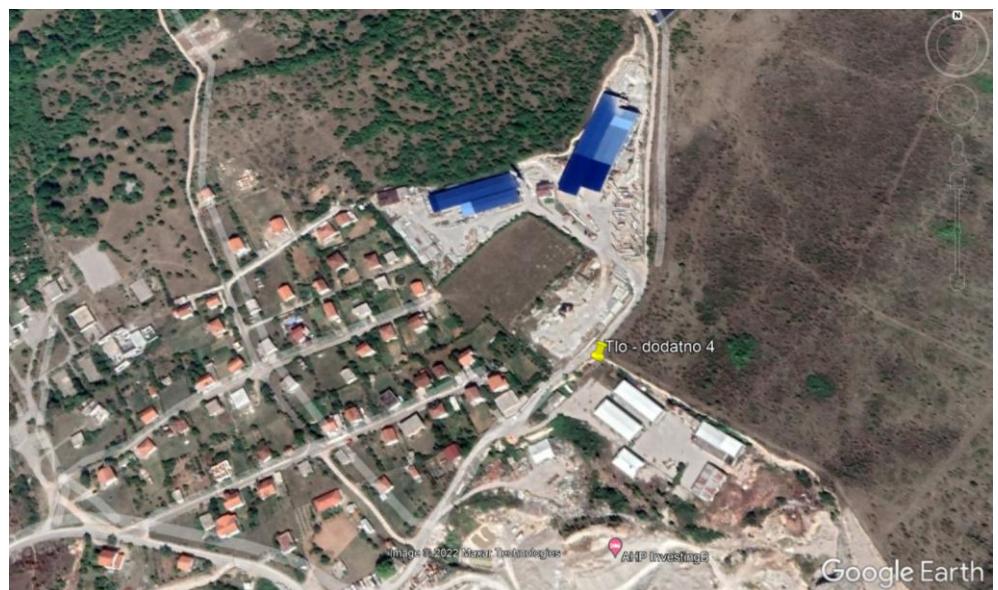
Figure 13-14: Access Road near the HP Investing industrial site

Ordinal number	Description of the SP	Location
SP 1 – Bijela	Access road in the settlement Bijela	N: 43°36'16.86" E: 17°56'43.92"
SP 2 – HP Investing site	Access road near the HP Investing industrial site	N: 43°26'40.13" E: 17°51'49.45"
SP 3 – Prigradjani	Access road in the settlement Prigradjani	N: 43°27'39.68" E: 17°52'25.22"

Based on the test locations and surrounding environment, SP 1, SP2, and SP 3 can be considered as agricultural land. According to the structure of the soil samples, the soil is sandy and is evaluated against the limit values given in the Rulebook. All parameters for all three analysed soil samples **meet the limit values** stipulated by the *Rulebook on determination of permitted amounts of harmful and dangerous substances in soil and their testing methods* except for zinc as follows:

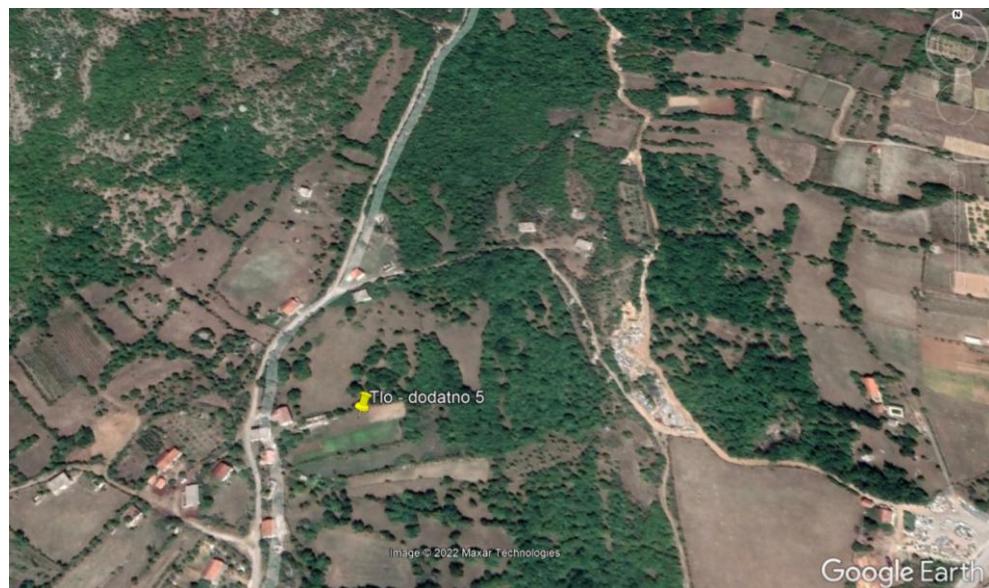
Figure 13-15: Access Road in the settlement Prigradjani

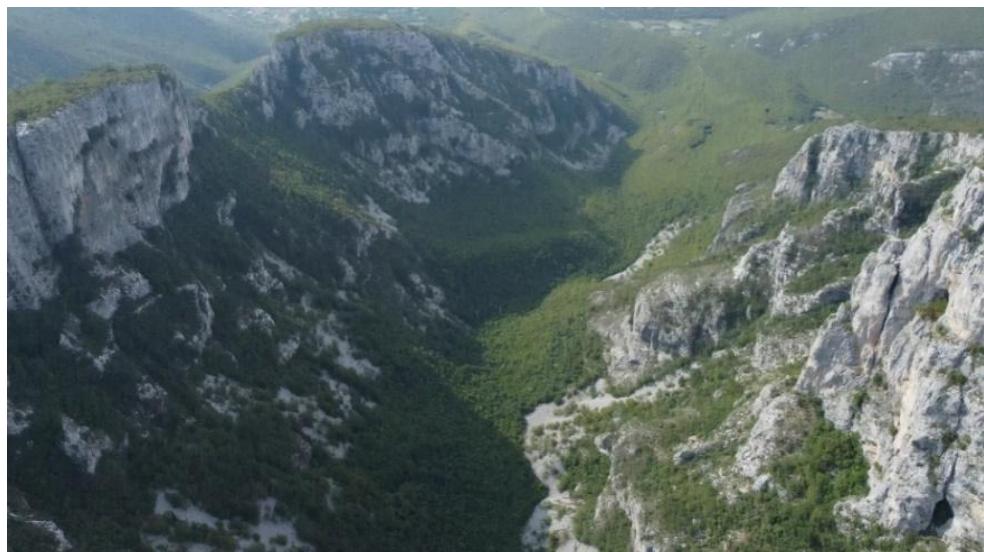
The alignment from tunnel Prenj exit on the southern part of the sub-section is extended through the tectonically deep canyon Klenova Draga with traces of intensely glacial erosion. Its cliffs are up to 550,0 m in height.

Figure 13-16: View at the Klenova Draga canyon from the tunnel Prenj exit portal direction

The bottom of the canyon is relatively narrow, i.e., 120,0 – 250,0 m wide and it is covered with scree deposits. Scree deposits have a maximum thickness over

Both rocky sides are tectonically degraded with a high risk of rock fall in case of stronger seismic shocks. As evidence there are localised landslides, especially where the entrance to Gradina tunnel (T4) is planned. Through the whole length of the canyon there is debris flow, active in the very wet periods.
