Nenskra Hydropower Project

Supplementary Environmental & Social Studies

Volume 6 Natural Hazards & Dam Safety

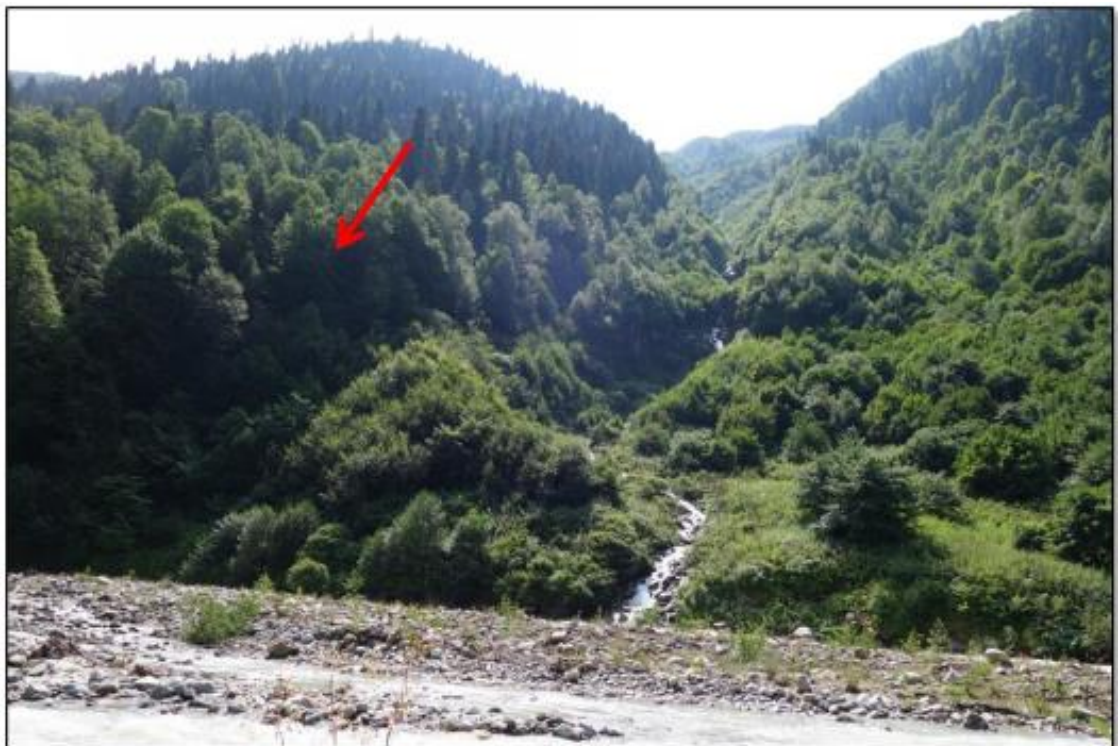
Figure 2 – Location of Nakra transfer tunnel outlet portal

- [SAF 8] Nakra transfer tunnel outlet portal structure protected from potential rockfall. The protection measures are included in the design and installed during construction.
- [SAF 9] Nakra transfer tunnel outlet portal worksite and construction workers are protected from potential rockfall. The protection measures are included in the design and installed at the start of the construction.

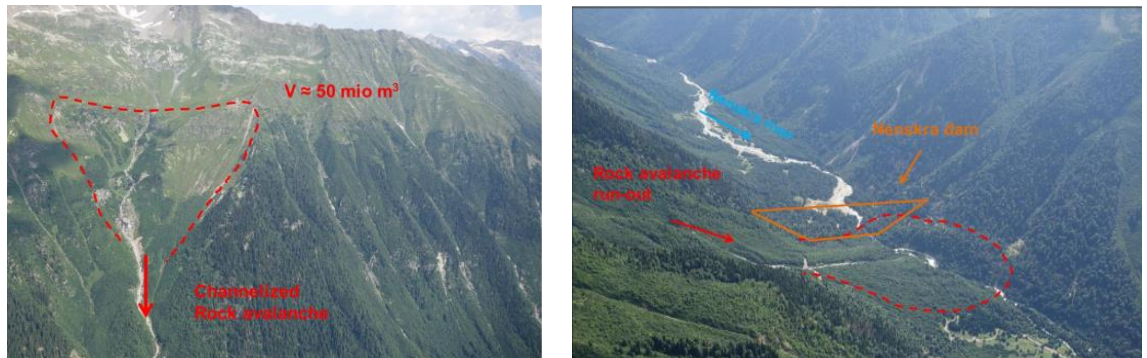
Figure 4 – Historical evidence of landslide at the dam site

Visual evidence of an historical landslide deposit at the dam emplacement. Left: View from the left bank towards the detachment zone of the landslide event. The volume of the material is probably significantly less than 50 million cubic metres. Right: Maximum extension of the landslide and run-up area on the opposite slope.

Figure 4 below shows the detachment and deposition areas. **The possibilities of further slope collapses are considered low** according to an inspection of the possible source areas by means of a satellite image inspection and helicopter overflight and a slope stability assessment using satellite radar interferometry (see Annex 5 and section 3.1.3.4).

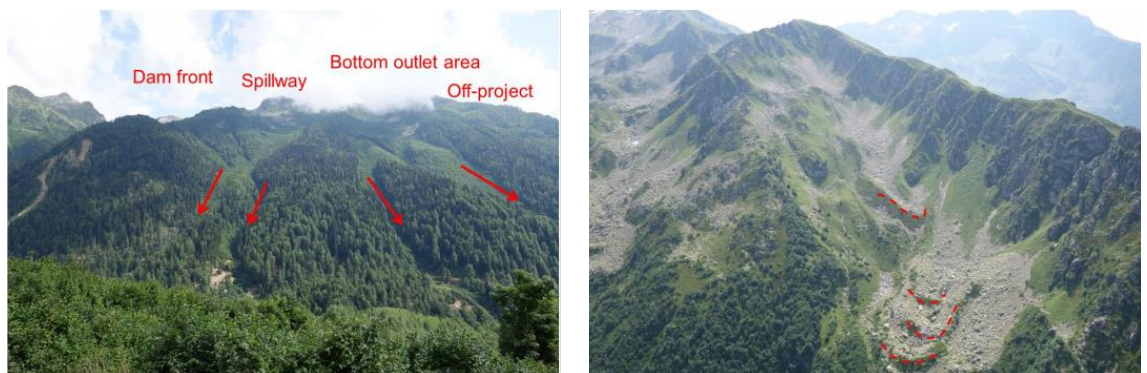
Figure 5 – Debris flow/avalanche channels in the area of the dam

Debris flow/avalanche channels on the left slope above the dam (left) and uphill area of the rightmost channel (right).

On the left bank (see Figure 3). There are 3 alluvial/debris channels which align (i) with the upstream dam face in the left abutment, (ii) the downstream dam face or spillway area and (iii) the Bottom outlet tunnel portal area. A forth channel probably points downstream of the project area (Figure 5).

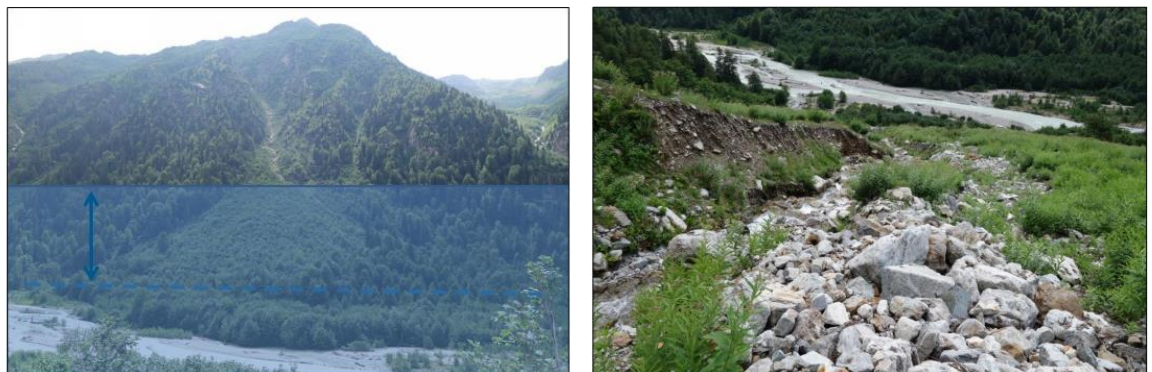
Figure 7 – Submerged alluvial/colluvial fans

Typical situation of a alluvial/colluvial fan which will be submerged by the reservoir and subject to reservoir draw-down (left) and soil structure of such a fan, composed of large-scale granular material (cobbles to blocks) in a sandy-gravelly matrix (right).

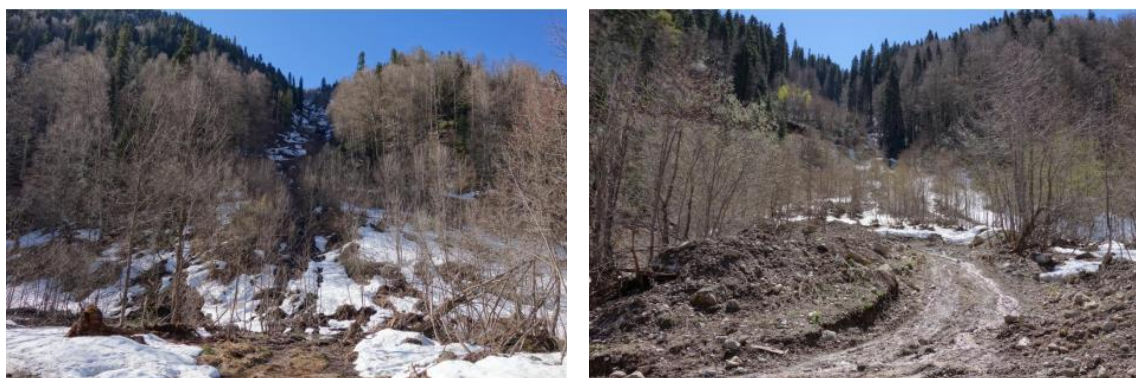
Figure 9 – Reservoir spillway – and avalanche and debris flow channels

The reservoir spillway will be a tunnel spillway. It is well protected against surface processes such as avalanches, debris flows and spontaneous earthquake-triggered soil slides, but is vulnerable to clogging from floating debris. However, the spillway inlet is a risk of blocking from avalanche and debris flow events and protection measures will be included in the design.

Alluvial/debris fans with possible debris flow and snow avalanche activity which point towards the upstream face of the dam (left) and the initial and middle/final part of the surface spillway (right).

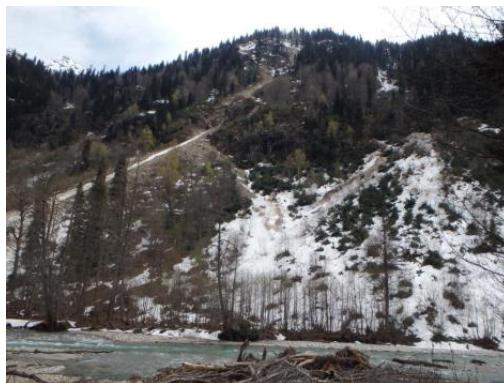
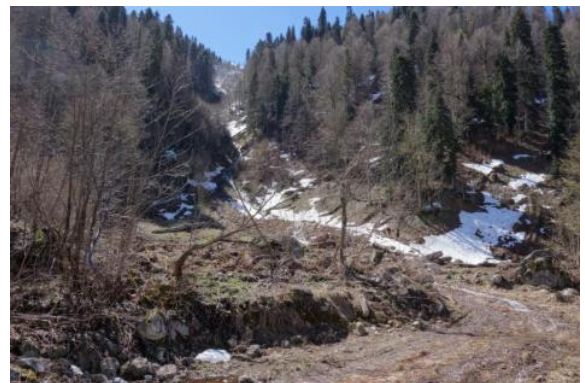
Figure 11 – Bottom outlet inlet and outlet portals

The Bottom Outlet's inlet and outlet portals are both situated in areas potentially affected by alluvial/debris fans with possible debris flow and avalanche activity. The inlet portal in particular is at risk of clogging due to floating debris (heavy rainfall, avalanches) and debris flow material. The design of the structures will take account of these possible hazards as the bottom outlet is a safety feature allowing the reservoir water level to be lowered if a safety issue arises, and blocking the bottom outlet would also stop the ecological flow leading (to environmental consequences).

The intake portal of the Bottom outlet tunnel is located at the foot of the snow-covered debris fan on the right of the photograph (left). The alluvial/debris fan with snow avalanche activity which points towards the area of the exit portal of the Bottom outlet tunnel (right).

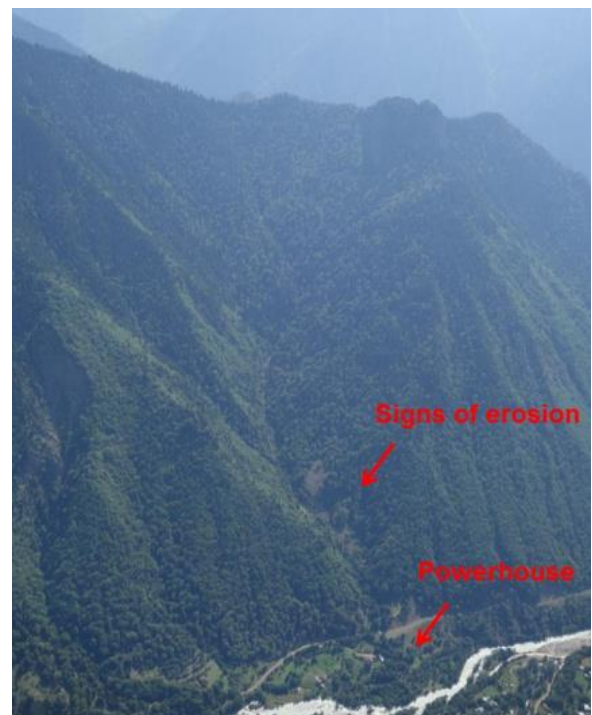
Figure 12 – Aerial view of the powerhouse area and smaller valley above

The powerhouse is located close to the exit of a smaller valley with a hydrographic basin of 1.9 square kilometres and maximum elevations around 1,750 metres asl (Figure 12).

A preliminary analysis of the geological, geomorphological and topographic situation shows that there may be possible sediment transport/debris flows during periods of heavy rainfall along the lateral torrent and at the exit of the upstream valley.

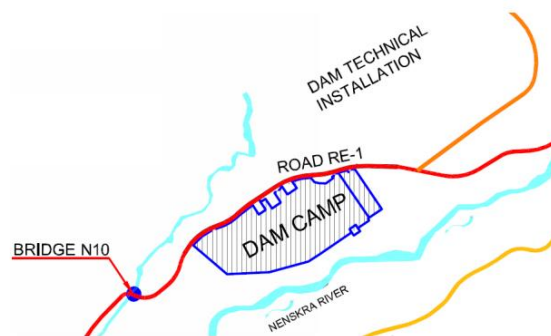
Figure 13 – Sketch of dam camp and technical installation layout

The layout of the dam camp and technical installation is illustrated in the sketch provide in Figure 13, and is situated approximately 2 kilometres downstream from the dam site.

The area where the camp is planned to be located is 1.5 kilometres downstream from the dam structure, it is located in a meadow where local people have constructed summer cabins. Local people report that in 1987 that the runout from an unusually large avalanche that occurred on the slopes above the meadow (on the right bank) extended across part of the meadow where the construction camp is planned to be located. Consequently, the risks for natural hazard events affecting the site are ranked as moderate and further studies will be undertaken to define the protection measures required. It should also be noted that the area earmarked for the construction camp is located 1.5 kilometres downstream from the area affected by the large avalanche that occurred in 1987 - near the dam site - and which blocked the valley which is very narrow at that point (see section 3.1.3.3A).

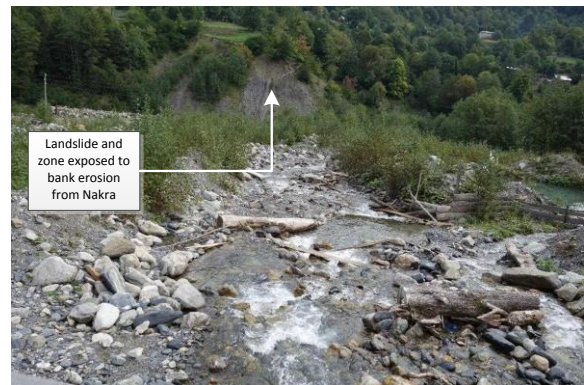
Lekverari torrent at Nakra village – looking downstream to the confluence with Nakra

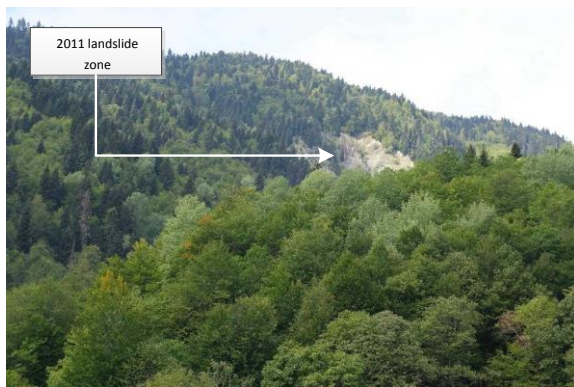
Lekverari gorge - zone exposed to landslide risk

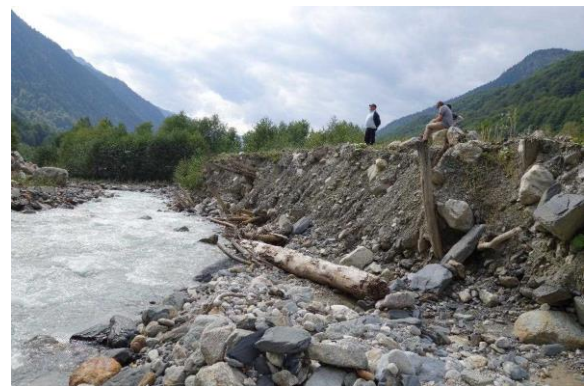
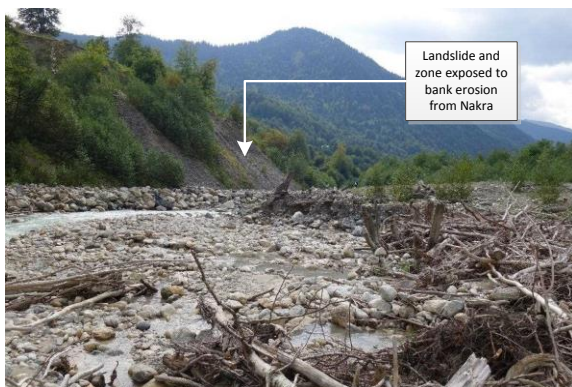
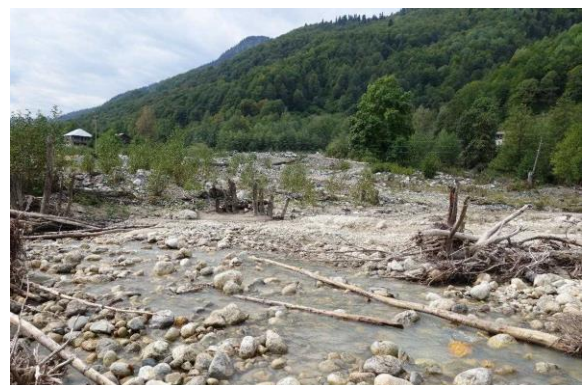
Photo Sheet 1– Geomorphology features at the Lekverari – Nakra confluence

Nakra River – at Nakra village – remains of solid material transported by Lekverari torrent following landslide in 2011 – and which blocked the Nakra
Illustrates the depth of material that blocked the river

Lekverari torrent aluvial fan at confluence with Nakra River

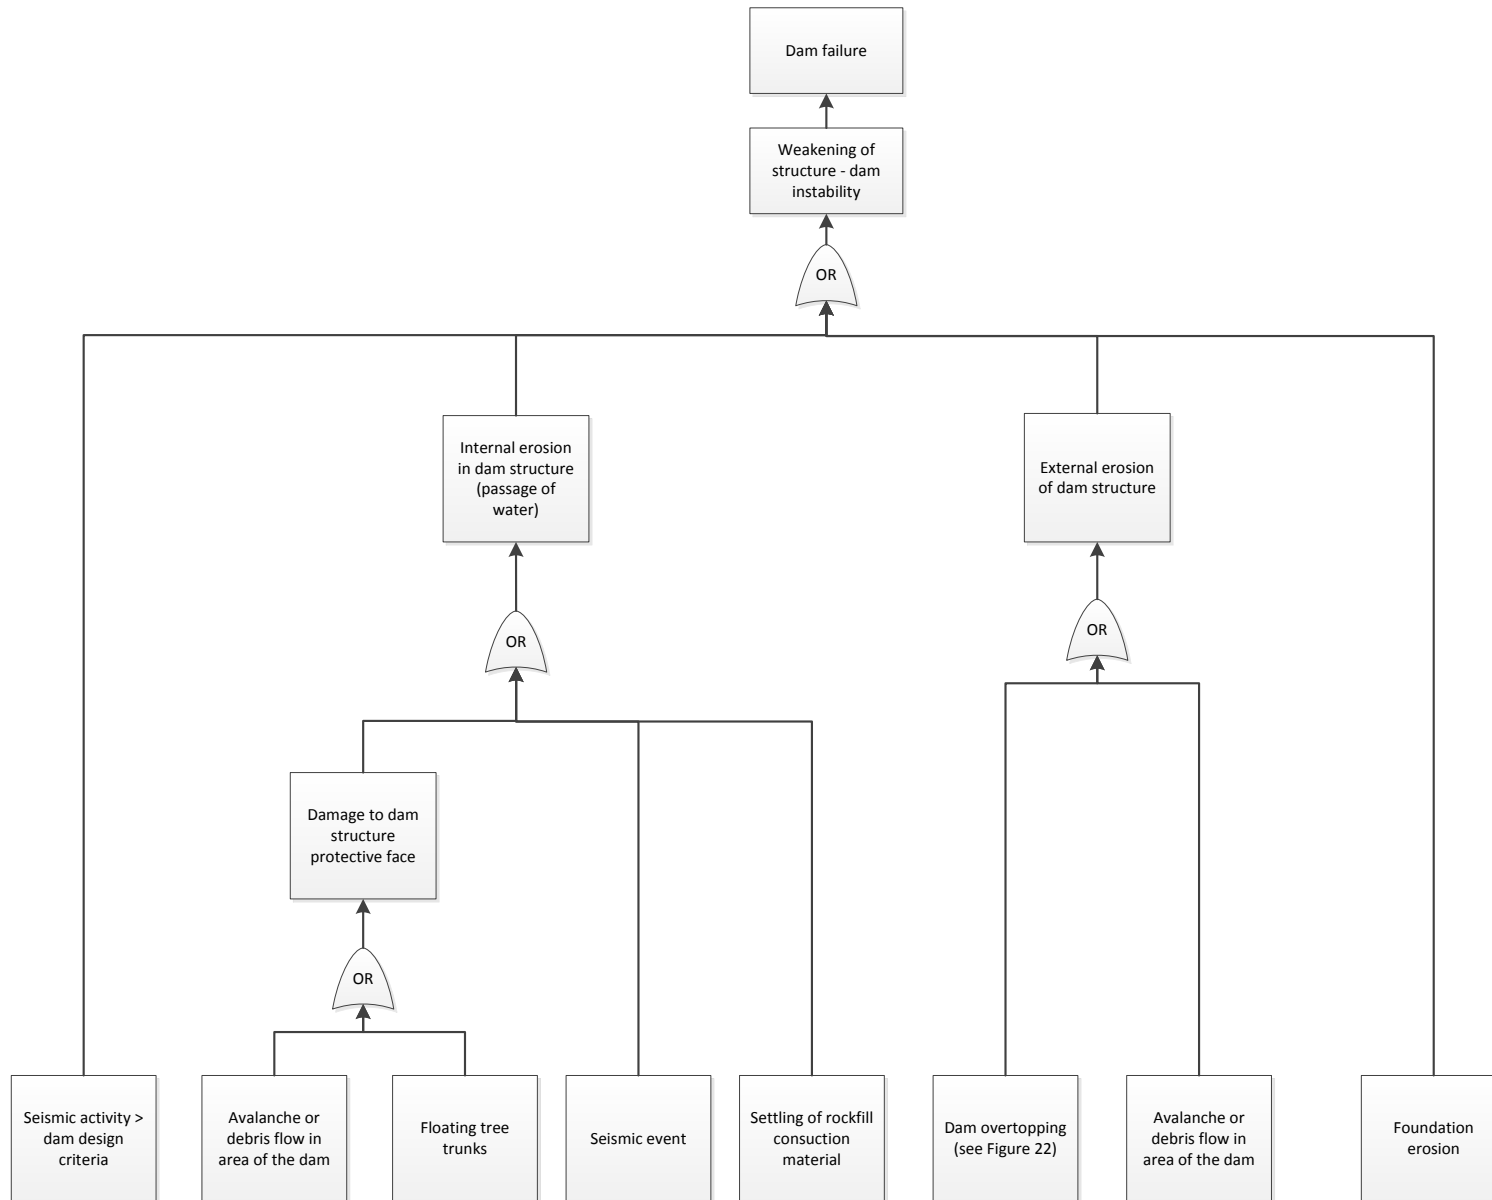
Figure 19 – Fault tree for dam failure during operation

Unwanted Event:	Dam structure instability and possibly leading to failure		
Description: Degraded dam stability could result in a reduction in the capacity of the dam to withstand hydraulic loads and could lead to the failure of the dam if the phenomenon is not detected and corrective action not taken. The overtopping is a cause of dam instability and is described in Table 8 on the previous page.			
Initiating Event 1: Internal erosion	Initiating Event 2: External erosion of the dam material	Initiating Event 3: Foundation erosion causing reservoir water to pass under the dam structure	Initiating Event 4: Seismic loading
Description: Rupture or damage to the protective face could cause increased ingress of water into the core material causing internal erosion and weakening the structure. The damage to the protective face could be caused by (i) settling of rockfill construction material, (ii) from avalanche or debris flow, (iii) floating tree trucks, or (iv) from a seismic event.	Description: Could occur in the event of overtopping (see Table 8) or as a result of avalanche or debris flow events impacting the dam structure. The external erosion can cause a weakening of the dam structure.	Description: The geology underlying the dam structure comprises a layer of pervious alluvial deposits overlaying the solid stable and impervious layer of rock. In the absence of the safeguards the passage of water through the layer of alluvial deposit under the dam could cause erosion, and cause a breach to be formed under the dam.	Description: In the event of an earthquake creating ground acceleration at the dam site that are greater than that of dam design criteria there will a weakening of the dam structure.

The possible (but extremely unlikely) unwanted events that could lead to dam failure when then dam is in operation are (i) dam structure instability, and (ii) overtopping of the dam structure. The sequence of events that could lead to these unwanted events and ultimately dam failure is illustrated in the fault trees provided in Figure 18 and Figure 19. The different initiating events and the safeguard measures are described in Table 8 and Table 9.
