Fig.2 General Layout of the Project

Fig.3 Main Electric Wiring Figure of the Booster Station

NORTHWEST HYDRO CONSULT	
Verified by		Gancheng Wind Fa	
Inspected by			
CHK'D.		2007.12	
DESIGN		HDGK1-Y-06

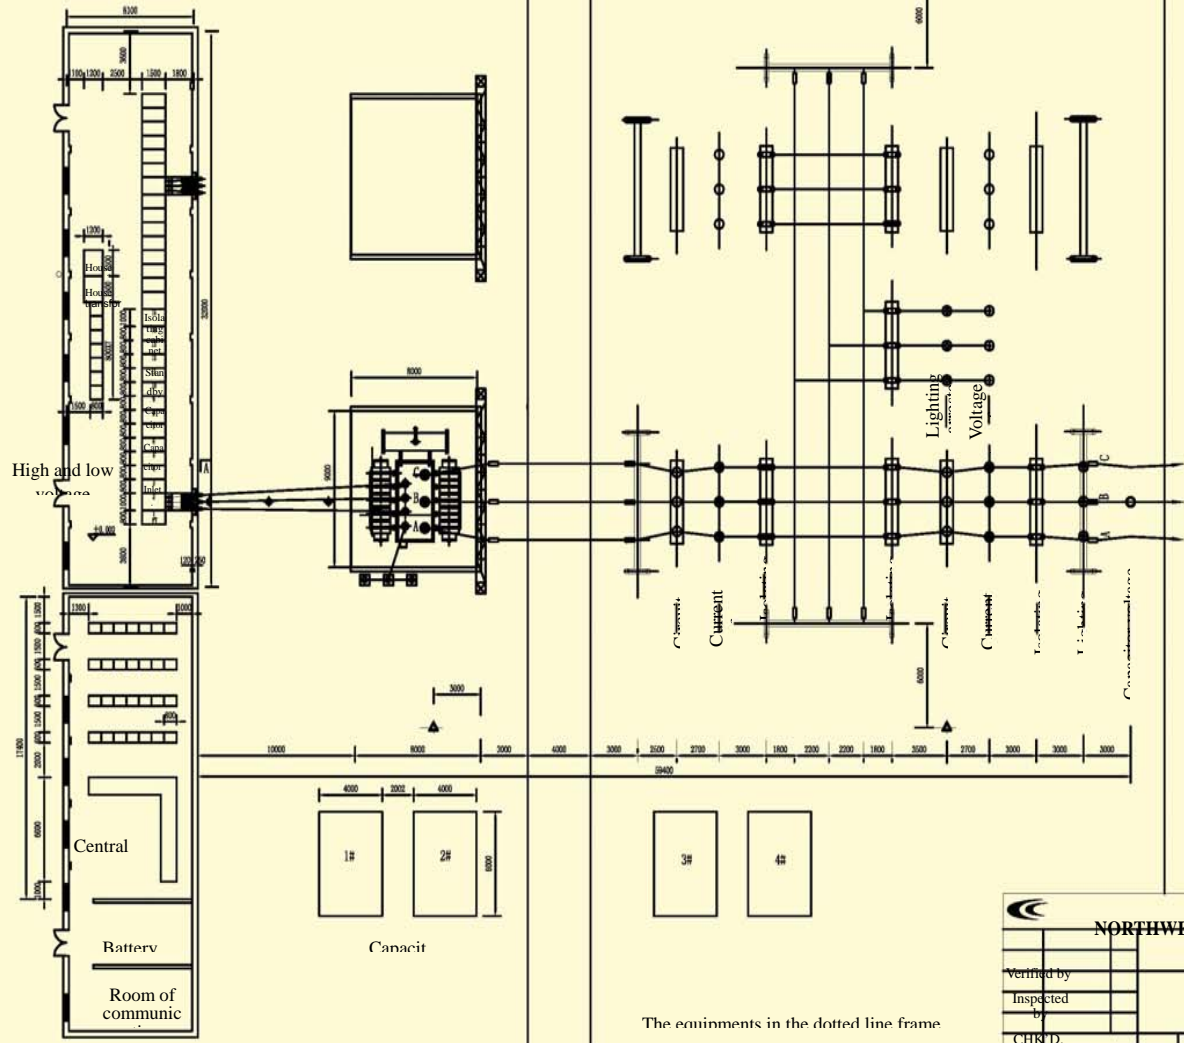
The equipments in the dotted line frame
